B3N 2H2 Block

Background

This block is a portion of Central Ave., in the Fairview neighbourhood of Halifax. Established primarily in the early 20th century, its streets are laid out in a grid pattern up the eastern slope of Geizers Hill.

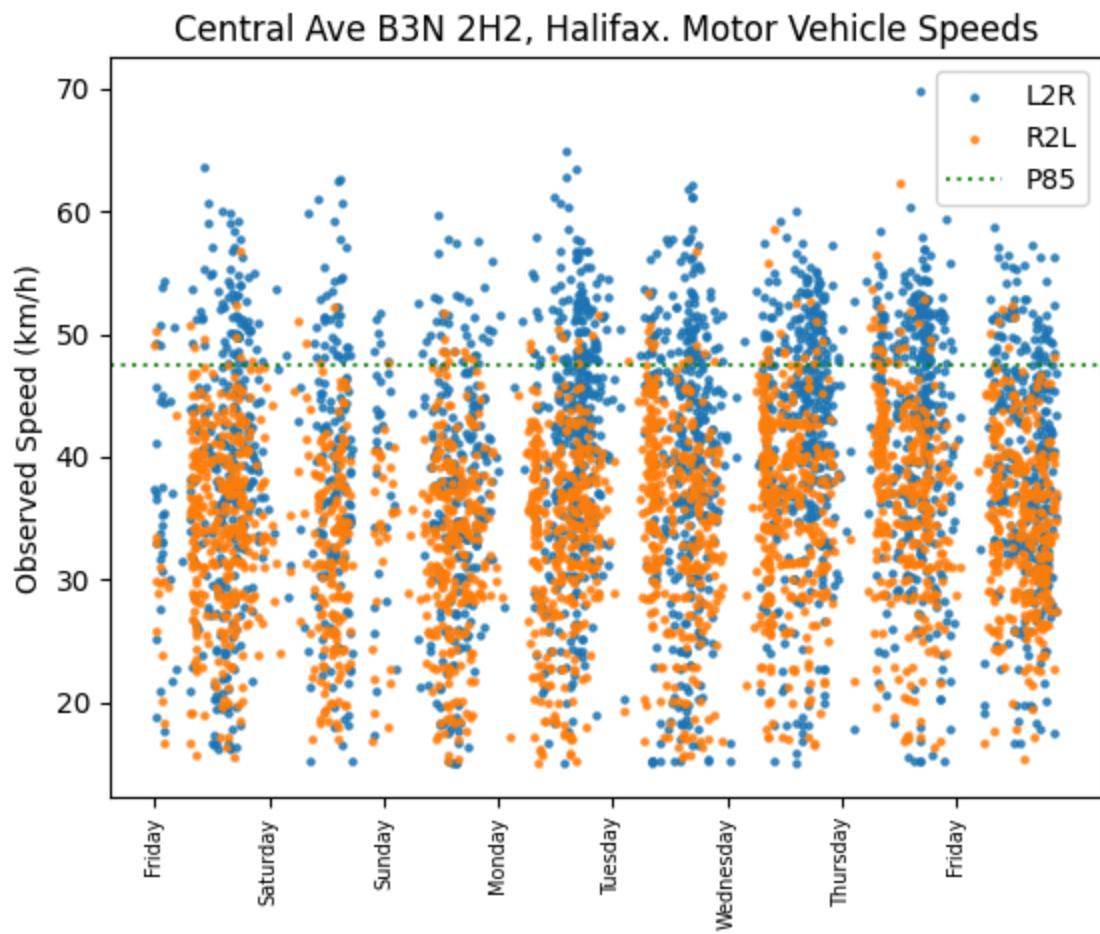
A scatter plot shows us the data in a raw form. Each dot represents a single observed vehicle. L2R and RL2 are acronyms for "Left To Right" and vice versa. On this street, there is a grade/slope (documented above). In simple terms, left to right (L2R) is going up hill. The 85th percentile is marked as the dotted P85 line.

The results of this test hold little surprises. This street is too wide and the single speed table installed up the slope has little effect. At a speed of 47km/h per hour at the 85th percentile, we see that most (85%) of vehicles go at or lower than the posted speed limit. However, it is silly that a residential road has a speed limit of 50km/h (the same posted limit as the urban highway nearby, Joseph Howe)

Additionally, we can see what is more problematic: There is plenty of opportunity to go faster than the posted speed limit. We see that 15% of vehicles are traveling over 47km/h, with some reaching variances as high as 60km/h. It is further concerning that we see typical speeds increase for L2R (Left to Right), as vehicles speed up the slope.

Prior to the installation of speed humps & tables, the primary concerns were around the spread in speeds. That spread continues to be significant, and it is clear that an optimal solution would be to reduce the width of the road.

This could be achieved by adding a side walk on the other side of the road without encroaching on existing boulevards and property lines. The existing sidewalk is 58 inches wide. If a similar sidewalk was implemented on the other side, the resulting road width would be near 300" (25 feet), which is comparable to traffic calmed streets like Liverpool (between 26 and 27 feet in width dependent on location)

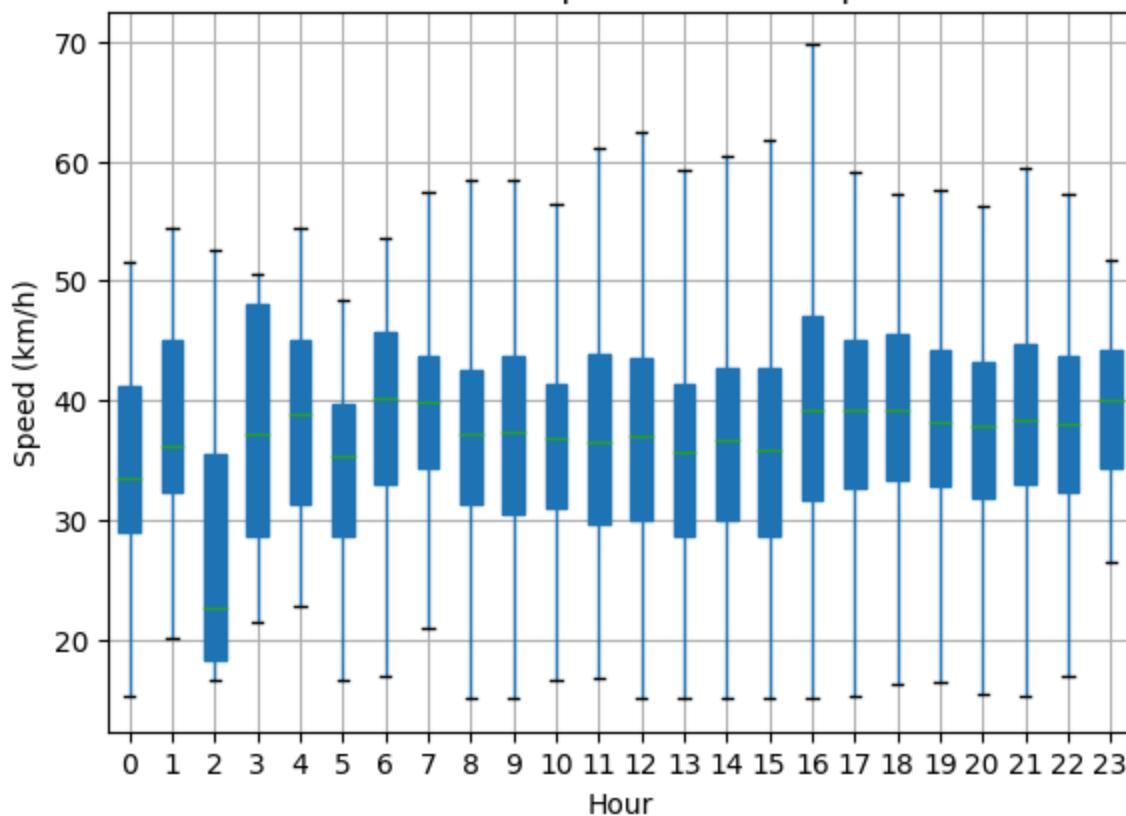
Motor Vehicle Speeds. Mean & Spread

As well, a box plot shows us motor vehicle mean & spread over each hour in the day. The data shown here is the same data (collected over a week), grouped by the hour.
