# **INDOOR AIR QUALITY ASSESSMENT**

**Furnace Brook Middle School**

**500 Furnace Street**

**Date of Assessment:** October 15, 2019

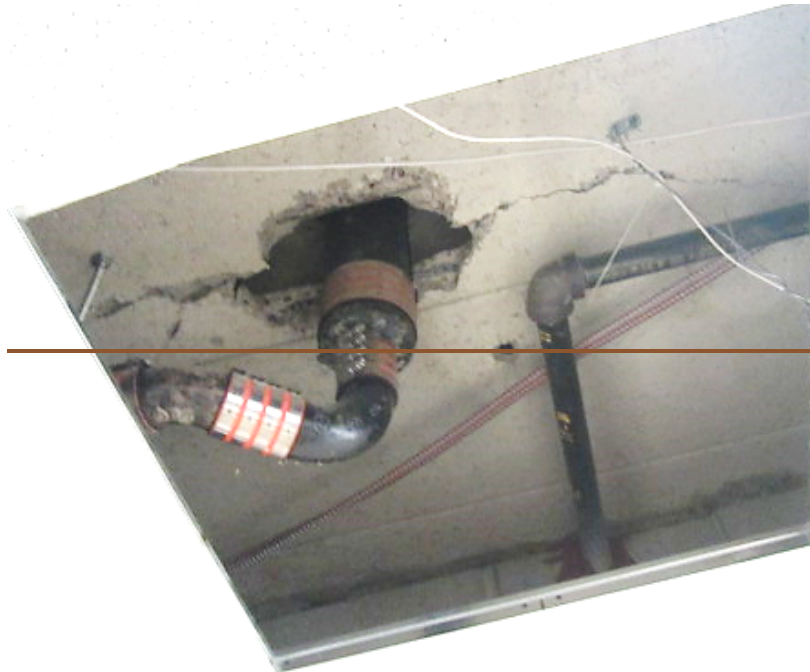
**Picture 1**

- ~~Conference Room: No measurable levels of TVOCs were detected in the breathing zone at the time of assessment; a slight reading of 2.4 ppm was measured in the utility hole above the ceiling (Picture 1).~~
- ~~Room 16: No measurable levels of TVOCs were detected in the breathing zone (note that the univent was operating and bringing in fresh air at the time of testing). A slight reading of 1.4 ppm was measured near the sealed skylight above the ceiling (Picture 2).~~

**Open utility hole in Conference Room**

- ~~4. Seal any/all open utility holes in walls and ceilings in both the Conference Room and Room 16.~~
- ~~5. If odors persist, work with roofing contractor, HVAC specialist and/or an Industrial Hygienist to examine more permanent solutions to remove and/or eliminate source of odors.~~

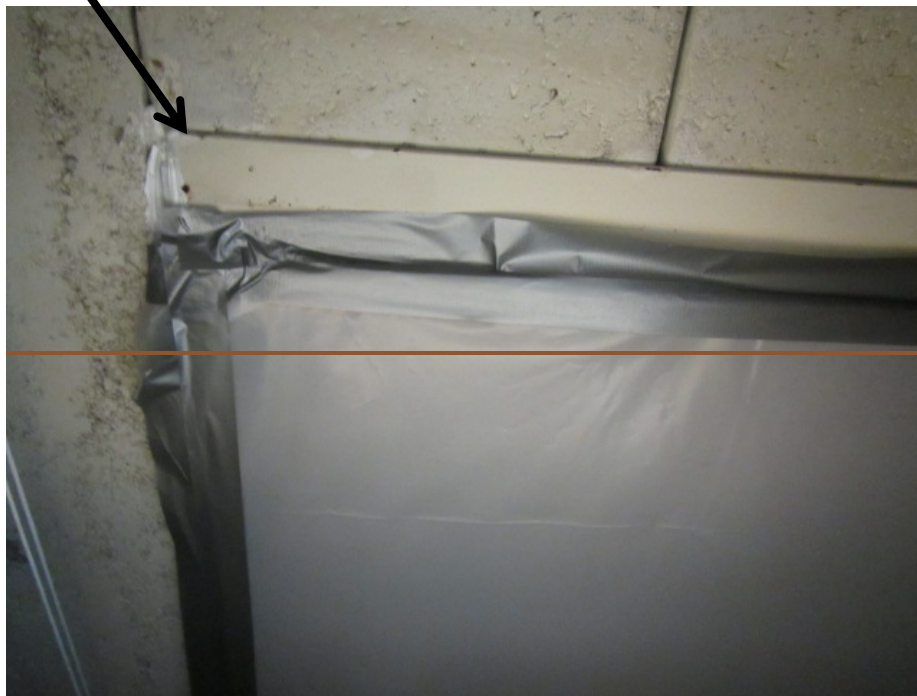
**Picture 2**

**Sealed skylight above ceiling in Room 16, note metal skylight frame (arrow)**

- ~~1. Ensure skylight is sealed as airtight as possible using caulking or other appropriate airtight sealant. Extend this covering over the metal skylight frame (shown in Picture 2).~~

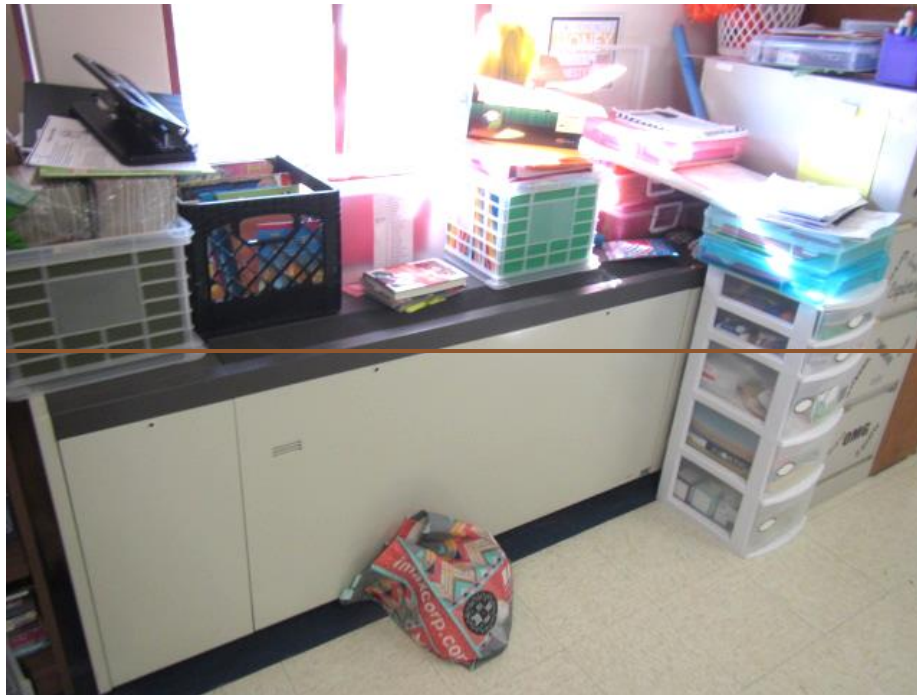
**Picture 3**

Mechanical ventilation for classroom 16, and most general classrooms, is provided by a unit ventilator (univent) located near classroom windows (Picture 3). Univents draw air from the outdoors through a fresh air intake located on the exterior wall of the building (Picture 4) and return air through an air intake located at the base of the unit. Fresh and return air are mixed, filtered, heated or cooled and provided to rooms through an air diffuser located in the top of the unit (Figure 1). It is important to note that the univent was reportedly deactivated for several days prior to the odor complaint. It was also reported that once the univent was reactivated odors began to lessen. Not only will operating the univent

**Classroom 16 univent**

- ~~2. Operate univent in Room 16 *continuously* during occupied hours and utilize openable windows to *pressurize* the room in relation to the ceiling plenum.~~

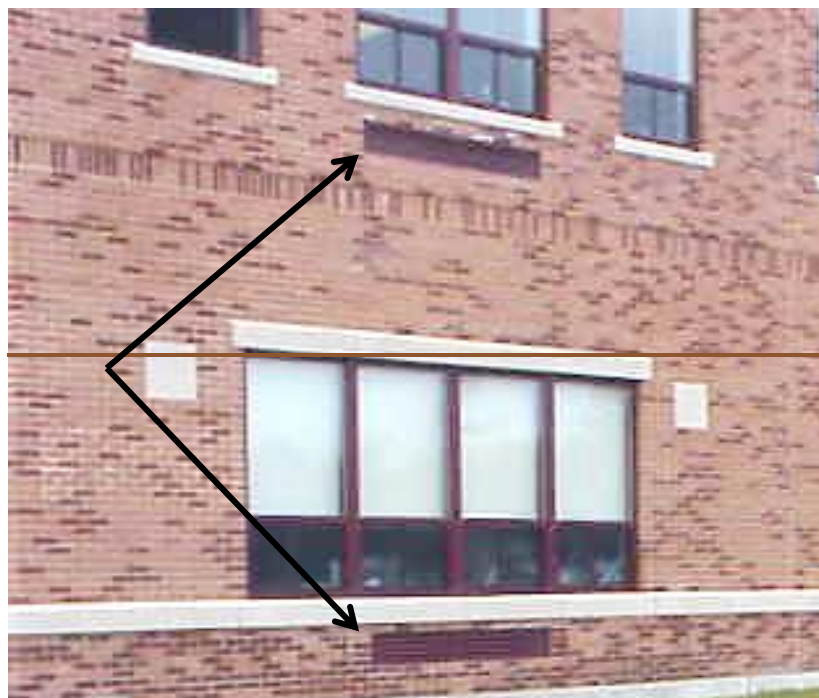
**Picture 4**

**Univent fresh air intakes (arrows)**

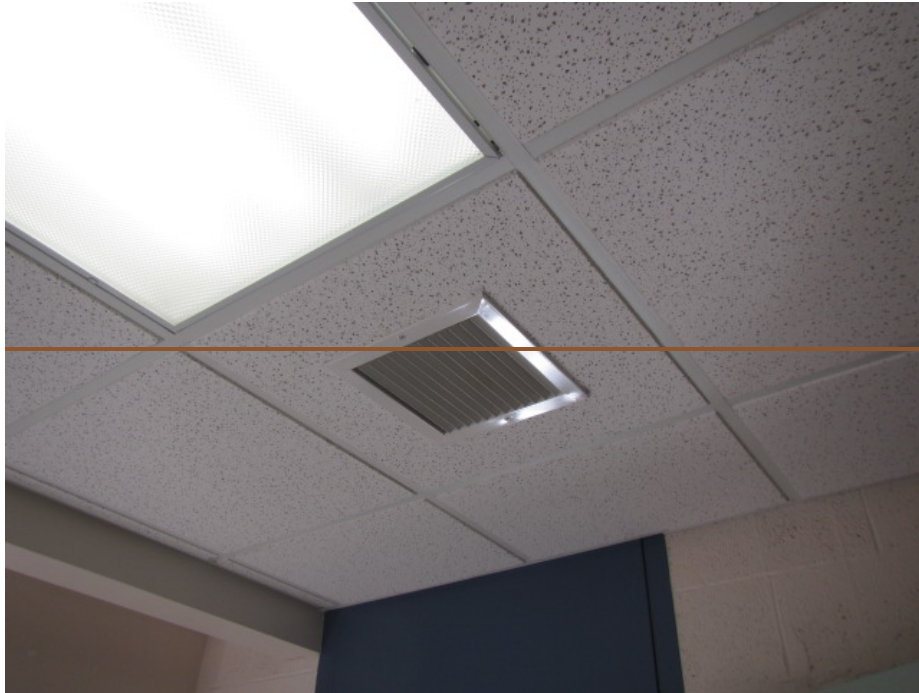
**Picture 5**

~~Most classrooms with mechanical ventilation typically have exhaust or return vents installed to remove naturally occurring airborne pollutants and provide air exchange. Room 16 does not have any exhaust/return vents. The Conference Room does have an operable mechanical exhaust vent mounted in the ceiling (Picture 5). BEH/IAQ Program staff recommended installing a vent in the exhaust ductwork above the ceiling (Picture 6) to depressurize the ceiling plenum in relation to the Conference Room, which will capture odors (if present) before they reach the occupied area.~~

**Ceiling-mounted exhaust vent in Conference Room**

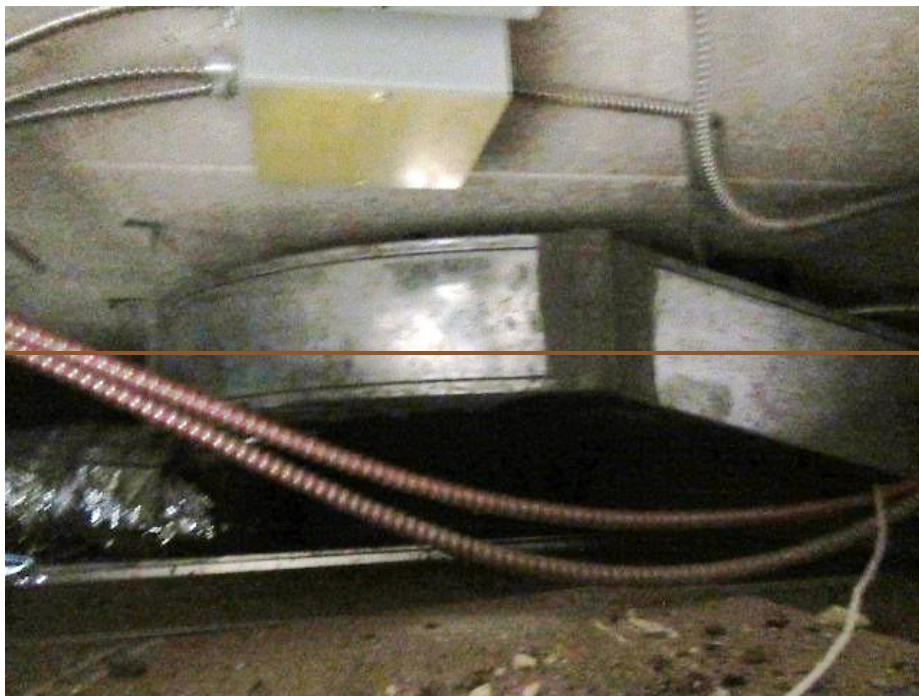
**Picture 6**

**Exhaust ductwork above ceiling in Conference Room**

- ~~3. Consider installing a vent or approximate one by drilling holes in the exhaust duct above the ceiling in the Conference Room to *depressurize* the ceiling plenum, which will capture odors (if present) and remove from building.~~
