Report of
Geotechnical Investigation
Parkway Village Apartments – West Complex
3103 - 3135 7th Place NE
Salem, Oregon

**CGT Project Number G1303961.A**

January 3, 2014

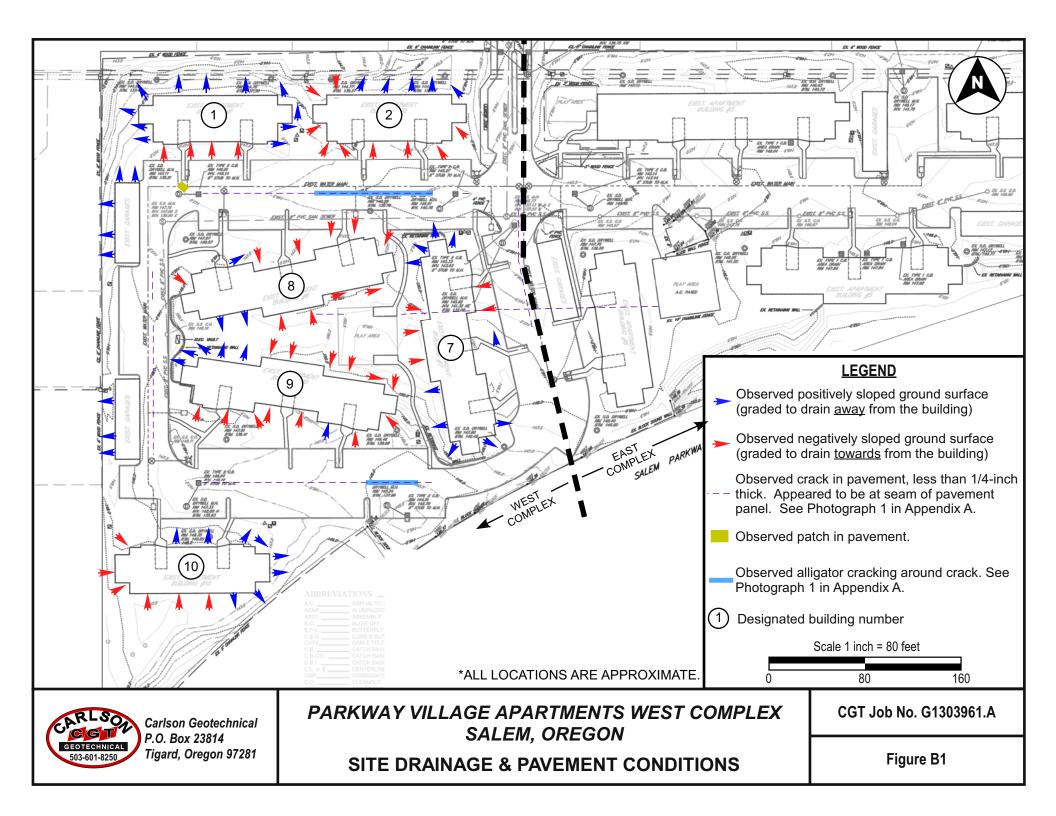
As shown on Figure B1 of the attached Appendix B, we observed some pavement areas that exhibited distress (surface deficiencies) in the form of cracking and localized disintegration (raveling). Photographs showing examples of surface deficiencies in existing pavement are shown in the attached Appendix A. We interpret the surface deficiencies observed within the existing pavement are the result of the pavement structure being near the end of its intended service life. Further deterioration of the existing pavement is expected to occur over time in its current condition and with future use.

- Option 1 Complete Removal & Replacement: This option would include complete removal of the
  existing pavement structure and replacement with a new pavement section. Geotechnical
  recommendations for pavement removal, preparation, placement, and compaction of new pavement
  sections at the site in Section 9.8 of this report.

- Option 2 Surface Treatment: This option would include treating surface deficiencies identified at
  the site with the intent to extend the service life of the existing pavement. Surface treatments, in the
  form of sealants, can be performed to repair most of the cracks identified within existing pavements.
  Sawcutting and patching could be performed in other areas exhibiting increased deterioration.
  Limitations of surface treatments would need to be recognized and accepted by the owner. If this
  option is considered, CGT can provide recommendations for treatment of existing pavement on a
  case-by-case basis for an additional fee.
