# MAIN DDR (DETAILED DIAGNOSTIC REPORT)

Generated strictly from: Sample Report.pdf and Thermal Images.pdf  
No outside data. Missing or unclear details are marked as Not Available.

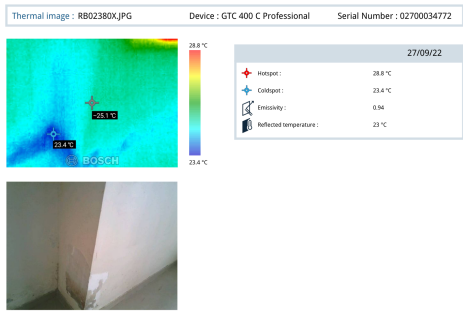
Inspection observation: Observed dampness at the skirting level of Hall of Flat No. 103  
Linked exposed/positive-side observation: Observed gaps between the tile joints of Common Bathroom of Flat No. 103  
Thermal readings from mapped thermal pages: Page 1 (RB02380X.JPG): Hotspot 28.8 °C, Coldspot 23.4 °C; Page 2 (RB02386X.JPG): Hotspot 27.4 °C, Coldspot 22.4 °C; Page 3 (RB02395X.JPG): Hotspot 27 °C, Coldspot 22 °C; Page 4 (RB02402X.JPG): Hotspot 25.7 °C, Coldspot 20.7 °C  
Image evidence from provided PDFs:

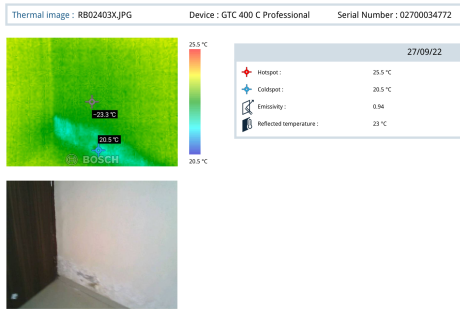
Inspection observation: Observed dampness at the skirting level of the Common Bedroom of Flat No. 103  
Linked exposed/positive-side observation: Observed gaps between the tile joints of Common Bathroom of Flat No. 103  
Thermal readings from mapped thermal pages: Page 5 (RB02403X.JPG): Hotspot 25.5 °C, Coldspot 20.5 °C; Page 6 (RB02404X.JPG): Hotspot 25.8 °C, Coldspot 20.8 °C; Page 7 (RB02405X.JPG): Hotspot 26.2 °C, Coldspot 21.2 °C; Page 8 (RB02406X.JPG): Hotspot 26.5 °C, Coldspot 21.5 °C  
Image evidence from provided PDFs:

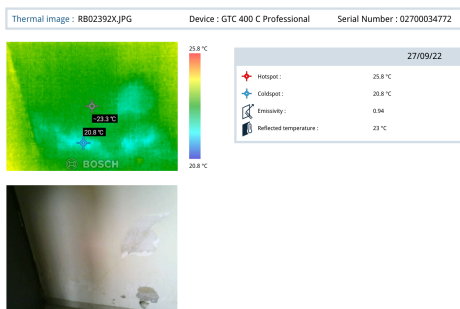
Inspection observation: Observed dampness at the skirting level of Master Bedroom of Flat No. 103

Linked exposed/positive-side observation: Observed gaps between the tile joints of Master Bedroom Bathroom of Flat No. 103

Thermal readings from mapped thermal pages: Page 9 (RB02392X.JPG): Hotspot 25.8 °C, Coldspot 20.8 °C; Page 10 (RB02393X.JPG): Hotspot 25.9 °C, Coldspot 20.9 °C; Page 11 (RB02394X.JPG): Hotspot 26 °C, Coldspot 21 °C; Page 12 (RB02396X.JPG): Hotspot 26.1 °C, Coldspot 21.1 °C

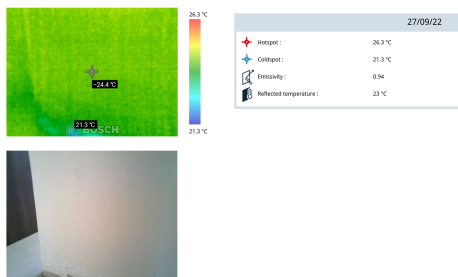
Inspection observation: Observed dampness at the skirting level of Kitchen of Flat No. 103

Linked exposed/positive-side observation: Observed gaps between the tile joints of Master Bedroom Bathroom of Flat No. 103

Thermal readings from mapped thermal pages: Page 13 (RB02397X.JPG): Hotspot 26.3 °C, Coldspot 21.3 °C; Page 14 (RB02398X.JPG): Hotspot 25.6 °C, Coldspot 20.6 °C; Page 15 (RB02399X.JPG): Hotspot 26.5 °C, Coldspot 21.5 °C; Page 16 (RB02400X.JPG): Hotspot 25.2 °C, Coldspot 20.2 °C

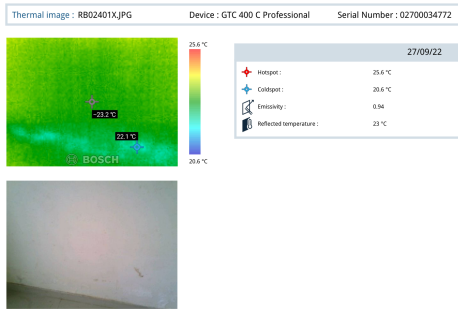
Inspection observation: Observed dampness & efflorescence on the wall surface of Master Bedroom of Flat No. 103

Linked exposed/positive-side observation: Observed cracks on the External wall of building near Master Bedroom of Flat No. 103

Thermal readings from mapped thermal pages: Page 17 (RB02401X.JPG): Hotspot 25.6 °C, Coldspot 20.6 °C; Page 18 (RB02381X.JPG): Hotspot 27 °C, Coldspot 22 °C; Page 19 (RB02382X.JPG): Hotspot 26.7 °C, Coldspot 21.7 °C; Page 20 (RB02383X.JPG): Hotspot 26.5 °C, Coldspot 21.5 °C

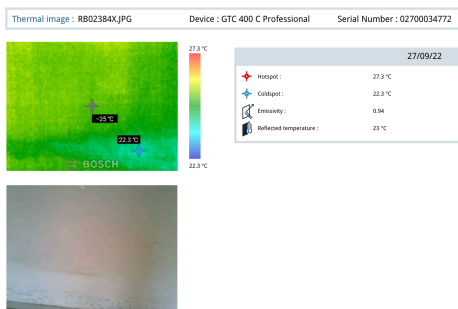
Inspection observation: Observed leakage at the Parking ceiling below Flat No. 103

Linked exposed/positive-side observation: Observed plumbing issue & gaps between the tile joints of Common Bathroom of Flat No. 103

Thermal readings from mapped thermal pages: Page 21 (RB02384X.JPG): Hotspot 27.3 °C, Coldspot 22.3 °C; Page 22 (RB02385X.JPG): Hotspot 27.3 °C, Coldspot 22.3 °C; Page 23 (RB02387X.JPG): Hotspot 25.2 °C, Coldspot 20.2 °C; Page 24 (RB02388X.JPG): Hotspot 25.1 °C, Coldspot 20.1 °C
