# MAIN DDR (DETAILED DIAGNOSTIC REPORT)

| <b>Inspection Date and Time</b> | 27.09.2022 14:28 IST |
| <b>Property Type</b> | Flat |

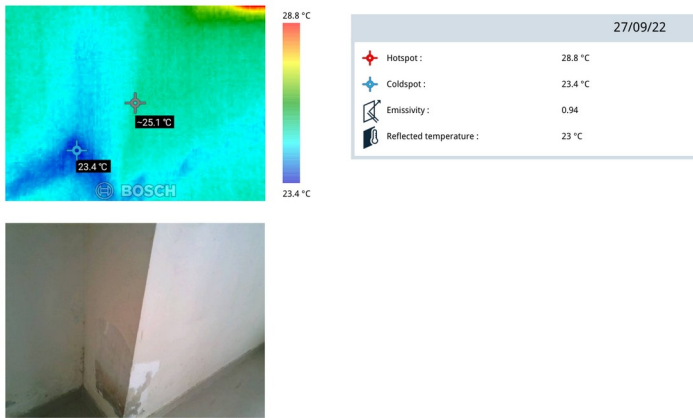
thermal page 01

| <b>Inspection observation</b> | Observed dampness at the skirting level of Hall of Flat No. 103 |
| <b>Linked exposed/positive side finding</b> | Observed gaps between the tile joints of Common Bathroom of Flat No. 103 |
| <b>Severity note</b> | Moderate (checklist records leakage condition and related defects as moderate/yes where applicable). |

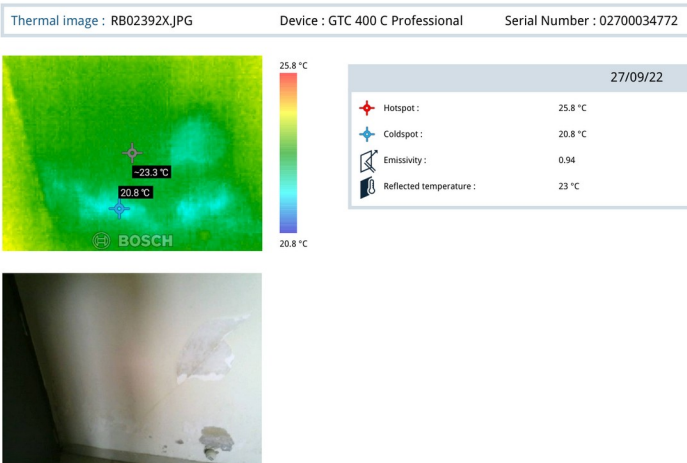
thermal page 09

Observed dampness at the skirting level of the Common Bedroom of Flat No. 103

Observed gaps between the tile joints of Common Bathroom of Flat No. 103

Moderate (same checklist category and dampness/leakage context).

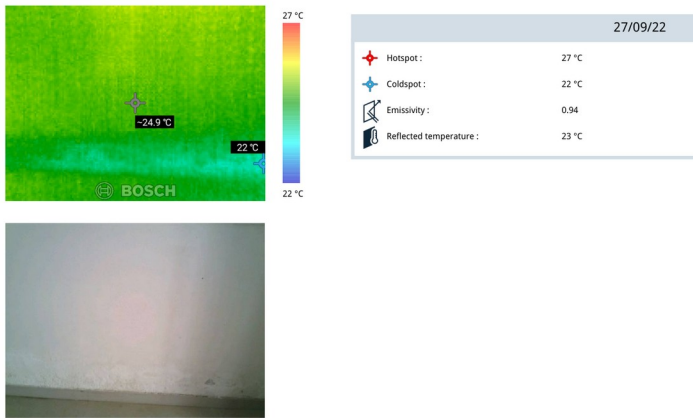
thermal page 18

Observed dampness at the skirting level of Master Bedroom of Flat No. 103

Observed gaps between the tile joints of Master Bedroom Bathroom of Flat No. 103

Moderate (same checklist category and dampness/leakage context).

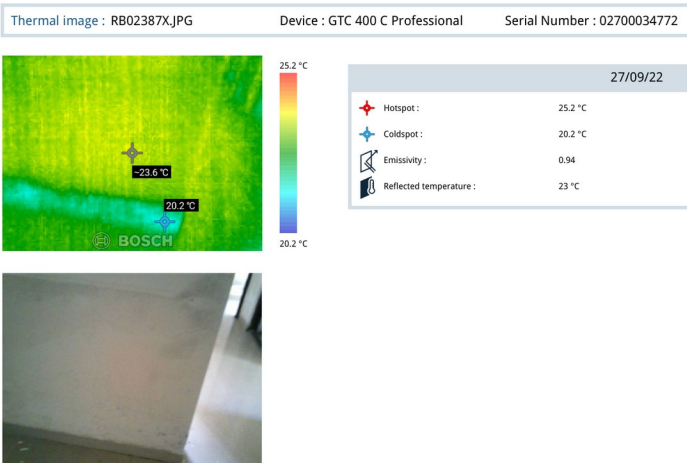
thermal page 23

Observed dampness at the skirting level of Kitchen of Flat No. 103

Observed gaps between the tile joints of Master Bedroom Bathroom of Flat No. 103

Moderate (same checklist category and dampness/leakage context).

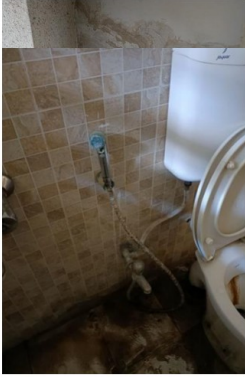
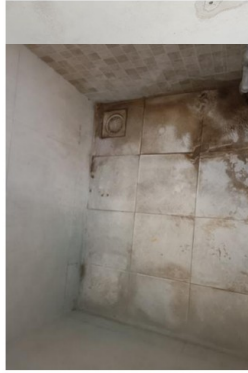
Observed mild dampness at the ceiling of Common Bathroom of Flat No. 103

Observed gap between tile joints of Common & Master Bedroom Bathrooms of Flat No. 203

Moderate (inspection mentions mild dampness, but checklist still records relevant leakage causes as Yes).
