# DETAILED DIAGNOSTIC REPORT (DDR)

## DETAILED DIAGNOSTIC REPORT (DDR)

**Inspection Date:** 27.09.2022, 14:28 IST **Inspected By:** Krushna & Mahesh **Property Type:** Flat (11 Floors) **Previous Structural Audit:** No **Previous Repair Work:** No **Inspection Score:** 85.71% | Flagged Items: 1

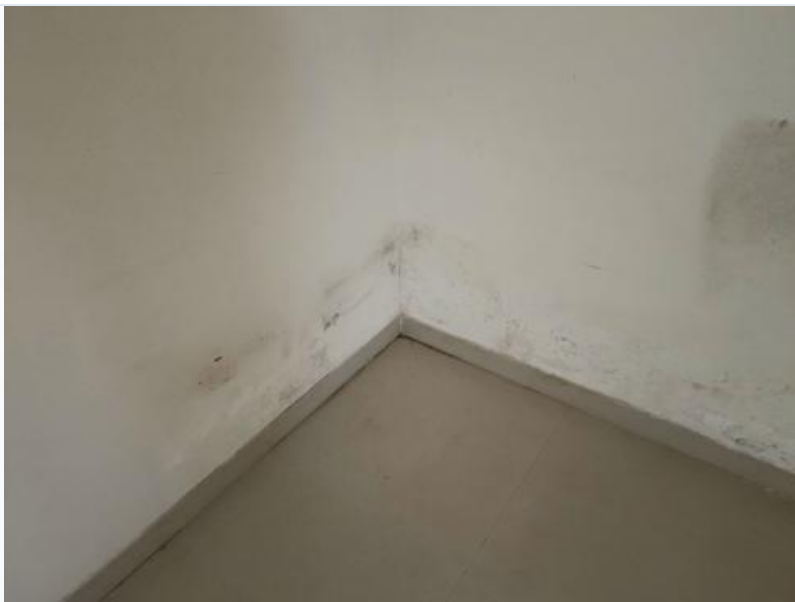
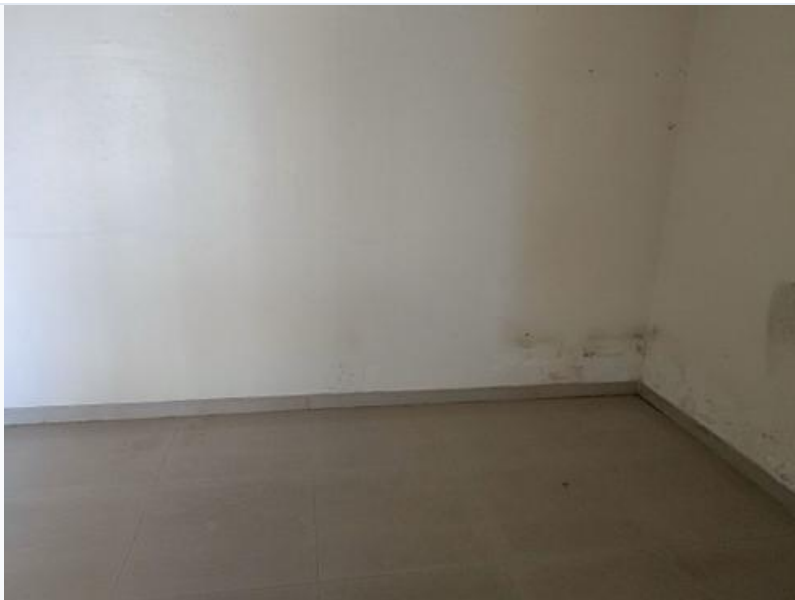
- **Negative Side (Damage):** Skirting-level dampness observed along hall walls, indicating prolonged moisture exposure at the base.

- **Positive Side (Source):** Traced to Common Bathroom — tile hollowness detected, allowing water to seep through the floor substrate and travel to adjacent hall walls.

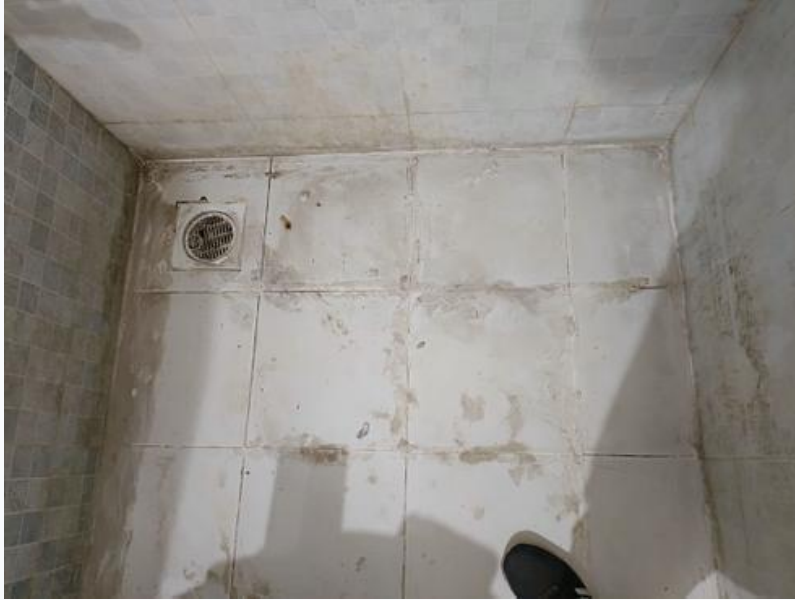
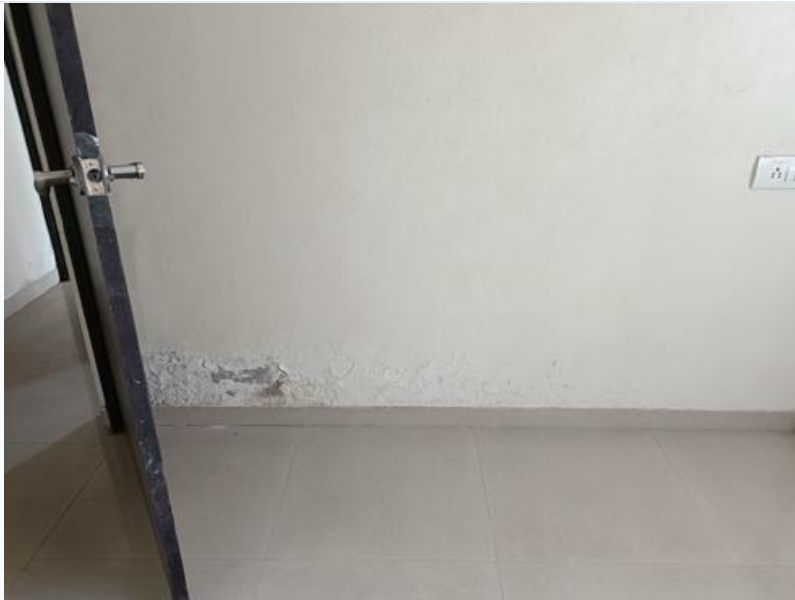
- **Positive Side (Source):** Same source as Hall — Common Bathroom tile hollowness. The bedroom shares a wall with the bathroom, and water is migrating through the masonry.

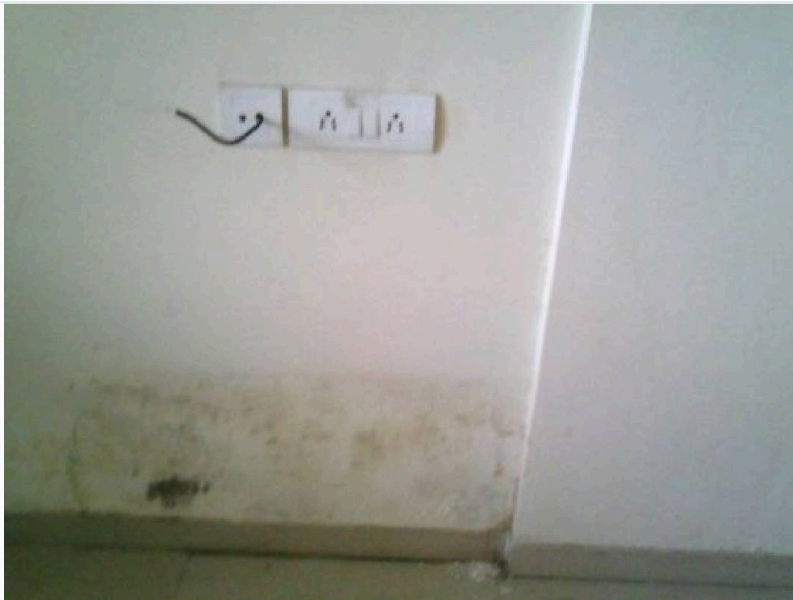
- **Thermal Findings:** Temperature differential of approximately 5°C observed between hot and cold spots, consistent with subsurface moisture.

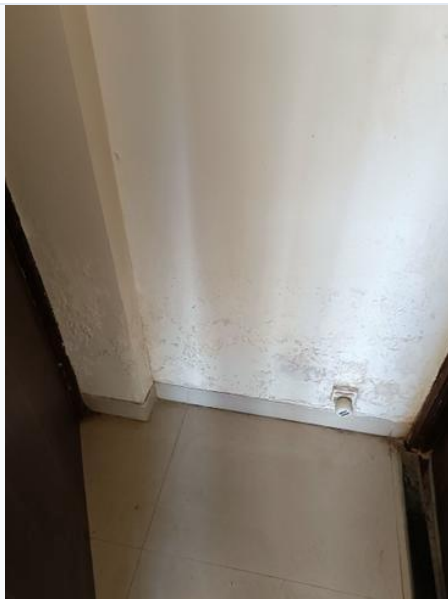
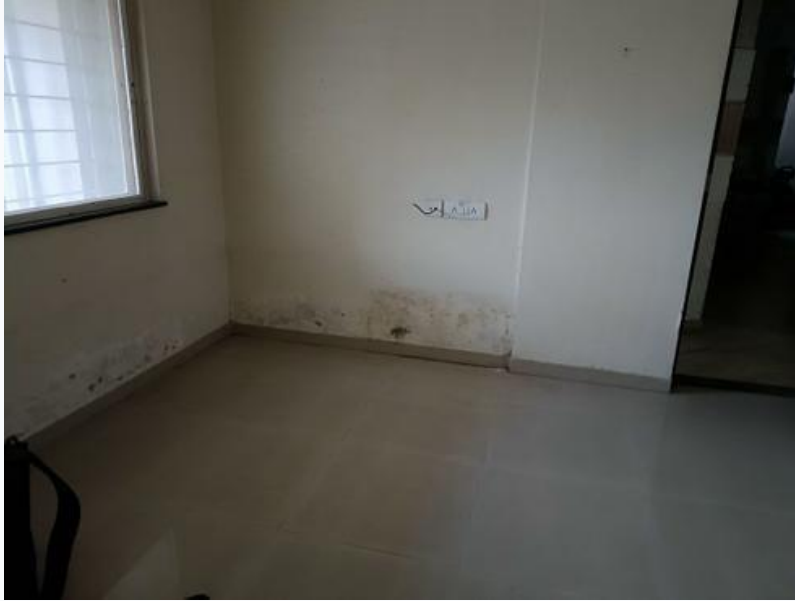
- **Negative Side (Damage):** Skirting-level dampness observed along the base of walls.

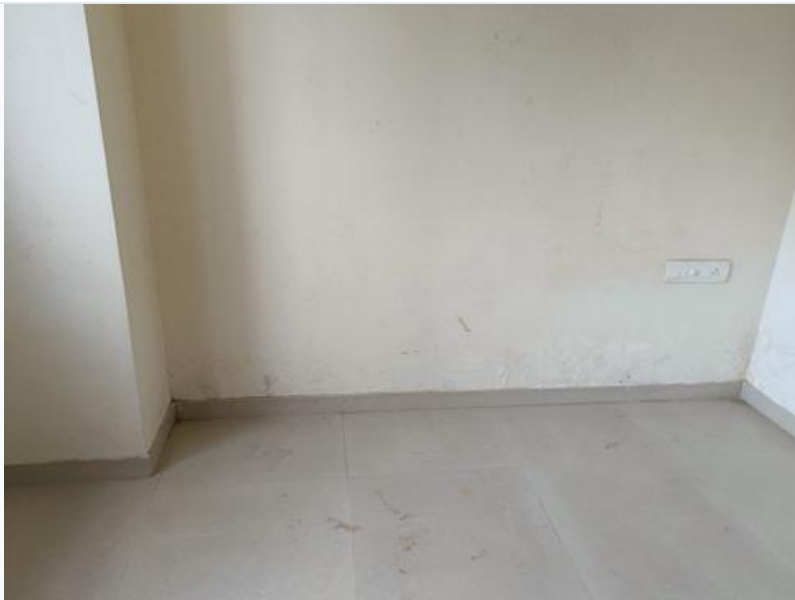
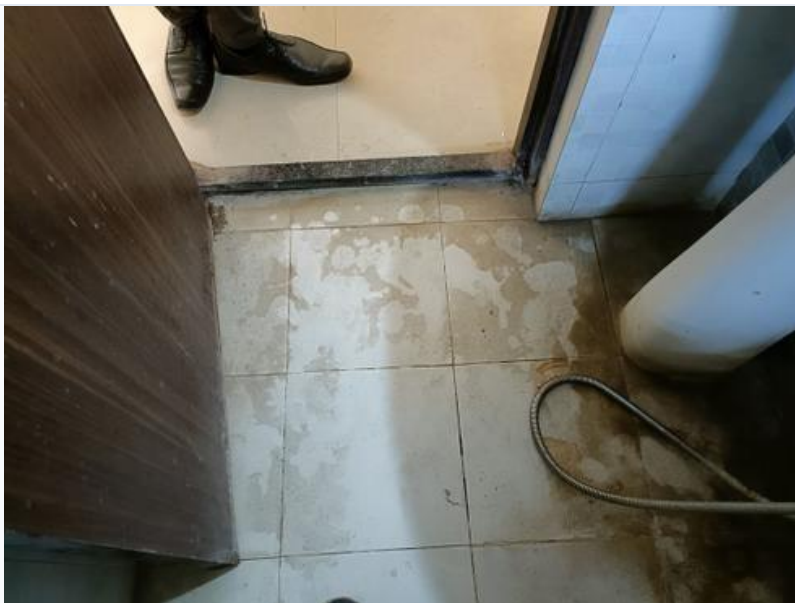
- **Positive Side (Source):** Master Bedroom Bathroom — tile hollowness detected, gaps in tile joints, gaps around Nahani trap, and loose plumbing joints with visible rust around edges.

- **Leakage Details:** Continuous ("All time") leakage confirmed. Cause attributed to concealed plumbing defects and damaged Nahani trap/brickbat coba layer beneath the tile flooring.
- **Thermal Findings:** Thermal scans show hotspot of 25.7°C and coldspot of 20.7°C, confirming active moisture zones.

1. **Bathroom Waterproofing Overhaul (Common & Master Bedroom Bathrooms)** - Remove all existing tiles in both bathrooms - Inspect and repair/replace the Nahani trap and brickbat coba layer - Apply fresh waterproofing membrane (polymer-modified cementitious coating recommended) - Re-tile with proper adhesive and sealed grout joints - Conduct water retention test (48-hour ponding test) before finishing
2. **Plumbing Fixture Replacement** - Replace all corroded/loose plumbing joints (flush tank, shower, angle cock, bibcock, washbasin connections) - Pressure-test concealed plumbing lines to identify hidden leaks - Replace any damaged concealed pipes

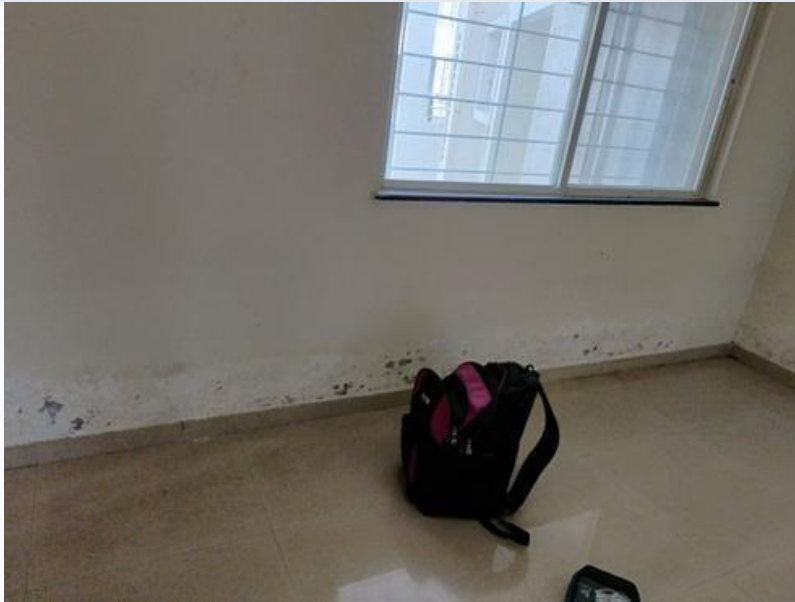
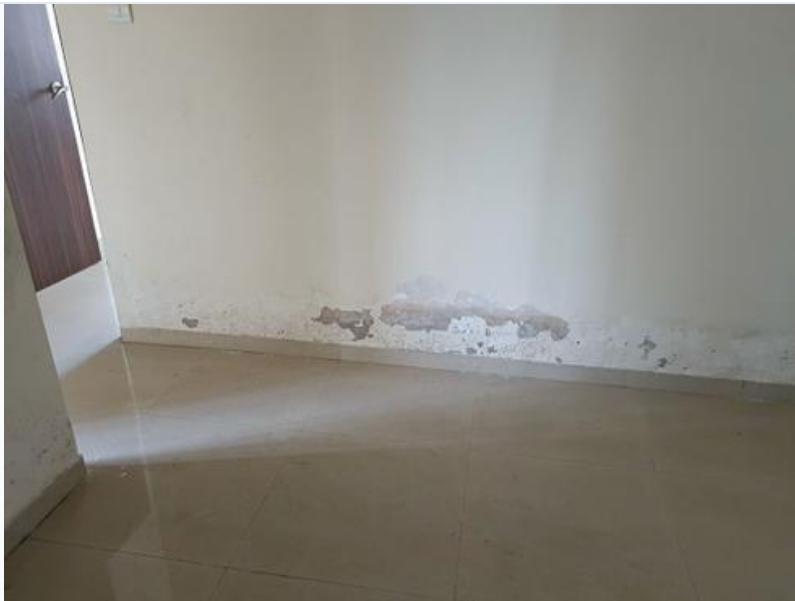
- **Negative Side (Damage):** Skirting-level dampness observed.

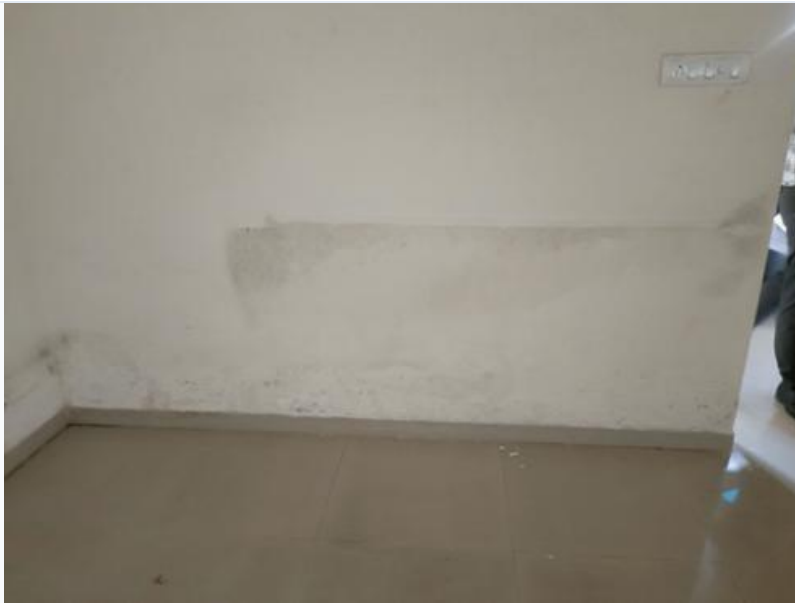
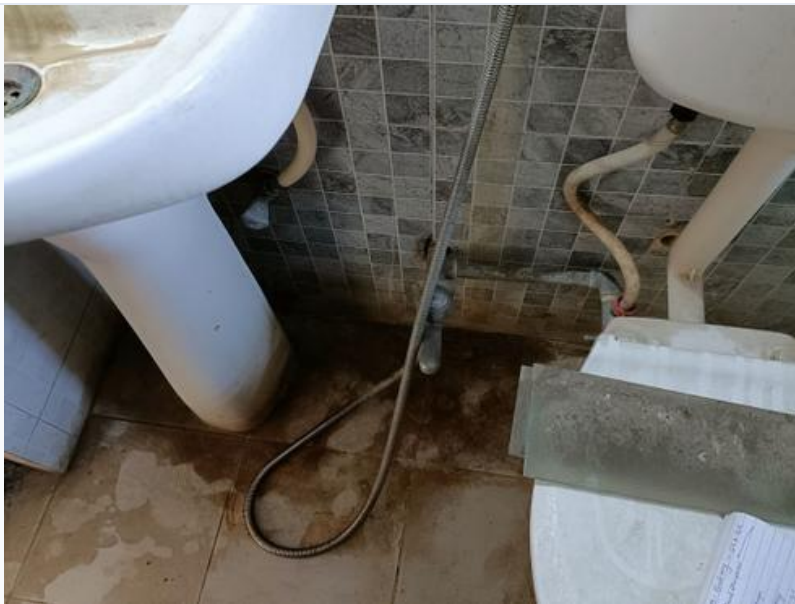
- **Positive Side (Source):** Traced to the Master Bedroom Bathroom, which shares a common wall with the kitchen. Water from the bathroom is migrating laterally through the wall structure.

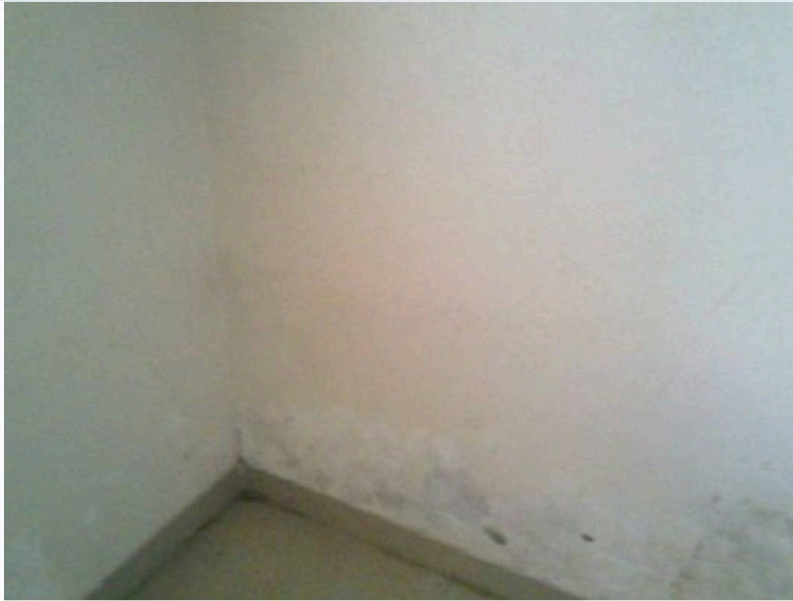
- **Thermal Findings:** Temperature range of 20.8°C to 25.8°C recorded, supporting the presence of moisture within the shared wall.

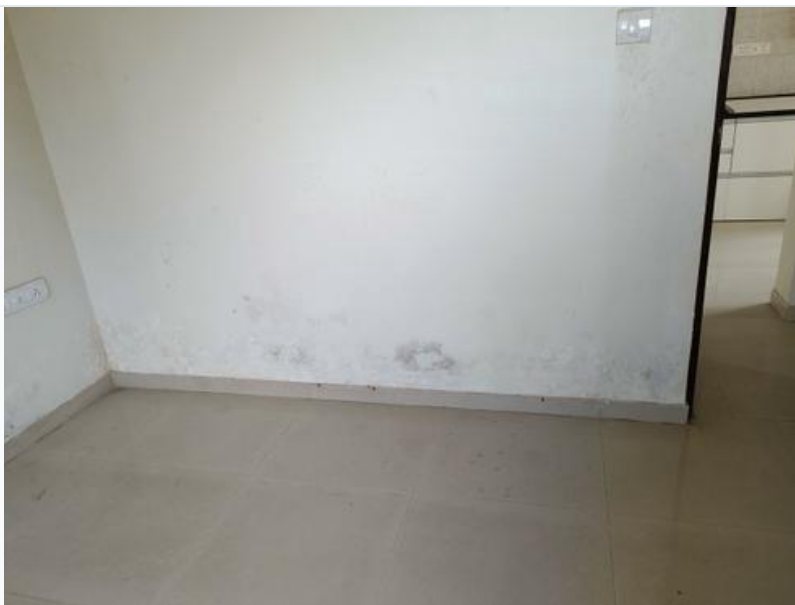
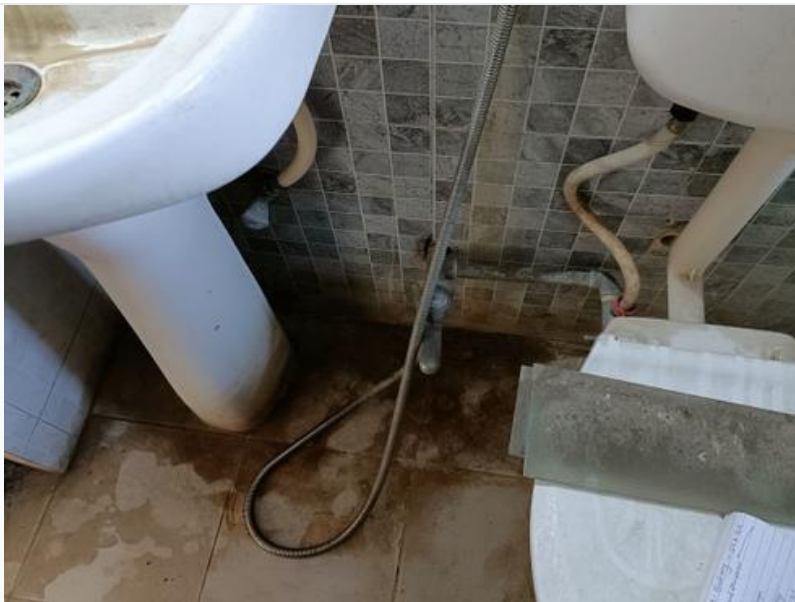
- **Positive Side (Source):** External wall cracks and duct issues identified. Moderate major and minor cracks were observed on the external surface, along with cracked and leaking external plumbing pipes. Algae, fungus, and moss growth on the external wall confirms prolonged moisture exposure.

Moderate cracks on the external wall allow rainwater ingress into the Master Bedroom walls. Cracked external plumbing pipes add to the problem. The presence of algae, fungus, and moss confirms the wall has been absorbing moisture for an extended period.

3. **External Wall Repair** - Fill all external wall cracks using appropriate crack-filling compound - Repair/replace cracked external plumbing pipes - Clean and treat biological growth (algae, fungus, moss) with anti-fungal solution - Apply waterproof external coating after repairs

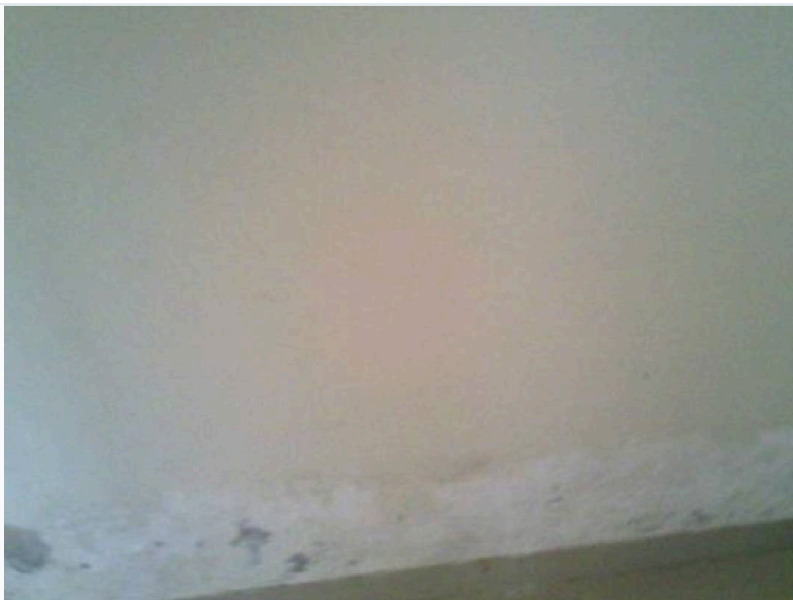
- **Thermal Findings:** Temperature range of 21.2°C to 26.2°C recorded in surrounding areas, consistent with moisture migration through the slab.

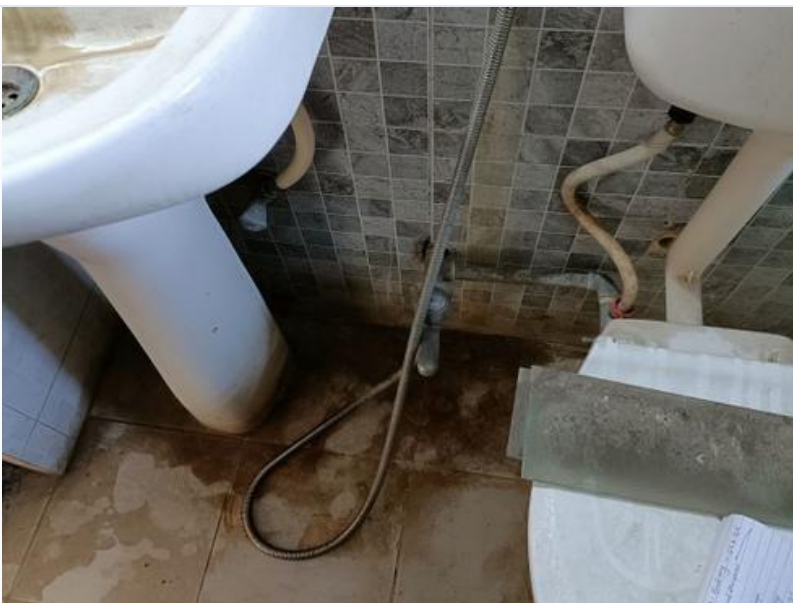
- **Negative Side (Damage):** Ceiling dampness observed in the Common Bathroom. Additionally, outlet leakage was noted.

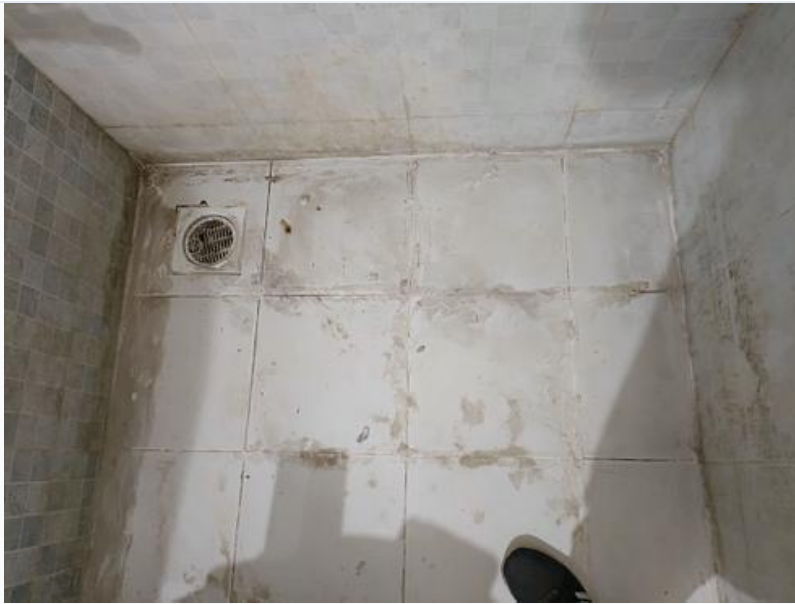
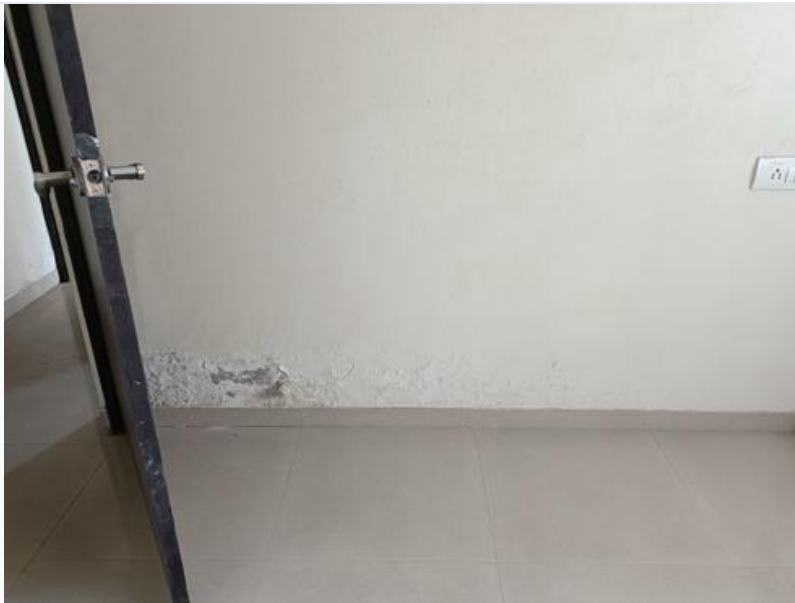
- **Positive Side (Source):** The leakage originates from Flat No. 203 (the unit directly above). Open tile joints and outlet leakage in Flat 203's bathroom are causing water to seep through the floor slab into this

unit's ceiling.

Open tile joints and outlet leakage in the flat above (203) are causing water to seep through the floor slab, resulting in ceiling dampness in the Common Bathroom of the subject property.

4. **Inter-floor Coordination (Flat 203)** - Notify building management about leakage from Flat 203 - Request inspection and repair of open tile joints and outlet in Flat 203's bathroom - Monitor ceiling dampness after repairs are completed upstairs
