GPI Greenman-Pedersen, Inc.

Re: NJTA OPS A3575
2016-2019 New Jersey Turnpike Authority Major Bridge Inspection Program
Turnpike Structure E109.83 - Cracked Floorbeam Webs at Main River Unit Intermediate Deck Joints - 2018 Biennial / 4th Interim Inspection Findings

Re: NJTA OPS A3575
2016-2019 New Jersey Turnpike Authority Major Bridge Inspection Program
Turnpike Structure E109.83 - Newly Discovered Floorbeam and Stringer Cracks at the Main River Unit Intermediate Deck Joints

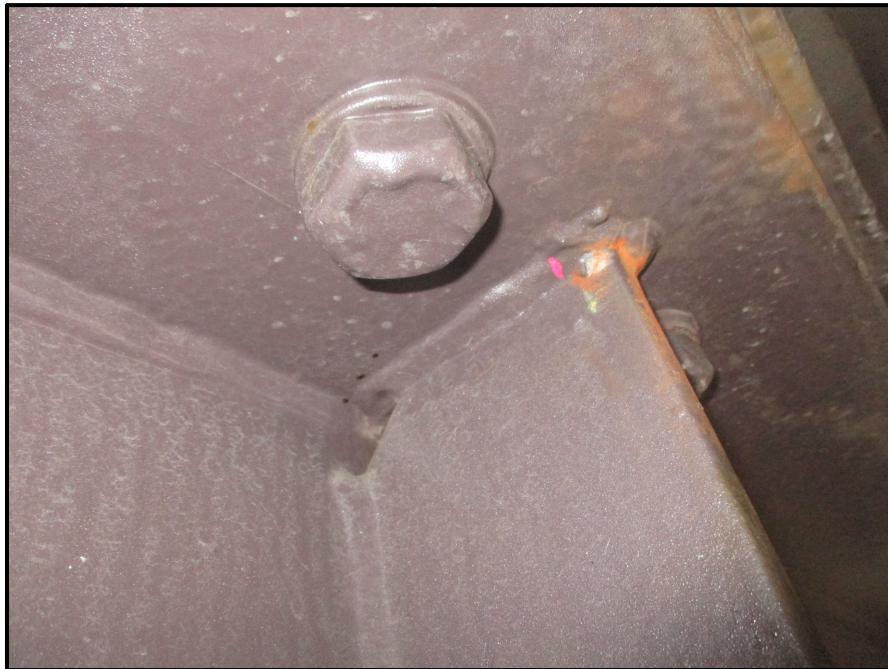
1. There are floorbeam web stiffener-to-upper flange weld deficiencies at 49 locations:
 - a. Two (2) of the cracks have grown in length since the 3rd Interim Inspection (April 2018) (**See Photos 1 and 2**);

Photo 1: Span S1, Floorbeam 8S at Stringer 2S - The previously cracked top weld on the south face floorbeam web stiffener has grown 1/4" in length on the west side of the stiffener, looking northeast.

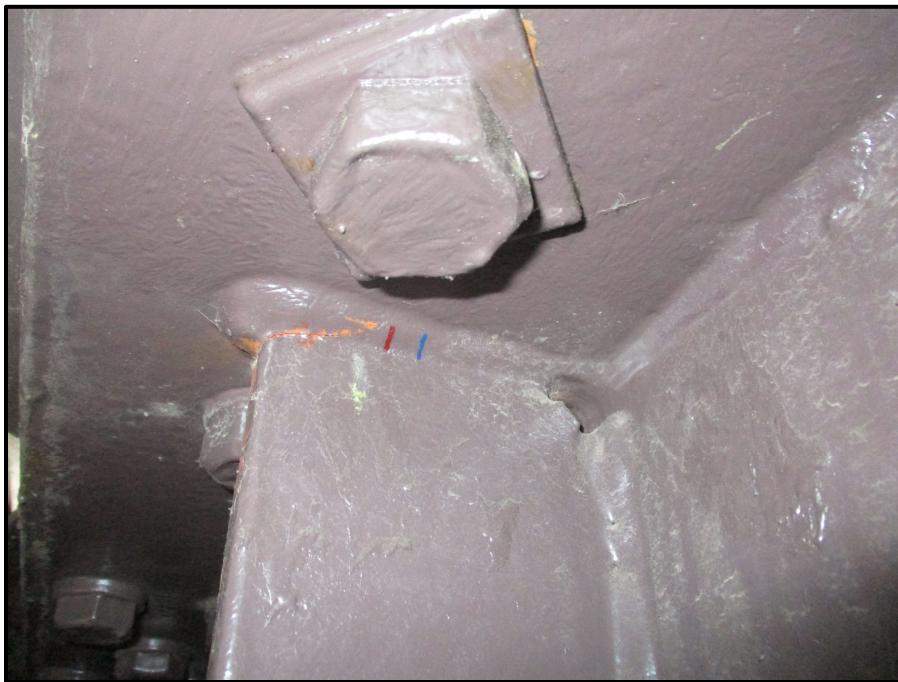
Photo 2: River Span-S, Floorbeam 18S at Stringer 2S - The previously cracked top weld on the south face floorbeam web stiffener has grown 3/8" in length on the east side of the stiffener, looking northwest.

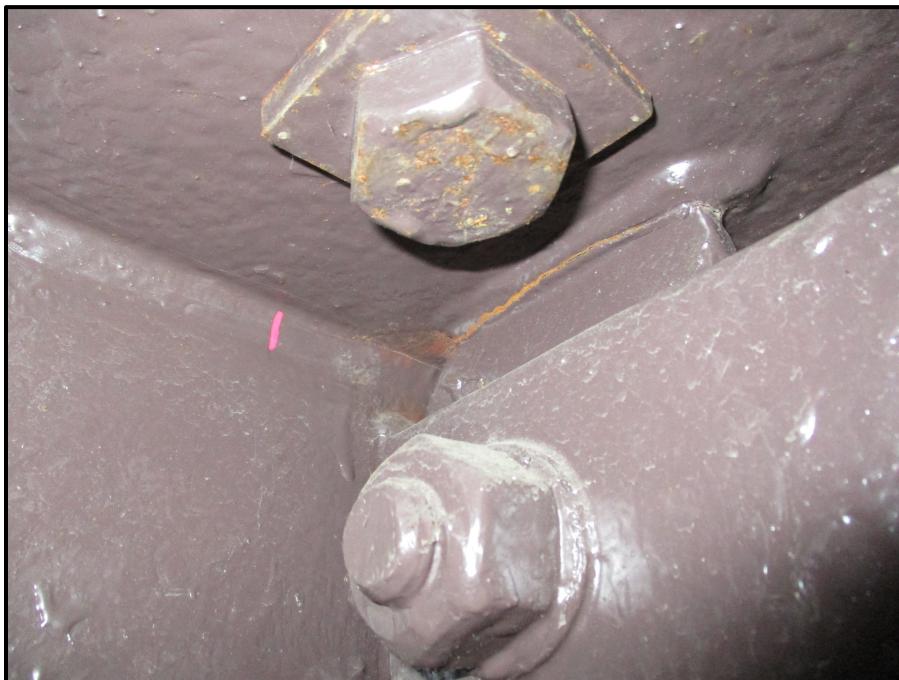
- e. North face of Floorbeam 14N at Stringer 14N in River Span-N: 3/4" growth. **See Photo 12.**
3. The previously noted distressed paint along the north face of the upper web at Floorbeam 18S beneath Stringer 3N in the River Span-S has now developed into a 5'L crack. **See Photo 3.**

Photo 3: River Span-S, Floorbeam 18S at Stringer 3N - Previously noted distressed paint along the north face of the floorbeam upper web has now developed into a 5'L crack, looking southwest. Note the completely severed web stiffener top weld (previously noted condition).

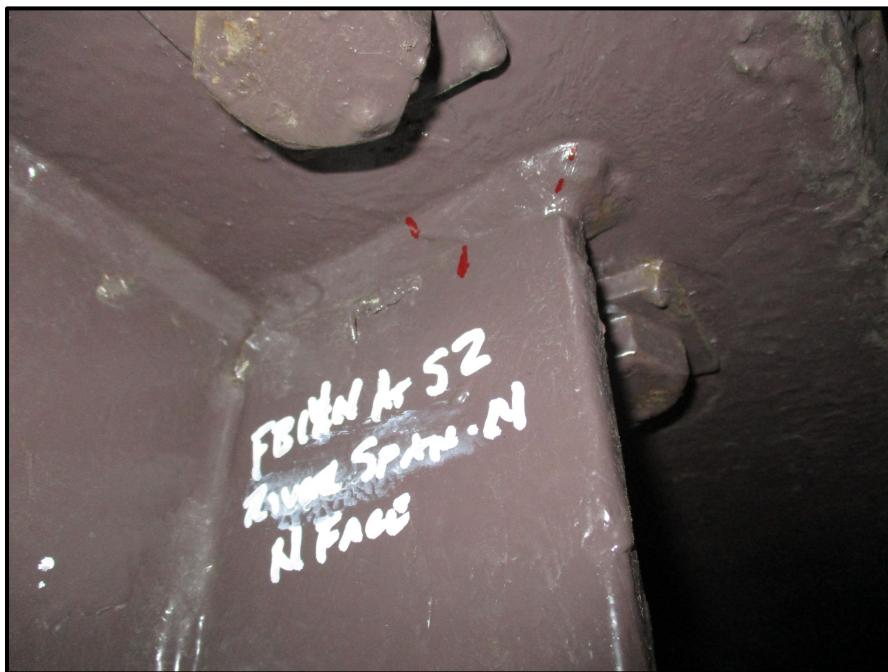
4. The previously noted distressed paint along the web stiffener top weld on the north face of Floorbeam 14N beneath Stringer 2N in the River Span-N has developed into a 7/8'L crack with extended distressed paint along the upper and lower toes of the weld. **See Photo 4.**

Photo 4: River Span-N, Floorbeam 14N at Stringer 2N - Previously noted distressed paint along the web stiffener top weld on the north face of the floorbeam has developed into a 7/8"L crack at the end of the weld with extended distressed paint along the upper and lower toes of the weld, looking southwest.

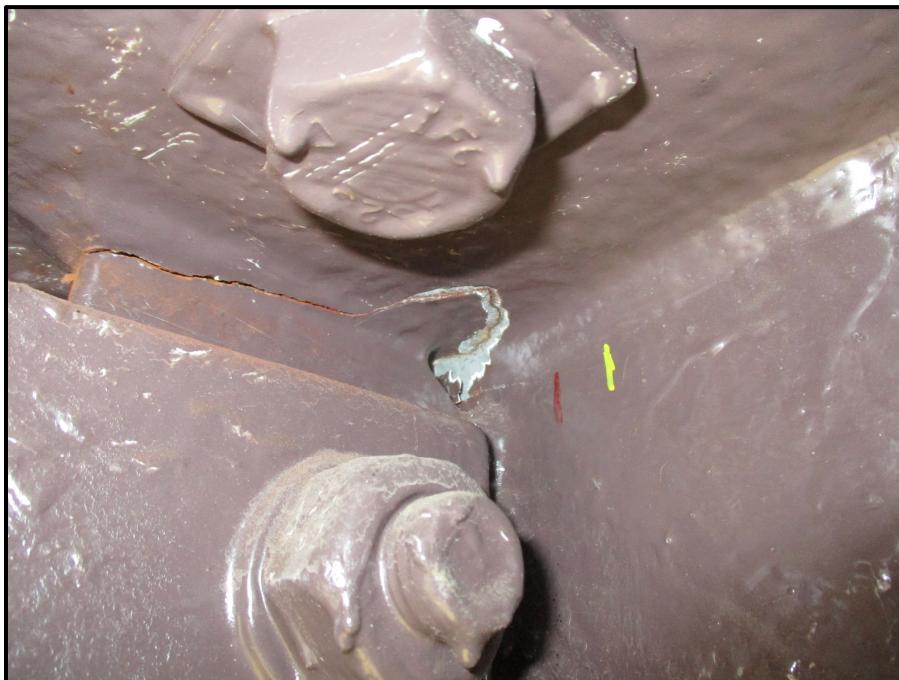
5. Previously, Floorbeam 4S beneath Stringers 14S & 14N in Span S1 exhibited distressed paint on both the north and south faces of the upper web with a partially cracked top weld on the north face of the web stiffener. The stiffener top weld is now completely broken and includes a small, thin portion of the underside of the upper flange along the apparent heat affected zone. Additionally, the floorbeam upper web now exhibits a 2-1/2'L crack on the north face and a 1'L crack with a 4" length of distressed paint on the south face. **See Photos 5 thru 7.**

Photo 5: Span S1, Floorbeam 4S at Stringer 14N - Previously noted partially cracked web stiffener top weld and distressed paint along the lower toe of the web-to-upper flange weld on the north face of the floorbeam now exhibits a completely broken weld and a 2-1/2" L crack on the web, west side of the stiffener, looking southeast. Note the broken weld includes a small, thin portion of the underside of the flange along the apparent heat affected zone.

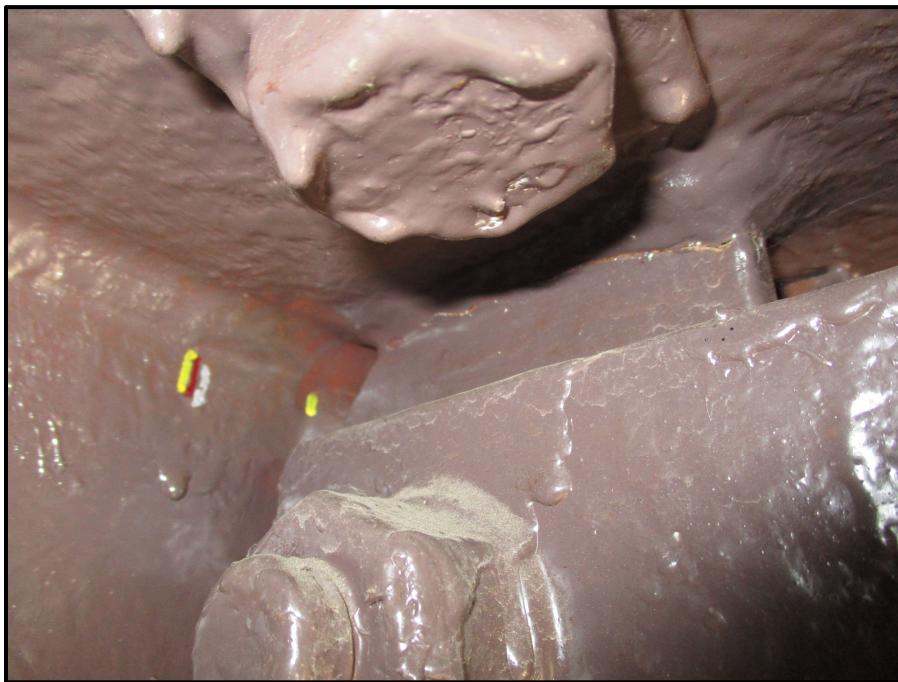
Photo 7: Span S1, Floorbeam 4S at Stringer 14S - Previously noted distressed paint along the lower toe of the web-to-upper flange weld on the south face of the floorbeam has developed into a 1'L crack with extended distressed paint, looking northeast. Note the completely severed stiffener top weld (previously noted condition).

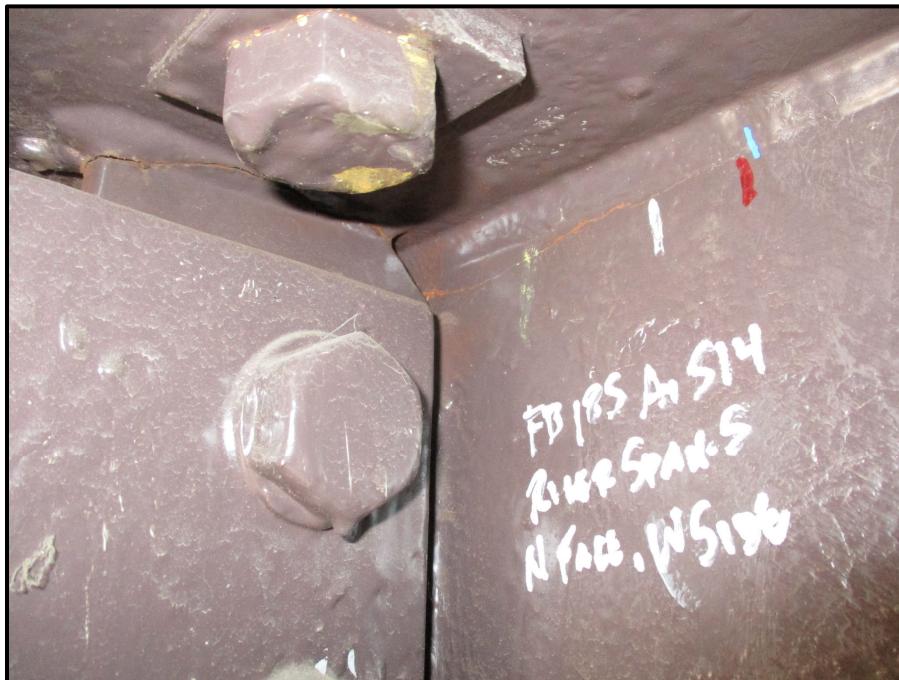
Photo 10: River Span-S, Floorbeam 18S at Stringer 14N - The upper web crack on the north face of the floorbeam has increased by 3/8" in length (total length measures 8-5/8"), looking southeast. Note the completely severed web stiffener top weld (previously noted condition).

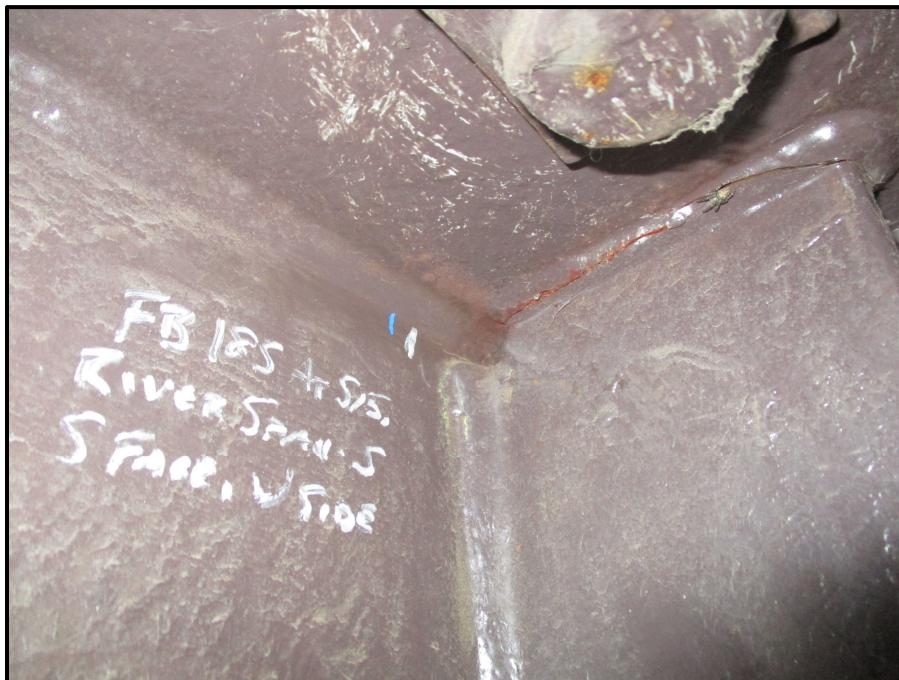
Photo 11: River Span-S, Floorbeam 18S at Stringer 15S - The upper web crack on the south face of the floorbeam has increased by 1/2" in length (total length measures 2-1/2"), looking northeast. Note the completely severed stiffener top weld (previously noted condition).

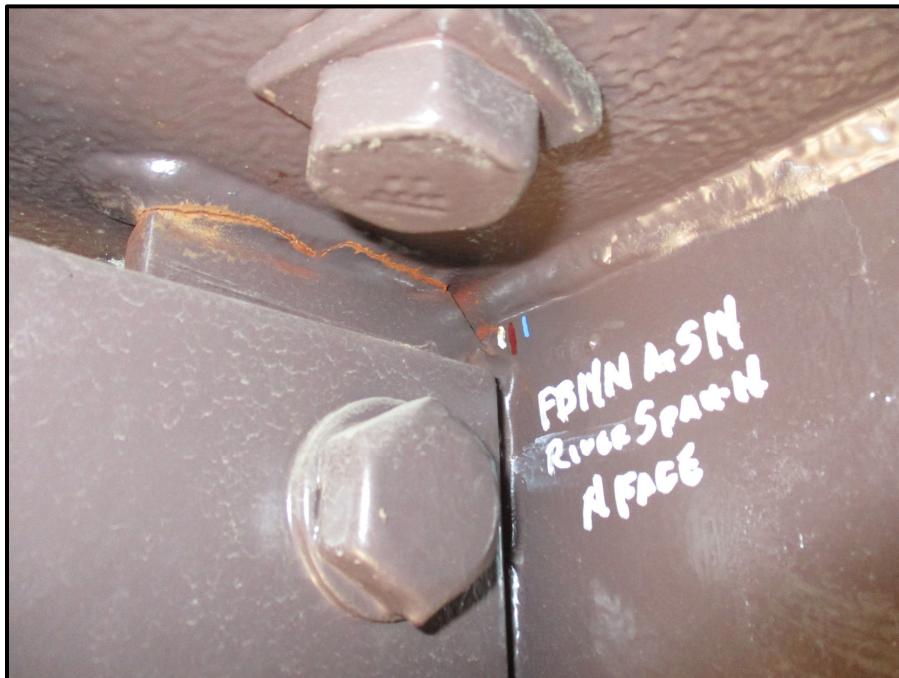
Photo 12: River Span-N, Floorbeam 14N at Stringer 14N - The upper web crack on the north face of the floorbeam has increased by 3/4" in length (total length measures 1-1/2"), looking southeast. Note the completely severed web stiffener top weld (previously noted condition).

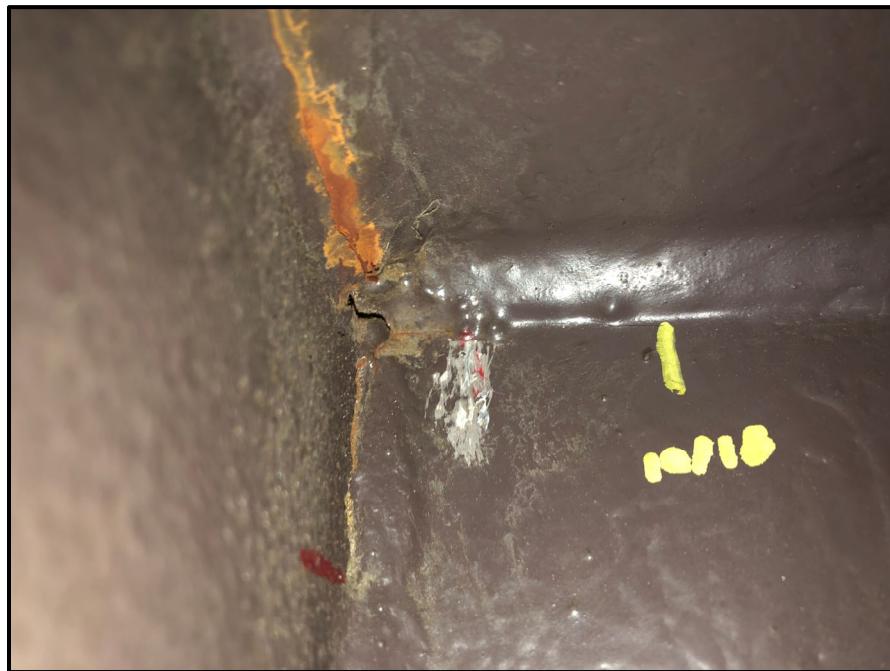
8. There is a 2-5/8'L paint crack along the lower toe of the web-to-upper flange weld, with light rust staining at the web stiffener (possible developing web crack); and a crack at the upper end of the web stiffener-to-web weld which extends horizontally to the west for 1-11/16" along the web and vertically for 1-1/8" down the upper toe of the east-side web stiffener-to-web weld on the south face of Floorbeam 8N beneath Stringer 15S in Span N1. The web cracks have apparently not changed since the last interim inspection; however, the paint crack appears to be growing. **See Photos 13 and 14.**

Photo 13: Span N1, Floorbeam 8N at Stringer 15S - Close-up view of the east projection of the 2-5/8" L (total) paint crack along the lower toe of the web-to-upper flange weld with light rust staining at the web stiffener (possible developing web crack) on the south face, looking north. Note the crack at the upper end of the web stiffener-to-web weld extending vertically down the upper toe of the east-side web stiffener-to-web weld for 1-1/8", looking north.

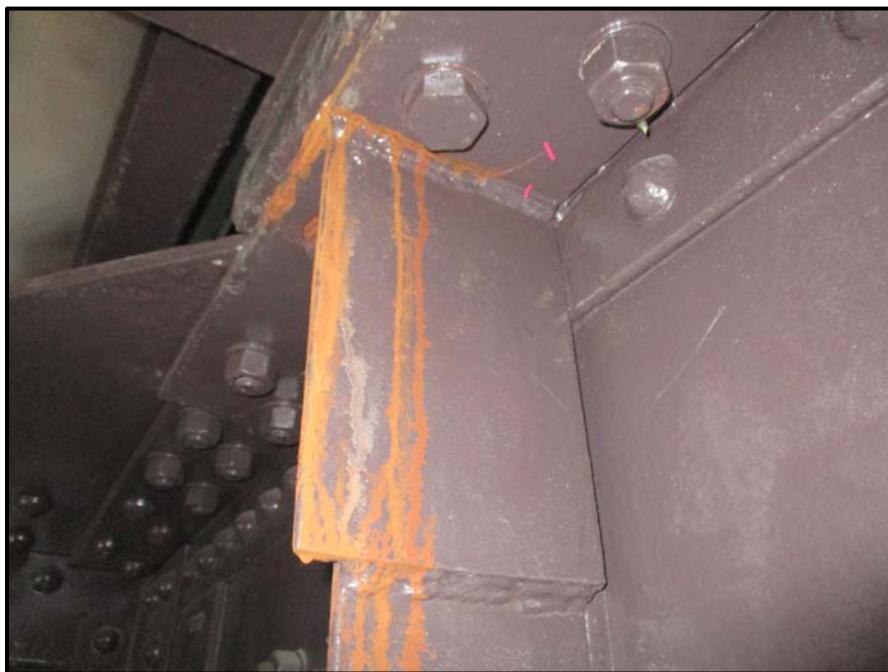
The upper flange repair plate is cracked-through extending along the west side of the vertical web stiffener-to-upper flange repair plate weld for 4". From that point, the crack turns toward the southwest to extend an additional 1-1/2" diagonally across the plate. There is also a 1" long crack in the paint that continues along the vertical web stiffener-to-upper flange repair plate weld from where the repair plate crack branches off. There is significant RMS along the break due to the flange and repair plate visibly pumping under heavy live load. For reference, the north horizontal leg of the original upper flange angle was reinforced with a bolted repair plate installed along its underside, and the upper end of the vertical web stiffener was repaired by removing the deteriorated section and then installing a welded repair plate to restore the detail. The stiffener repair plate is fillet welded along both edges to the underside of the upper flange repair plate and overlap welded to the faces of the original stiffener. The web stiffener repair

Photo 1: River Span-S, Floorbeam 14S at Stringer 4N - General view of the vertical web stiffener-to-upper flange interface, looking southeast. Note the repair plates welded to the upper end of the stiffener and bolted to the underside of the upper flange horizontal angle leg; the stiffener repair plate is welded to the underside of the flange repair plate which is where a thru-crack has developed along the west side as evidenced by the RMS.

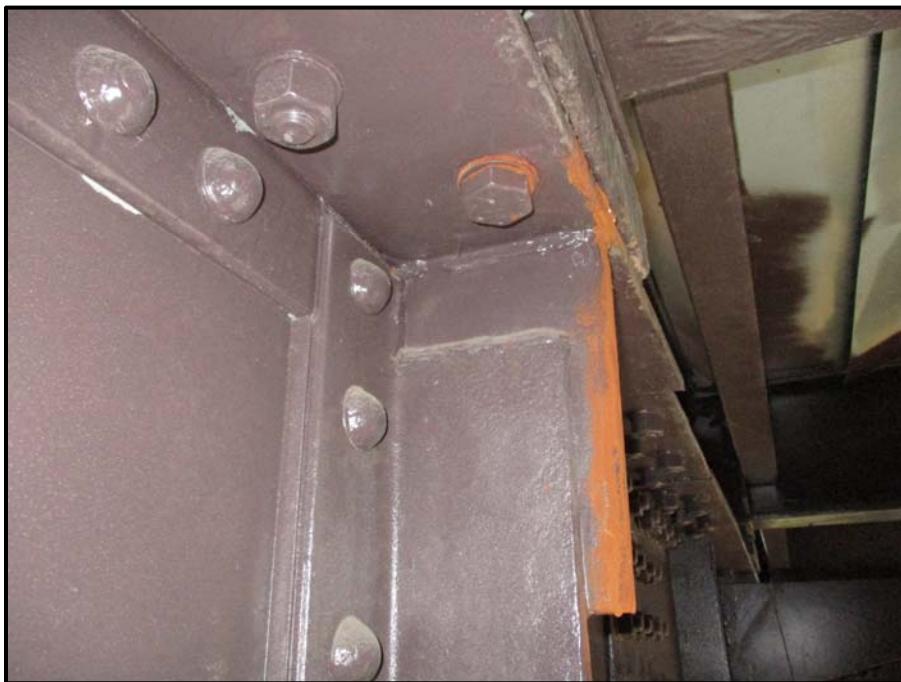
Photo 2: River Span-S, Floorbeam 14S at Stringer 4N - General view of the vertical web stiffener-to-upper flange interface, looking southwest. Note the repair plates welded to the upper end of the stiffener and bolted to the underside of the upper flange horizontal angle leg. Also note the RMS emanating from the thru-crack along the west side of the stiffener repair plate-to-upper flange repair plate weld as depicted in Photo 1.

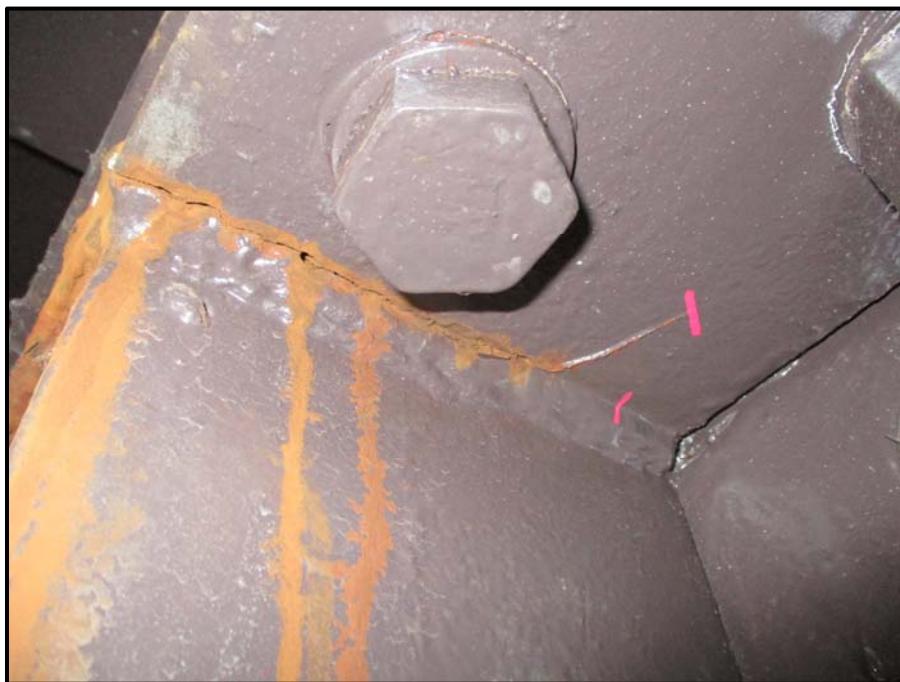
Photo 3: River Span-S, Floorbeam 14S at Stringer 4N - Close-up view of the 4" long thru-crack along the web stiffener repair plate-to-upper flange repair plate weld, looking up facing southeast. Note the end of the crack branches off and extends 1-1/2" toward the southwest. Also note the paint is cracked along the upper toe of the weld for an additional 1" from the end of the thru-crack; and the RMS resulting from pumping of the flange under heavy live load.

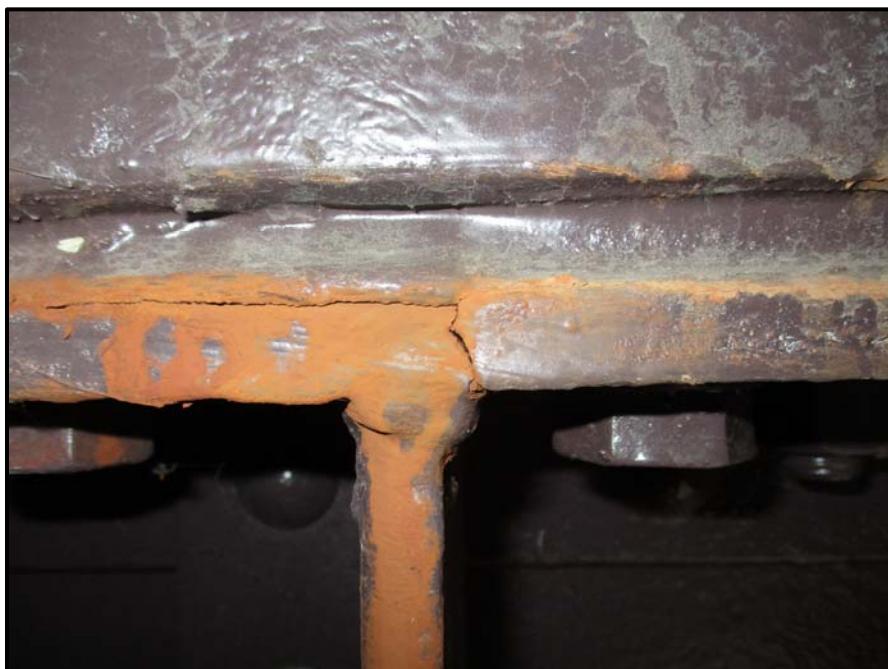
Photo 4: River Span-S, Floorbeam 14S at Stringer 4N - Close-up view of the thru-cracked upper flange repair plate along the west edge of web stiffener repair plate-to-upper flange repair plate weld, looking south.

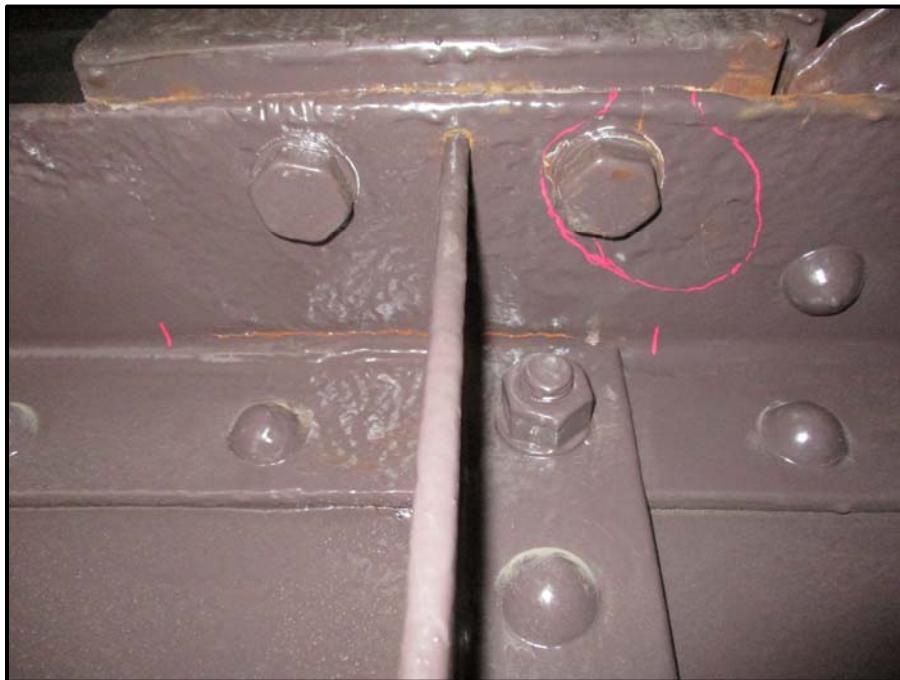
The base of the horizontal leg of the upper flange angle is cracked for 3-3/4" long on the east side and 5-5/8" long on the west side of the vertical web stiffener (total length of 9-3/4", including the length behind the web stiffener). The horizontal leg of the upper flange angle is also cracked - the crack begins at the leading edge of the angle and then travels around the southeast bearing anchor bolt where it terminates in a ±2-1/2" diameter asterisk-shaped crack located at mid-width of the angle leg, beneath the east edge of the stringer bearing bolster. The web stiffener-to-upper flange interface is of original construction (tight-fit clearance, no repair plate, not welded). **See Photos 5 thru 8.** Note - there were no floorbeam web and/or upper flange defects below Stringer 4N noted at the time of inspection. The upper end of the vertical web stiffener at this location was repaired by removing the deteriorated section and then installing a welded repair plate to restore the detail. The stiffener repair plate is fillet welded along both edges to the underside of the upper flange horizontal angle leg and overlap welded to the faces of the original stiffener. The web stiffener repair plate is not welded to the vertical leg of the upper flange angle or to the floorbeam web.

Photo 5: River Span-N, Floorbeam 14N at Stringer 4S - General view of the 9-3/4" long crack along the base of the original upper flange horizontal angle leg, and of the cracked upper flange horizontal angle leg at the southeast stringer bearing anchor bolt, looking up, facing north.

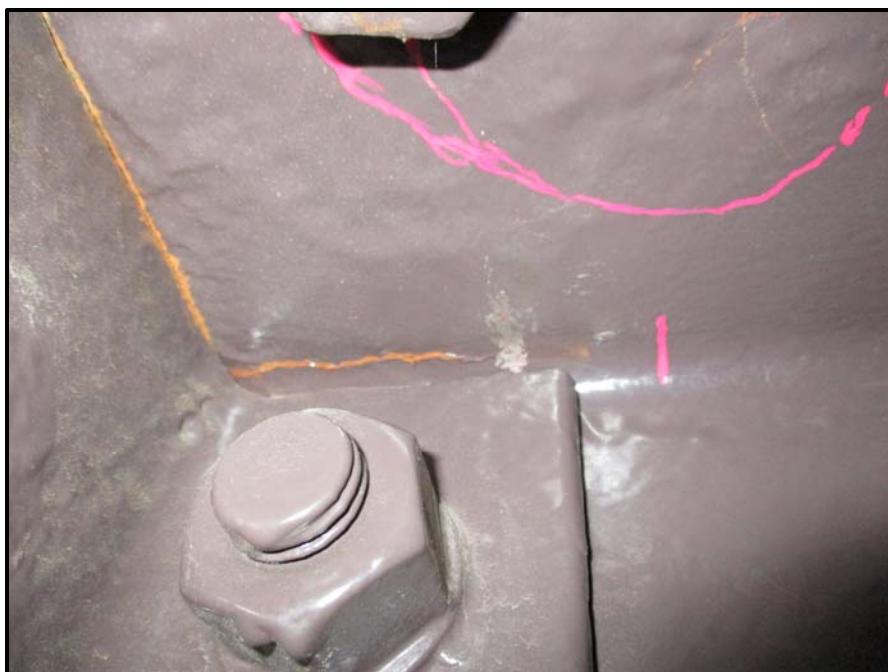
Photo 6: River Span-N, Floorbeam 14N at Stringer 4S - Close-up view of the 3-3/4" long crack along the base of the original upper flange horizontal angle leg on the east side of the vertical web stiffener, looking up, facing north.

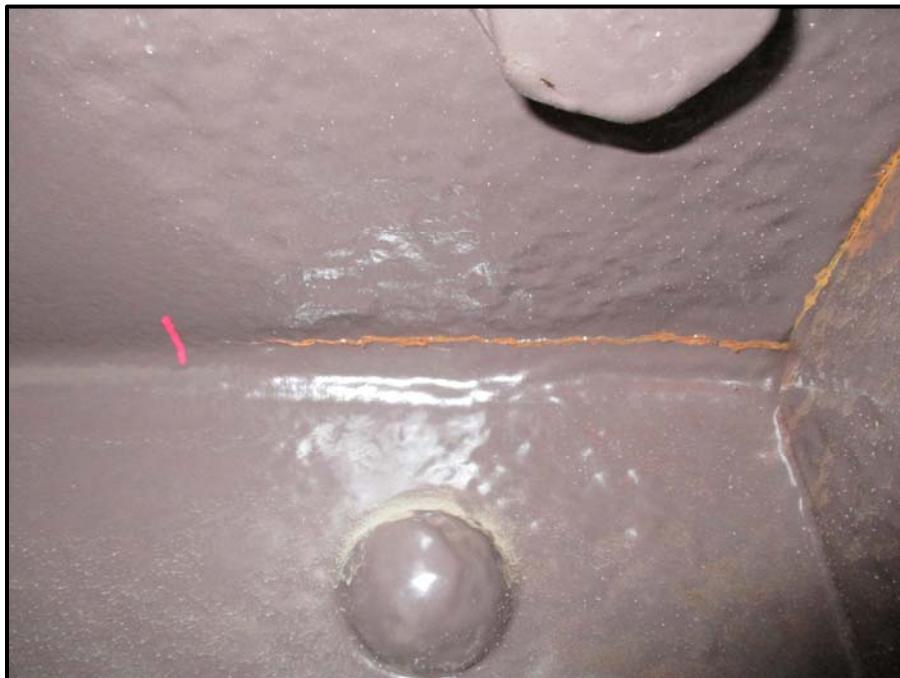
Photo 7: River Span-N, Floorbeam 14N at Stringer 4S - Close-up view of the 5-5/8" long crack along the base of the original upper flange horizontal angle leg on the west side of the vertical web stiffener, looking up, facing north.

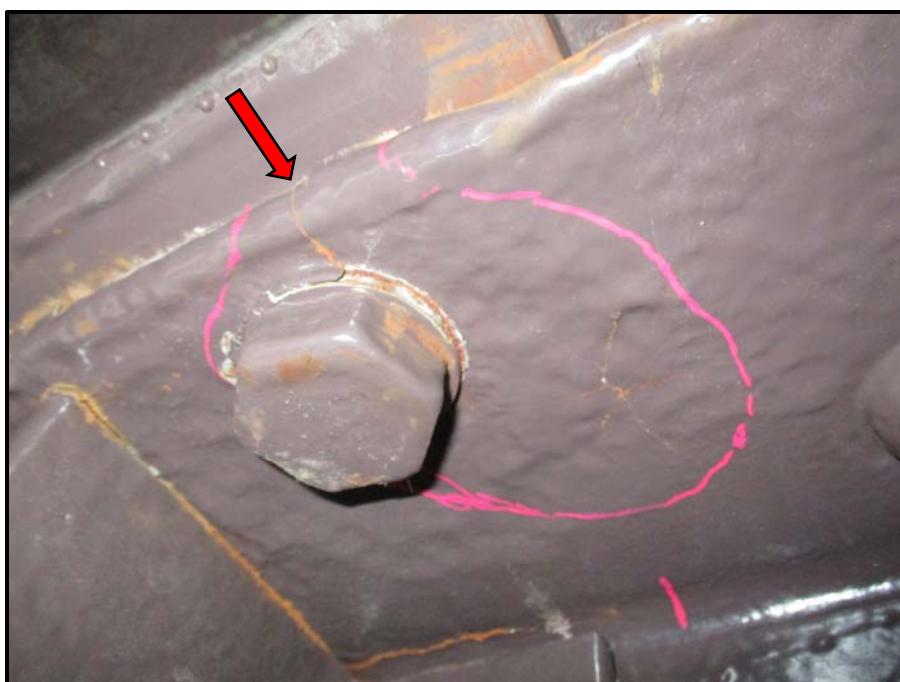
Photo 8: River Span-N, Floorbeam 14N at Stringer 4S - Close-up view of the cracked horizontal leg of the upper flange angle leg, looking up, facing north. The crack begins at the leading edge of the angle (arrow) and then travels around the southeast bearing anchor bolt where it terminates in a ±2-1/2" diameter asterisk-shaped crack located at mid-width of the angle leg, beneath the east edge of the stringer bearing bolster.

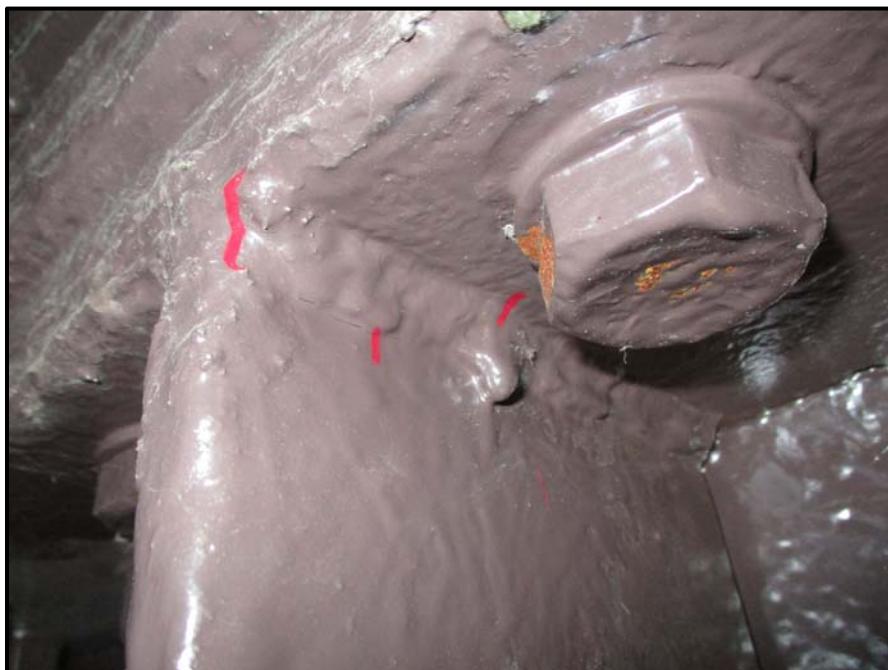
There is distressed paint along the upper and lower toes of the west-side weld between the vertical web stiffener repair plate and upper flange horizontal angle leg repair plate. **See Photo 9.** Note - there were no floorbeam web and/or upper flange defects below Stringer 4S noted at the time of inspection. The web stiffener-to-upper flange interface at this location is of original construction (tight-fit clearance, no repair plate, not welded).

Photo 9: Span N1, Floorbeam 8N at Stringer 4N - Distressed paint along the west-side weld between the vertical web stiffener repair plate and upper flange horizontal angle leg repair plate, looking southeast.

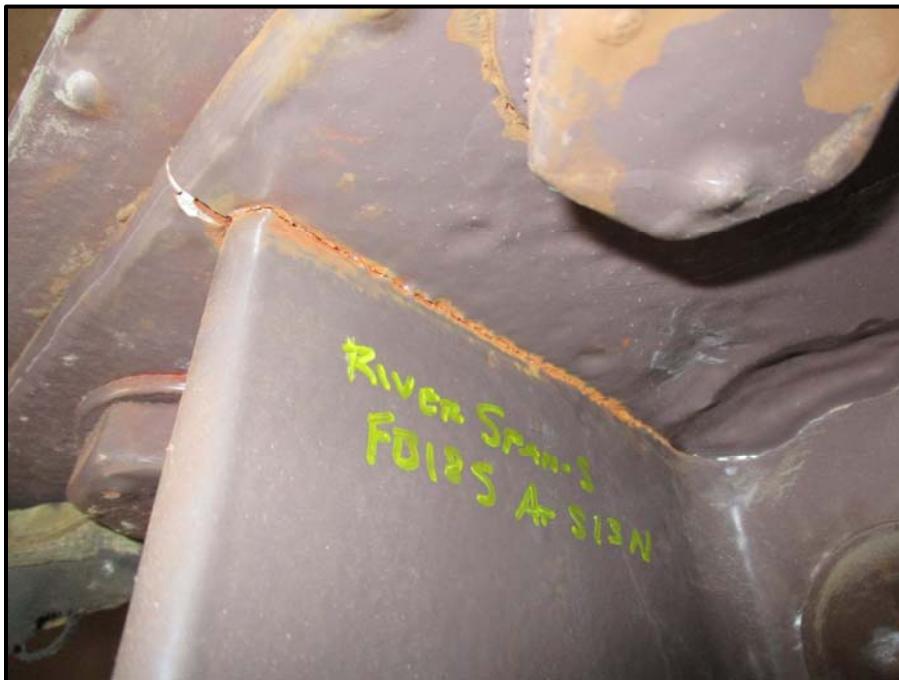
The north horizontal leg of the upper flange angle is cracked-thru for nearly its full width directly above the vertical web stiffener. The web stiffener-to-upper flange interface is of original construction (tight-fit clearance, no repair plate, not welded), and the angle leg visibly pumps under heavy live load (a slight banging noise is heard). **See Photos 10 and 11.** Note - there is RMS along the seam between the floorbeam web stiffener and upper flange angle leg below Stringer 13S; however, no visible cracks in the web and/or angle leg were observed. The web stiffener-to-upper flange interface at this location is of original construction (tight-fit clearance, no repair plate, not welded).

Photo 10: River Span-S, Floorbeam 18S at Stringer 13N - The north horizontal leg of the original upper flange angle is cracked-thru for nearly its full width directly above the original vertical web stiffener (tight fit clearance, not welded), looking up, facing southeast. Note the light RMS emanating from the crack indicating the angle leg pumps under heavy live load (interface bangs lightly under passage).

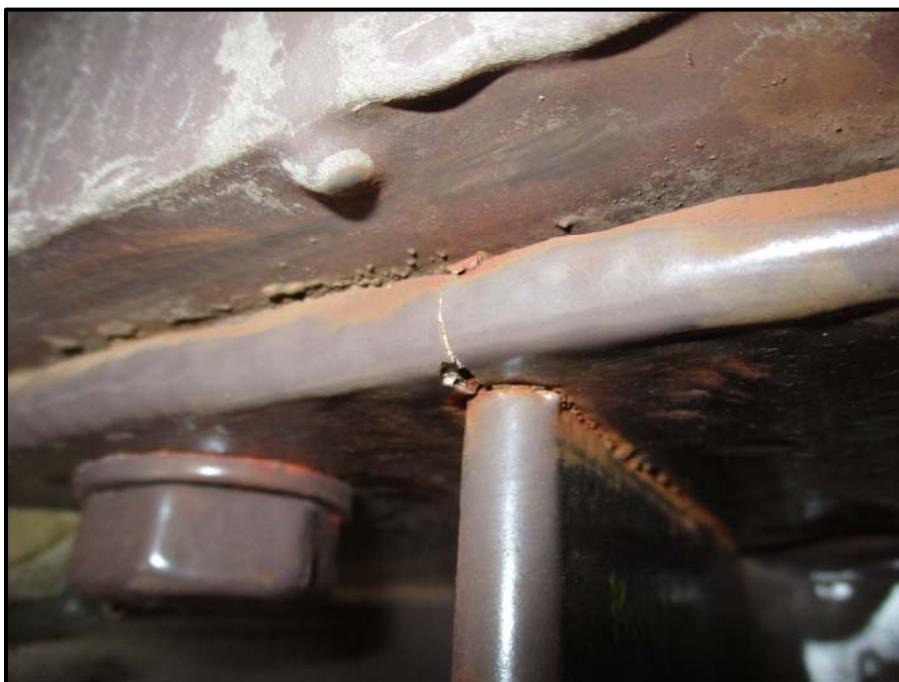
Photo 11: River Span-S, Floorbeam 18S at Stringer 13N - Close up-view of the thru-cracked original upper flange angle leg directly above the original vertical web stiffener, looking south.

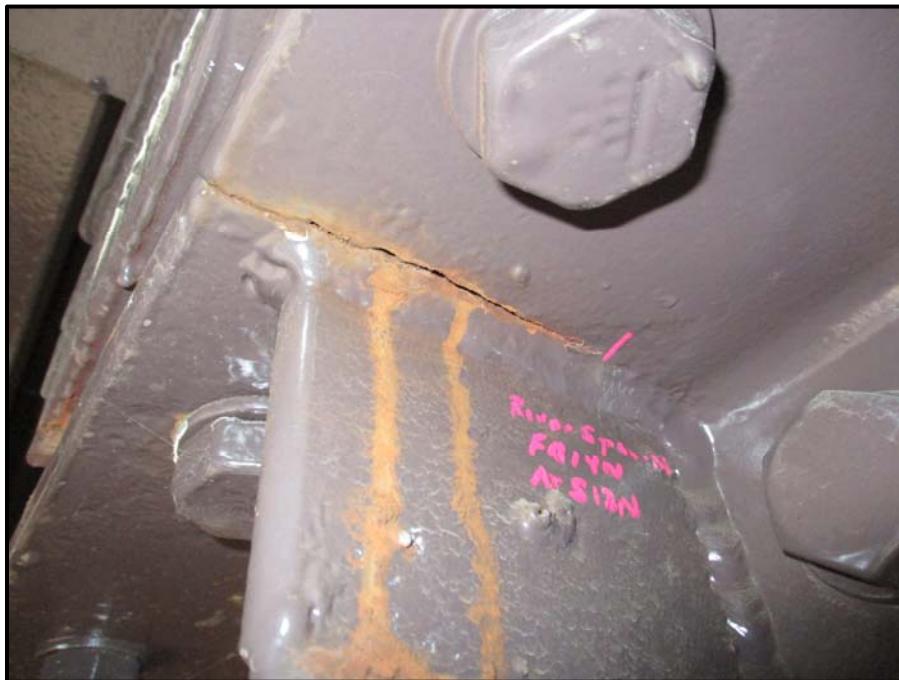
There is a 4" long thru-crack in the north horizontal leg of the upper flange angle beginning at the leading edge and extending along the upper toe of the floorbeam web stiffener repair plate-to-upper flange weld, west side. The crack visibly pumps under heavy live load and exhibits RMS as a result. For reference, the upper end of the vertical web stiffener was repaired by removing the deteriorated section (3" high) and then installing a welded repair plate to restore the detail. The stiffener repair plate was cut to fit the removed portion and is fillet welded along both edges

Photo 12: River Span-N, Floorbeam 14N at Stringer 13N - 4" long thru-crack in the north horizontal leg of the upper flange angle beginning at the leading edge and extending along the upper toe of the floorbeam web stiffener repair plate-to-upper flange weld, west side, looking up, facing southeast. Note the RMS emanating from the crack due to pumping under heavy live load.

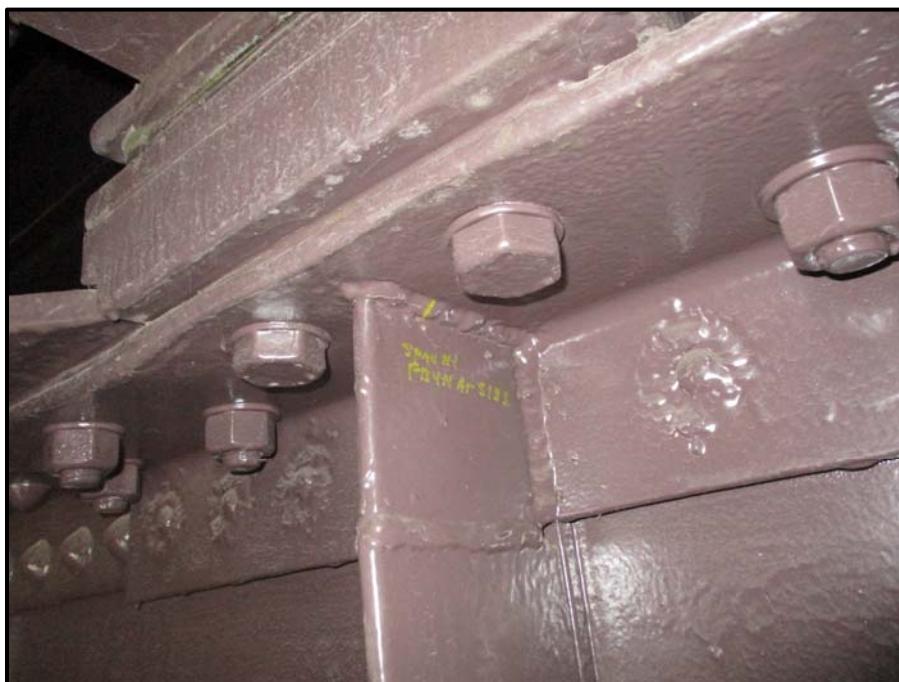
There is a crack along the vertical web stiffener-to-upper flange weld for 1-1/4" long on the east face and 1-3/4" long on the west face. For reference, the upper end of the vertical web stiffener was repaired by removing the deteriorated section (4" high) and then installing a welded repair plate to restore the detail. The stiffener repair plate was cut to fit the removed portion and is fillet welded along both edges to the underside of the horizontal angle leg and face of the vertical angle leg of the original upper flange, and butt welded to the trimmed end of the original stiffener. **See Photos 13 thru 15.**

Photo 13: Span N1, Floorbeam 4N at Stringer 13S - General view of the cracked vertical web stiffener repair plate-to-upper flange weld, looking northwest.

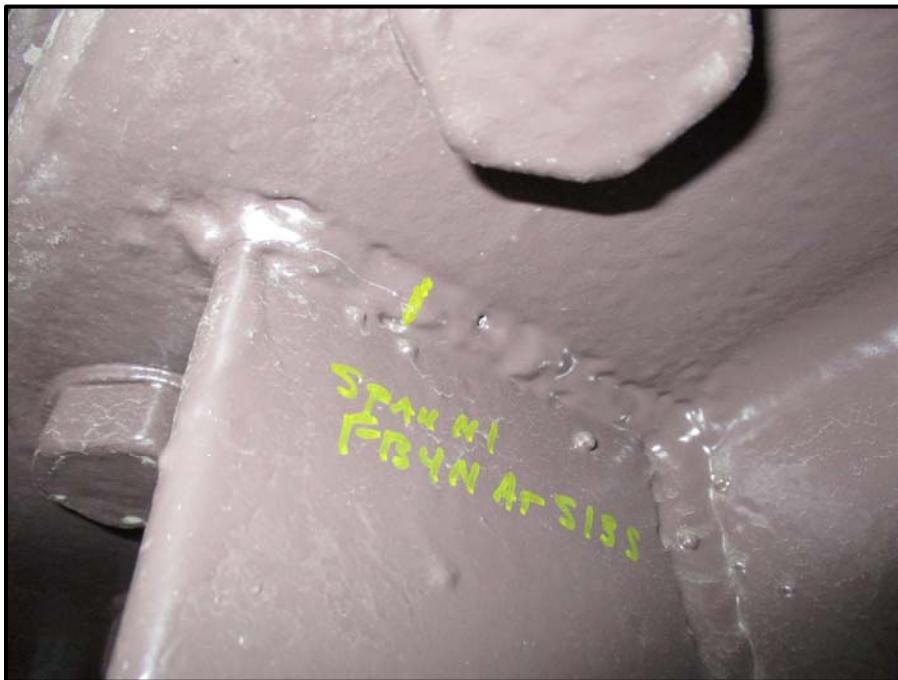
Photo 14: Span N1, Floorbeam 4N at Stringer 13S - Close-up view of the 1-1/4" long crack along the east side of the web stiffener repair plate-to-upper flange weld, looking up, facing northwest.
