1   **Application of Structural Identification and Non-Destructive Evaluation Techniques**  
2   **to Diagnose Root Causes of Bridge Performance Problems**

3   *J. Weidner, F.L. Moon, N. Gucunski and A. E. Aktan.*

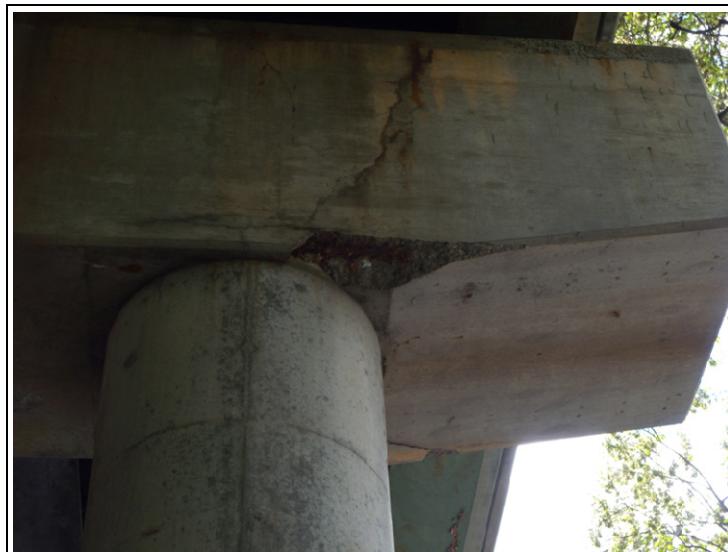
**Figure 3 - Crack in the Span 2 SB Piercap**

99 delamination and efflorescence on the pier caps. In particular, a large diagonal crack that  
100 ran between the bearing of the exterior girder and the first supporting column (Figure 2)  
101 was noted on Pier 1S (Figure 1). Finally, all research teams and the past inspection  
102 reports noted that the bridge exhibited “lively” vibrations under normal traffic.

386 is clear that at the highest load level, Girder #1 experienced a vertical translation of one of its  
387 supports. A support settlement would directly manifest in displacement response, but only  
388 indirectly observed through strain responses if the support movement results in a re-distribution  
389 of forces. Given that the observed displacement response was isolated to Girder #1, it was  
390 determined that it was a result of the crack in the piercap near Girder#1 (shown in Figure 3).

485 identified. This finding was supported through the use of model calibration. The root cause of  
486 this behavior was a crack in the piercap, which was shown to be active through targeted  
487 instrumentation over the crack. Subsequent review of the documentation for the structure  
488 indicated that rebar in the top of the piercap was likely not fully developed. This behavior point  
489 to a critical design error and would not have been identifiable with strain information only.
