**Load Testing, Model Calibration, and Analysis for a Three-Span
Reinforced Concrete T-Beam Bridge and a Highly Deteriorated
Filled Arch Bridge**

FINAL REPORT

Jeff Weidner, John B. Prader, Franklin L. Moon and A. Emin Aktan

April 21, 2009

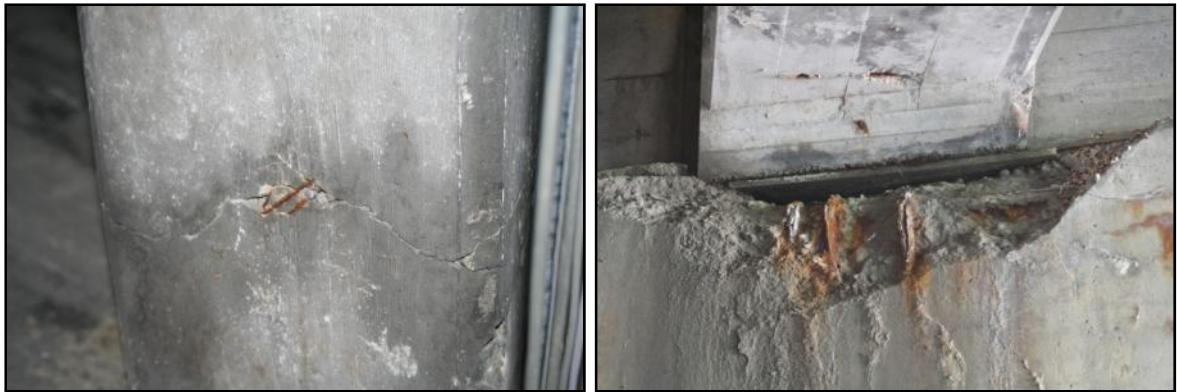
At the location of the damage to the beam seats (Figure E- V), vertical displacement gages were installed to monitor the relative vertical deformation of the beam to the pier. Any observed nonlinearity in these gages would indicate that damage was accumulating at that location. Figure E- VI shows the plot of load versus displacement at the beam

seats. The behavior remained linear throughout the test, indicating that the damage was likely caused due to some other mechanism besides loading. The magnitude of the response was very small as well.

Figure E- IV - Diaphragm Crack

Figure E- V - Damaged Beam Seat

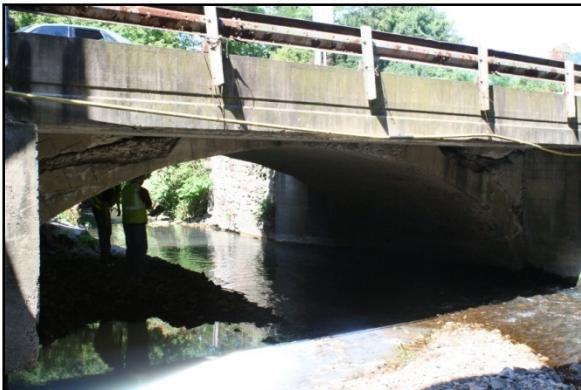
Figure E- VII - Michigan Avenue Bridge

The arch portion of the bridge shows heavy deterioration on the spandrel walls, as seen in Figure E- VIII. Additionally, there are two long horizontal cracks at the base of either

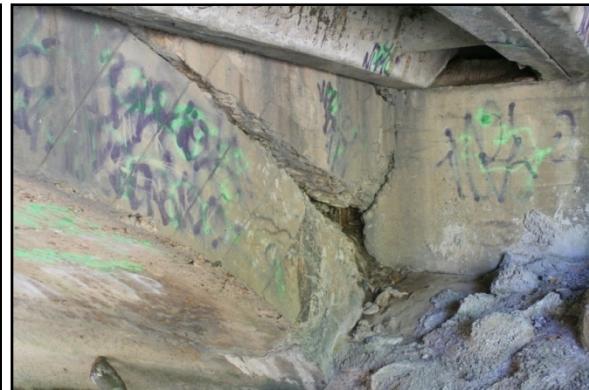
Figure E- VIII - Deterioration of Spandrel Walls

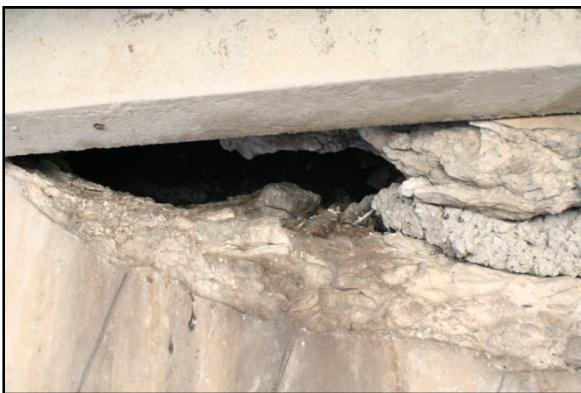
side of the arch, which penetrate the width of the structure. On the upstream edge of the arch, a portion of the spandrel wall is missing, as well as the fill directly behind the exposed location Figure E- IX. The underside of the arch showed large voids, which were a result of using sizeable (in some cases larger than 6 in.) river stone as aggregate, see Figure E- X. Pachometer scanning revealed that no rebar was present in the arch.

Figure E- IX - Void in the Arch and Prior Repair

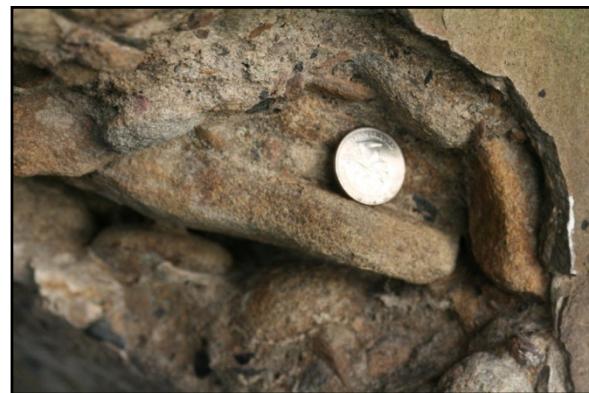
Figure E- X - Large Visible Aggregate Pieces

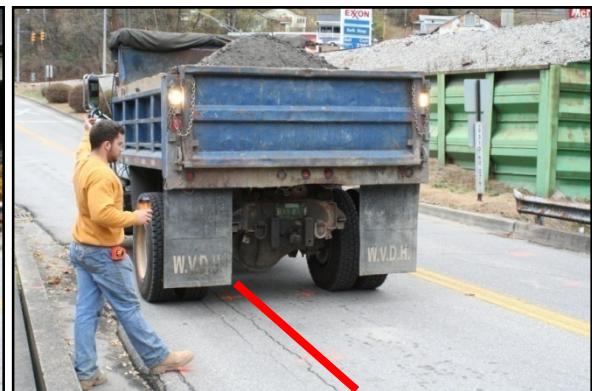
Figure E- XIV - Left Side of Truck Loading the Beam Directly (Red Line is the Beam-Arch Interface)

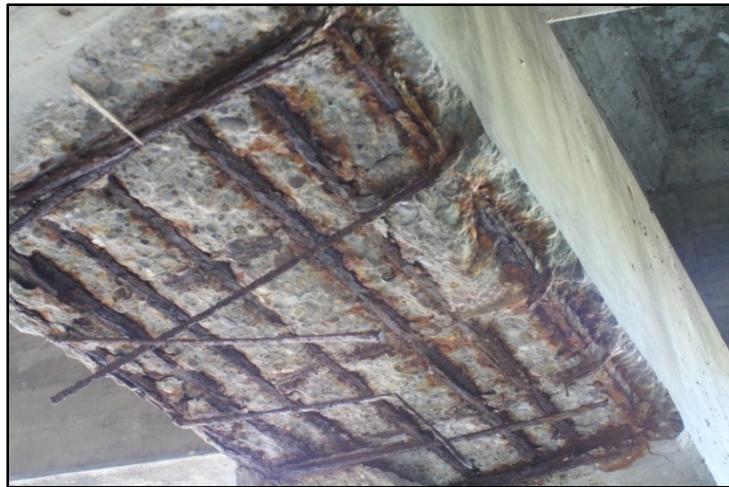
The bridge exhibits some deterioration in critical locations. There is substantial spalling on the piers, pier caps and at some of the beam seats as seen in Figure 1-5 and Figure 1-6. The beams show flexural cracking, and some sparse locations of shear cracking. At the locations of the piers and abutments, the roadway surface shows substantial cracking (Figure 1-7). The bridge appears to have a serious drainage problem, with water seeping out from between the diaphragms and buildup of sediment atop the pier caps (Figure 1-8).

Figure 1-5 – Extensive Spalling on the Underside of the Pier Cap

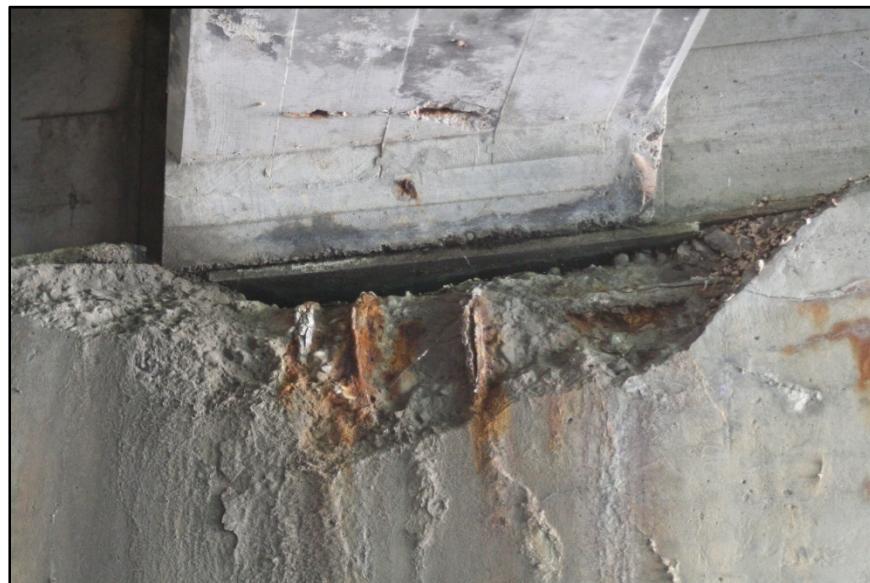
Figure 1-6 - Spalling and Exposure of Beam Seat

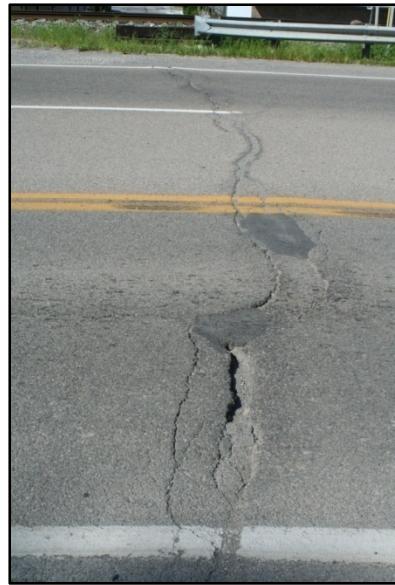
Figure 1-7 – Typical Damage to Wearing Surface at the Piers and Abutments

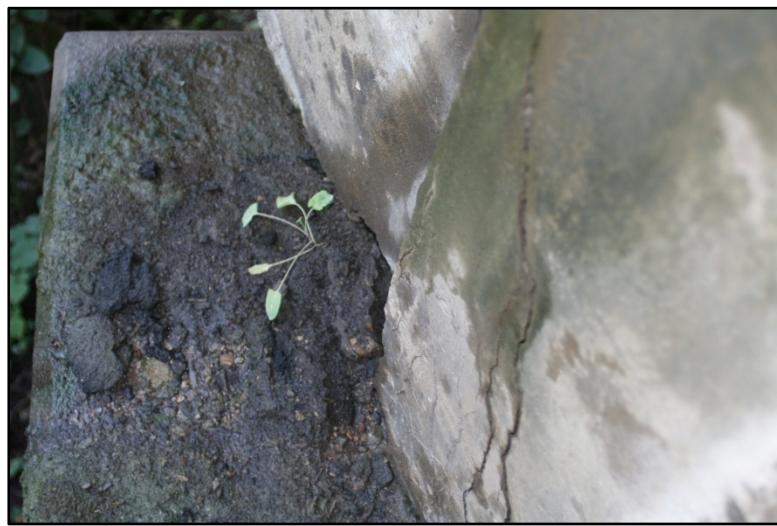
Where the spans meet at the pier caps, there is a full width diaphragm on each span. It appears that water is infiltrating between these diaphragms. When it rains, water can be seen escaping from the edges of the joint between the diaphragms, from underneath bearing plates for the beams, and from various cracks on the underside of the structure. This water infiltration should be mitigated through modification of the bridge's drainage system.

Figure 1-8 – Seepage and Build-up at Pier Caps from Drainage Issues

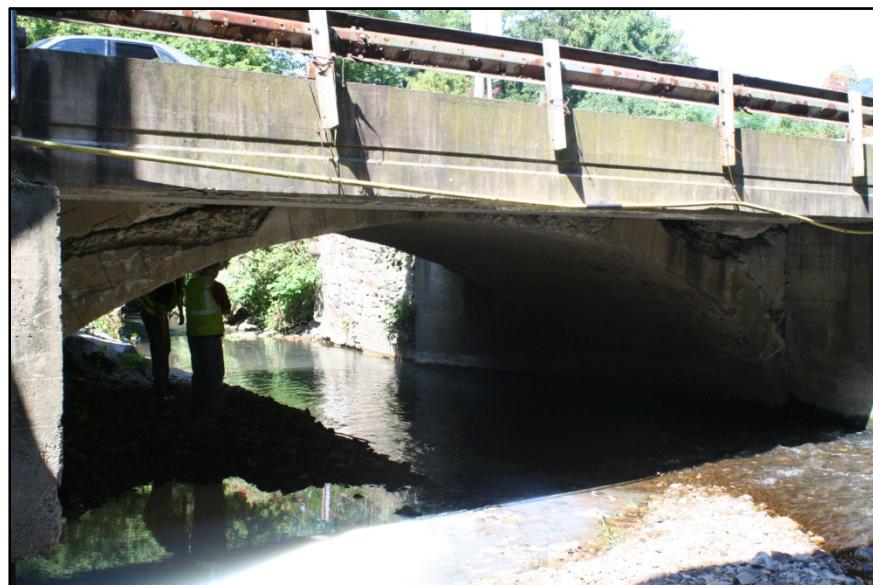
Figure 1-9 - Michigan Avenue Bridge

In general the condition of the Michigan Avenue Bridge is very poor. There are large horizontal cracks in the arch near the base, and patches of voided areas all along the underside (Figure 1-10). The spandrel walls are substantially deteriorated, and in one case, absent entirely, exposing a void beneath the roadway surface (Figure 1-11). The aggregate used for the arch appears to be river stone, and can vary in size up to approximately 6 inches. The beams, while

much newer, are in similar condition. There are long longitudinal cracks near the bottom of the webs which could be indicative of a bond failure (Figure 1-12). Between the components of the superstructure there is very little connectivity, resulting in extensive longitudinal cracks in the roadway. The eastern foundation is a scour hazard, already exhibiting substantial undercutting. The bridge is currently on the replacement list.

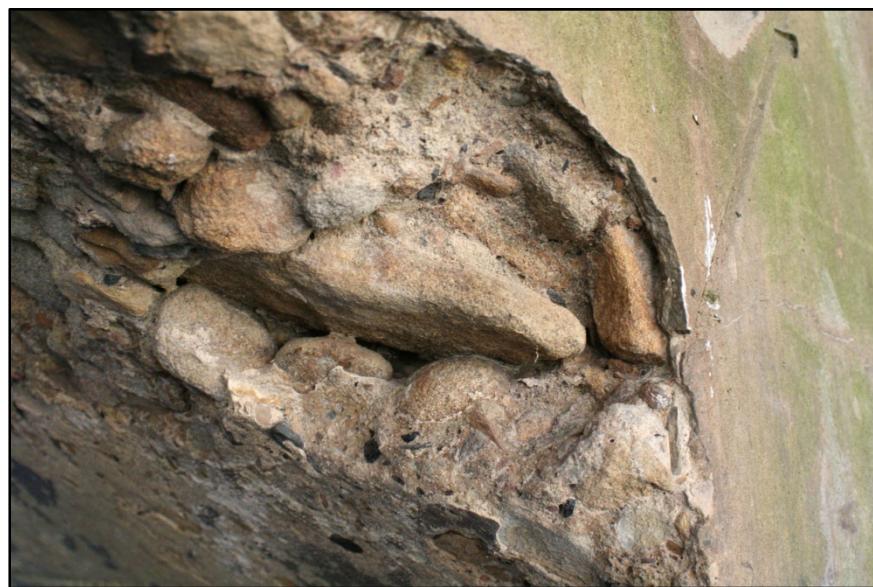
Figure 1-10 - Voided Area on Michigan Avenue

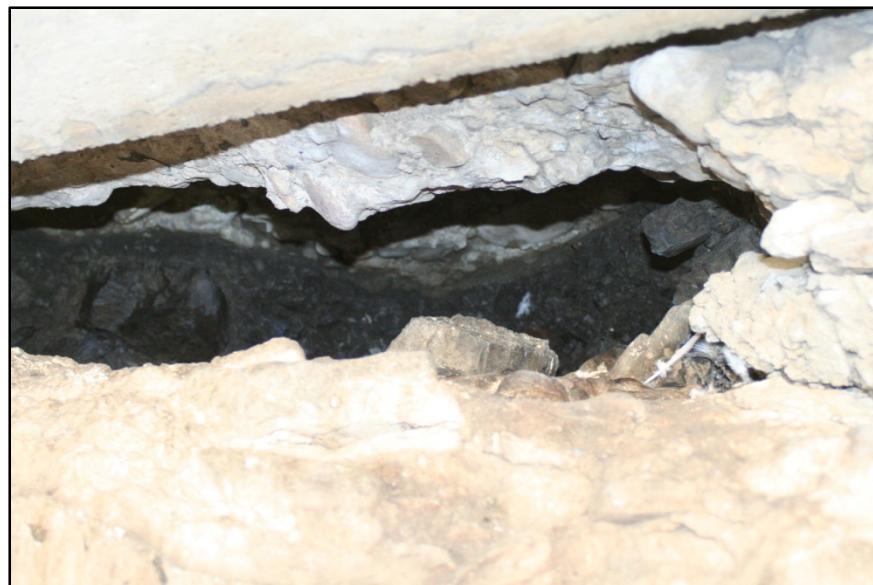
Figure 1-11 - Missing Spandrel Wall and Void

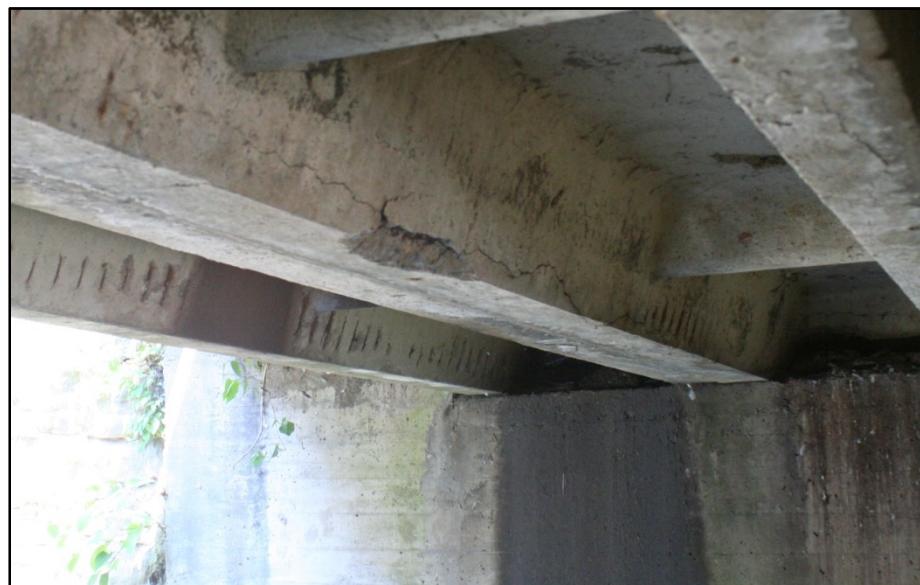
Figure 1-12 - Longitudinal Crack in Web
