# Complementing Visual Inspection with Technology Tools and Heuristics

## for Bridge Condition Evaluation and Asset Management

#### STRUCTURE NO. 1618-150

US 202 & NJ 23 OVER US 202 (MOUNTAIN VIEW BLVD.),  
RAMPS M & N, AND NORFOLK SOUTHERN RAILROAD  
WAYNE TOWNSHIP, PASSAIC COUNTY

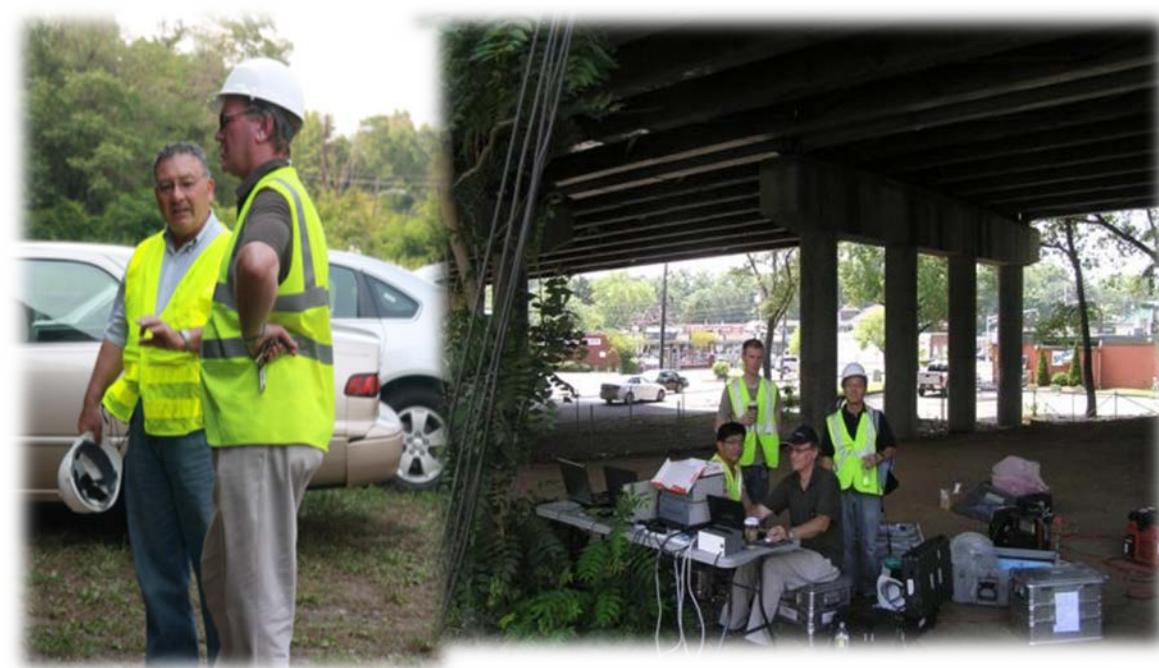
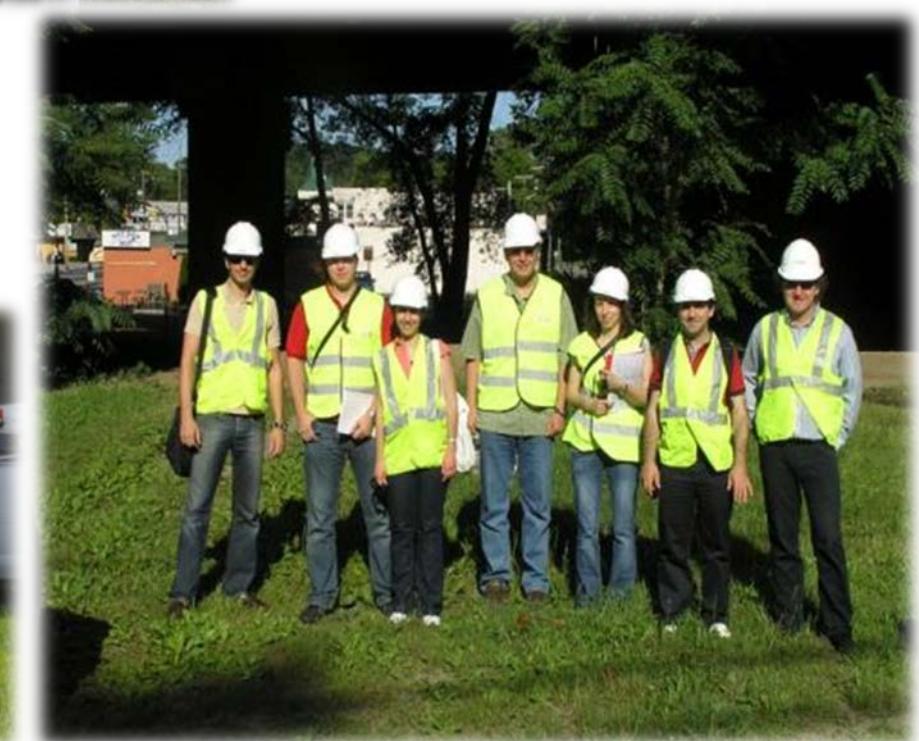
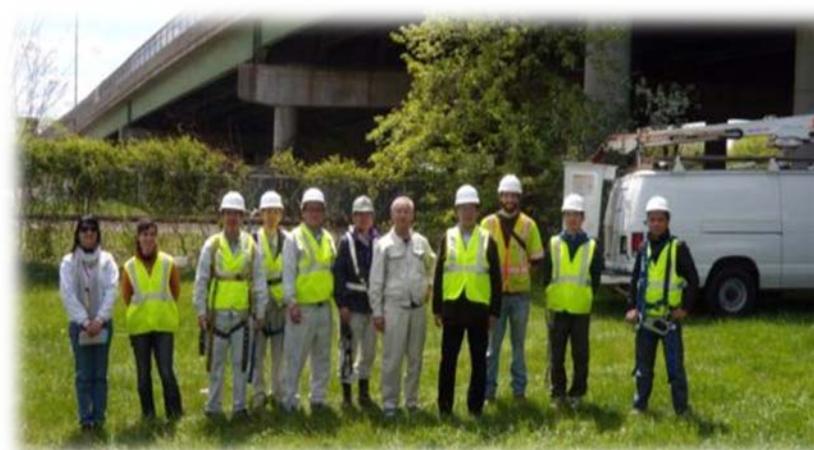
- The superstructure is in fair condition due to the common cracks in the welds connecting the lateral bracing horizontal gusset plates to the girder webs in spans 1, 2, and 4. Cracks propagating into the girder webs observed in previous cycles have been arrested by drilling holes and installing bolts. During this inspection, a crack was observed originating at the north gusset plate of lateral brace point "B" and extending approximately Y." into the web of girder 8 from west in span 2 from south (See Priority Letter and Memorandum).
- The approaches are in fair condition due to erosion at the southeast embankment, 2" $\pm$  settlement of the southbound center through lane slab, up to 7" $\pm$  settlement of the northwest approach sidewalk, and 3" $\pm$  settlement of the southeast approach sidewalk.

A sample of fatigue crack

Cracks arrested by drilling holes and installing bolts

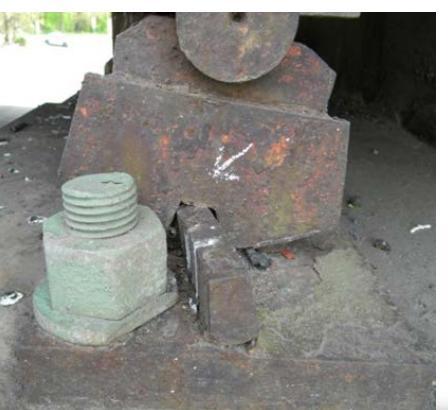
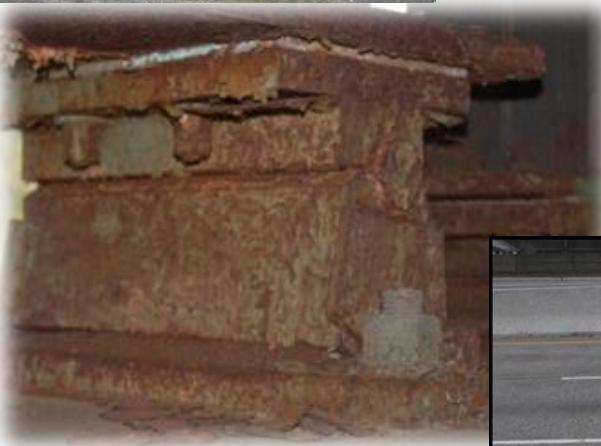
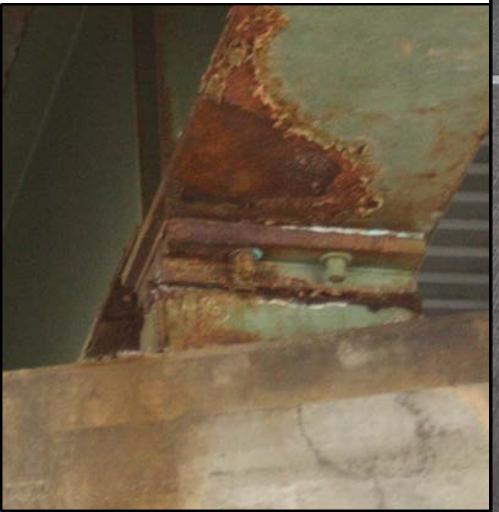
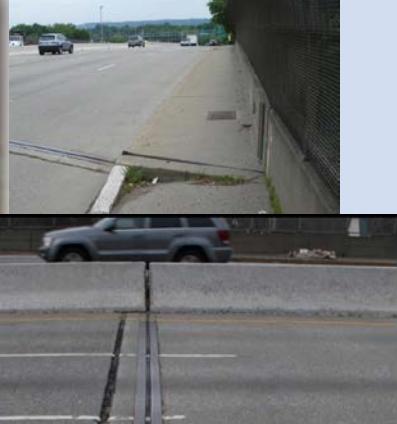
Functionality	Serviceability	Safety	Resilience
<ul style="list-style-type: none"><li>• Insufficient Drainage</li><li>• Bump @ entry</li></ul>

<ul style="list-style-type: none"><li>• Fill erosion led to settlement and movement of the approach slabs</li><li>• Excessive vibrations</li><li>• Deck cracking</li><li>• Joint failures</li><li>• Bearing corrosion</li><li>• Cracking of Abutments and Piers</li></ul>	<ul style="list-style-type: none"><li>• Gas Utility pipe</li><li>• Water Trunk-line</li><li>• Fractured Bearings</li><li>• Pier cap corbel <b>shear crack</b></li><li>• Fatigue cracks on girder webs</li></ul>	<ul style="list-style-type: none"><li>• Bridge serves over 100,000 vehicles per day</li><li>• Major link to GWB to NY City and NE</li><li>• Major impacts to regional GDP if bridge has to be closed</li></ul>

It appears that the professional bridge inspectors spent most of their effort in recording the fatigue cracks on girder webs. Experienced bridge engineers in the research team observed that these cracks were caused by the forces/displacements exerted by wind bracing on the gusset plates at girder webs for connections.

Additional performance concerns include the pier-cap corbel shear crack, vibrations, deck cracking, bearing failures and fill erosion leading to bumps at the entries to the bridge. Each of these were found to be significant performance concerns.

- Fatigue cracks occur primarily due to distortion of the wind bracing caused by live load deflection
- Braces appear to be redundant for lateral loading and irrelevant for vertical loading
- Removal of wind bracing elements should be considered

Gusset plates should not be directly welded on girder webs. They may be connected through stiffeners that will stiffen and protect the girder web against distortion-induced fatigue failure.

It is recommended to replace all bearings with multi-directional elastomeric bearings

Post-tensioning the Pier-Cap by coring within/thru may be considered for repairs in conjunction with epoxy injection.

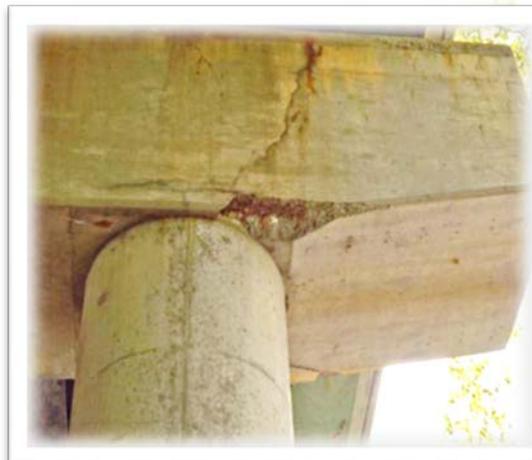
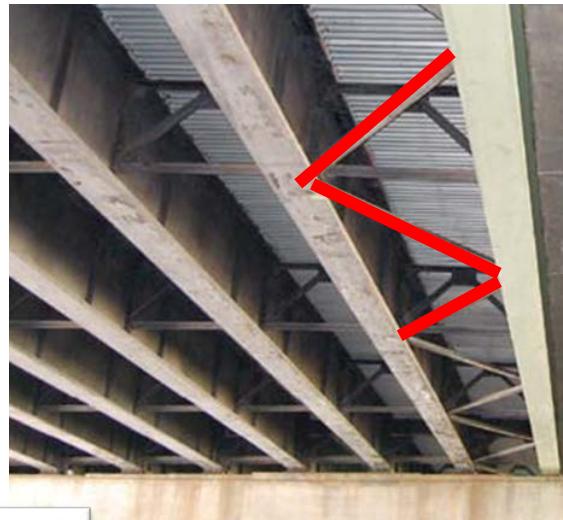
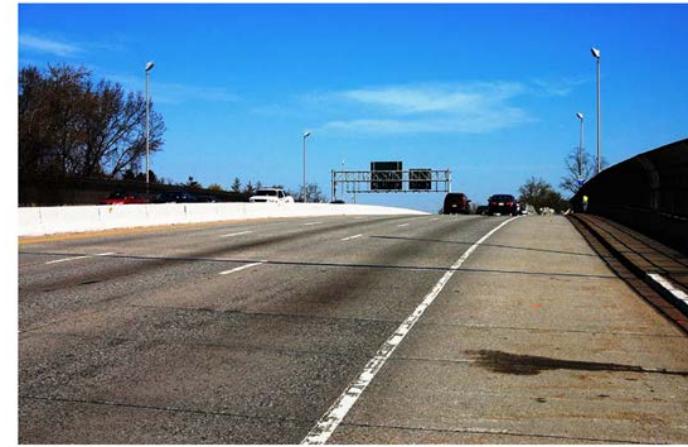
Reasoning behind the design of wind bracing with fatigue-prone details is unclear. The bracing may have been omitted or connections to girder webs may have been detailed differently.

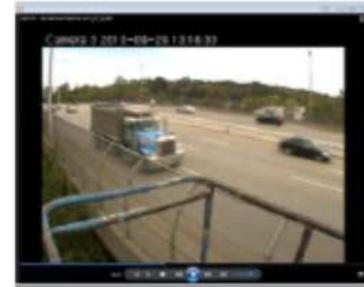
Truck #1 – Lane 1:  
80us response in Girder #3,  
followed by four vibration  
cycles where Girder #1 shows  
larger response

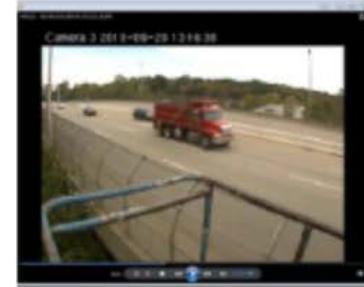
Truck #2 – Lane 3:  
37us response in Girder #6,  
followed by traffic excitation  
causing 20us response in  
Girder #1

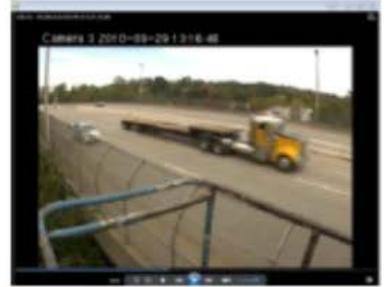
Truck #3 – Lane 3:  
15us response in Girder #6  
which does not excite Girder  
#1 at all

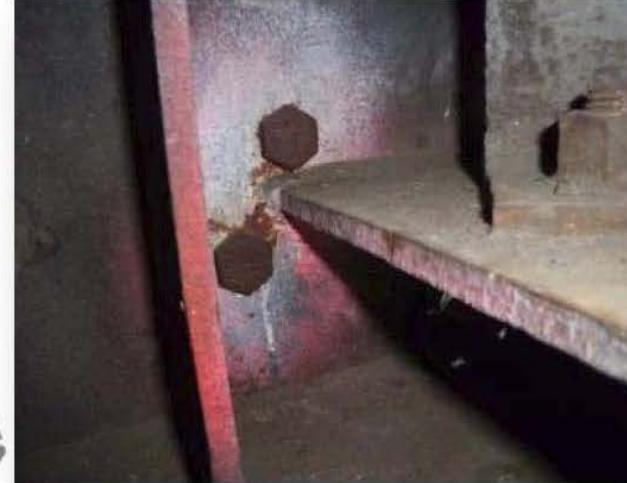
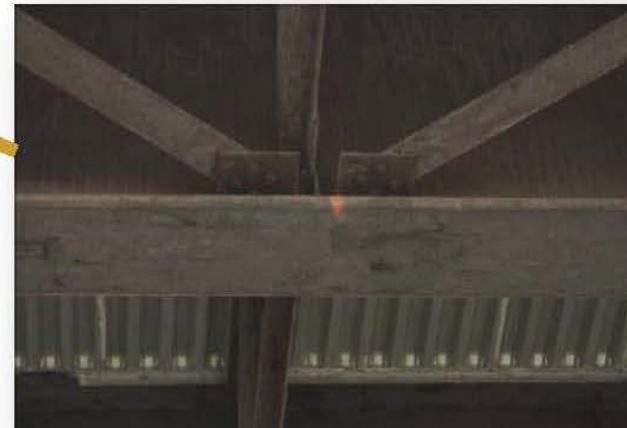
# Findings: Wind Braces are NOT contributing to Structural Stiffness or Strength Capacity

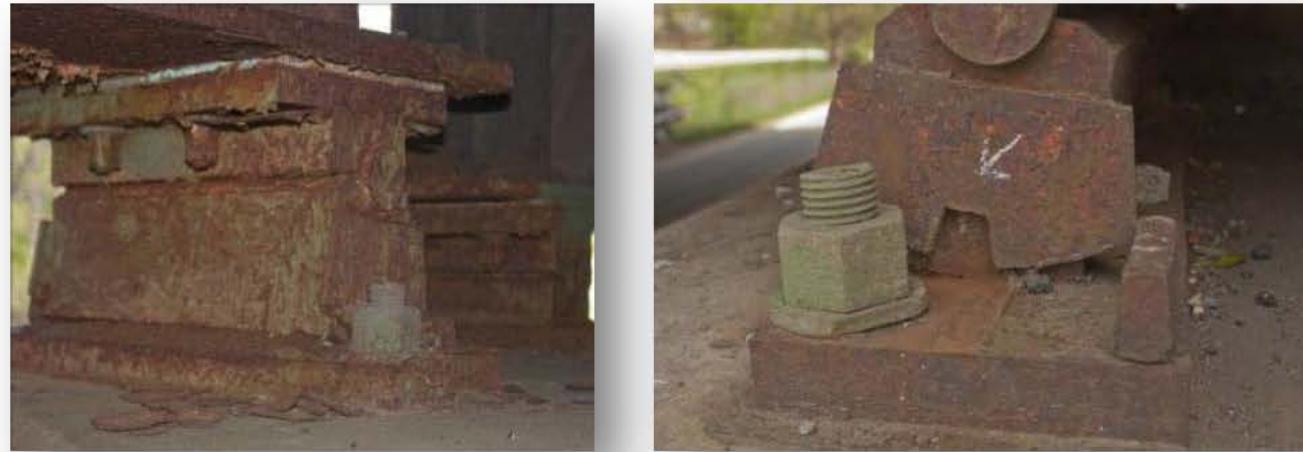
# Findings: Fixed-Direction Rocker Bearings

- Original rocker bearings are deteriorated and, in some cases, damaged
- Water drains through joints onto bearings
- Additionally, the calibrated finite element model indicates ideal bearing movements are not uniaxial along span
- Any bearing replacement should explicitly consider bi-directional movement (and its impact on the joints)

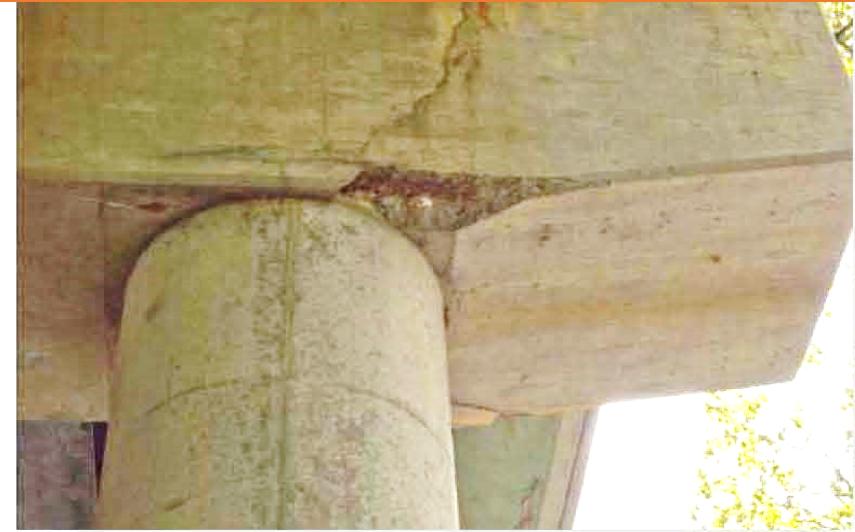
# Findings: Pier-Cap Corbel Shear Crack is Active

- Crack opening was directly measured both during the static test and during normal operations
- Static testing indicated nonlinear behavior of girder #1
- Significant flexibility of pier cap identified through model updating
- Apparent detailing error in the original plans
