## INSPECTION REPORT

CLAIM NUMBER: 260626590  
INSURED: ANGELA MOBBS  
LOSS ADDRESS: 418 CUMMINS ST  
PINEVILLE LA 71360

PROFESSIONALLY PREPARED BY PATRIOT CLAIMS  
June 30, 2026  
Josh Cargile , INSPECTOR

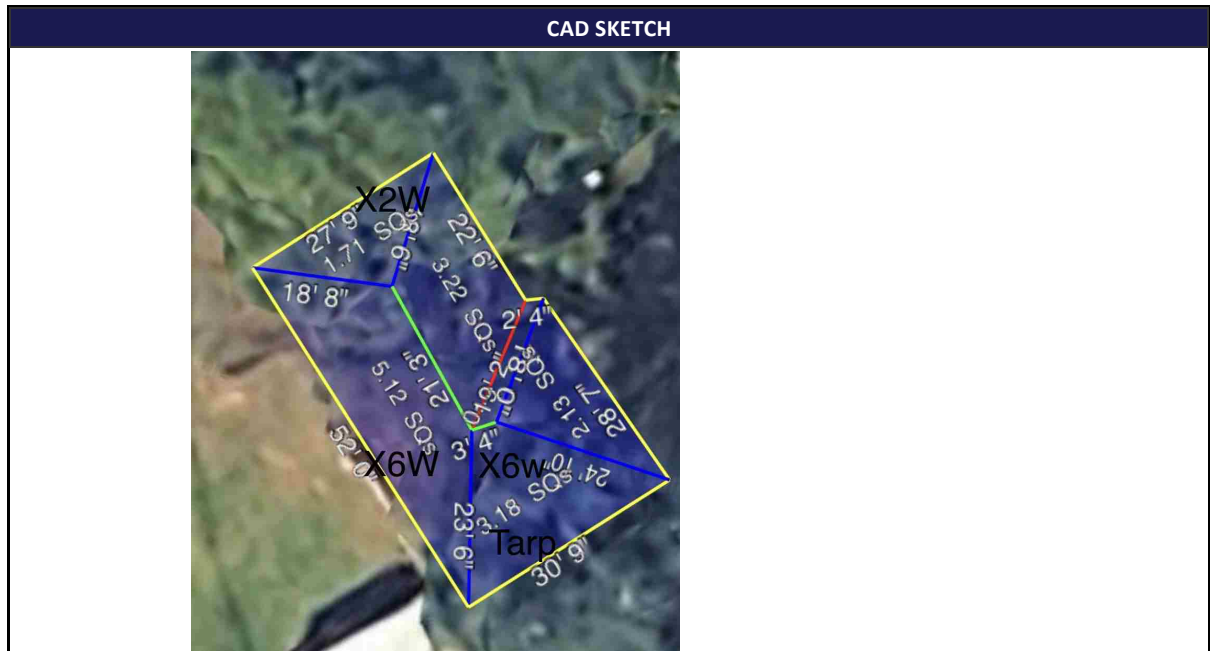
Back slope potential wind x6, left slope potential wind x6, Right slope potential wind x3

**Slope** - Potential Wind Findings: 6 - Tarp Length: 2 - Tarp Width: 2 - Qty of Cap Nails: 6 - Qty Shingles Affected by Cap Nails: 4

Tarp 1 - Tarp: Yes - Tarp Length: 2 Ft - Tarp Width: 2 Ft - Service Provided: New Install Provided - Qty of Cap Nails: 6 Each - Qty Shingles Affected by Cap Nails: 4 Each

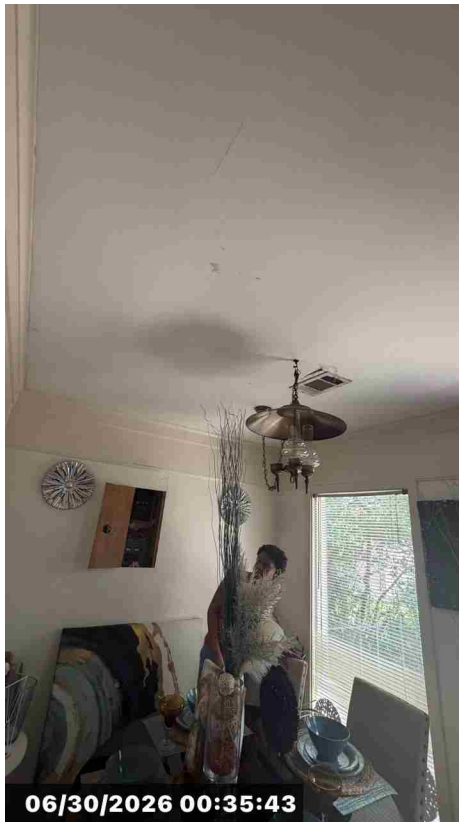
**Dining Room overview(8x12)**  
Room name: Dining Room

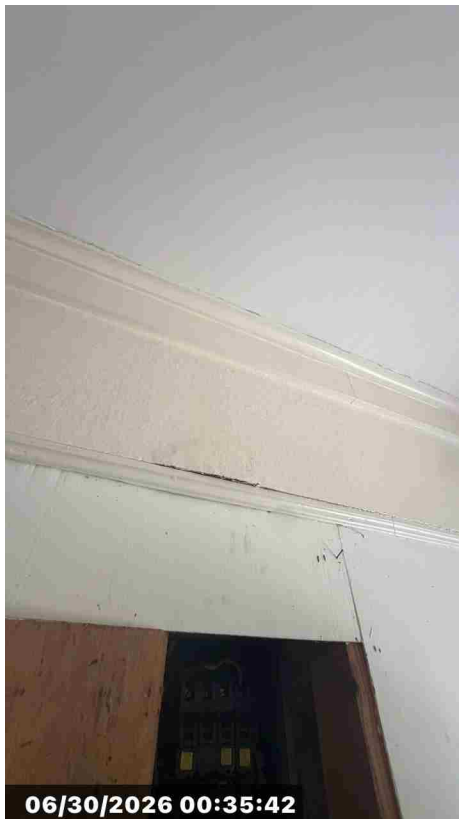
**Dining Room potential leak (3x1) on wall**  
Room name: Dining Room

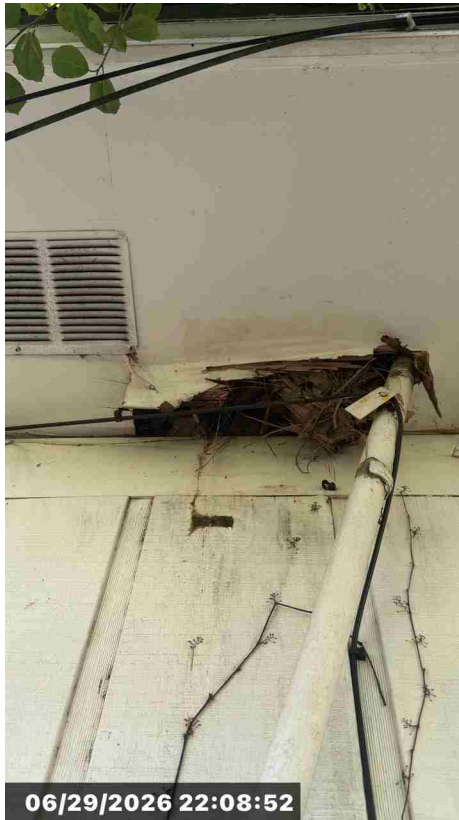
Left slope has a spot where a limb fell all the way through the roof and the soffit, damaging a pipe boot as well. Insured reports pipe boot causing fuses to short so I was very careful not to mess with it but it will need to be replaced. The meter was knocked sideways off its mount on the left elevation as well but appears functional.

Left elevation soffit potential wind/ limb 1 24 x6 ft piece

Left Elevation fascia potential wind/ limb

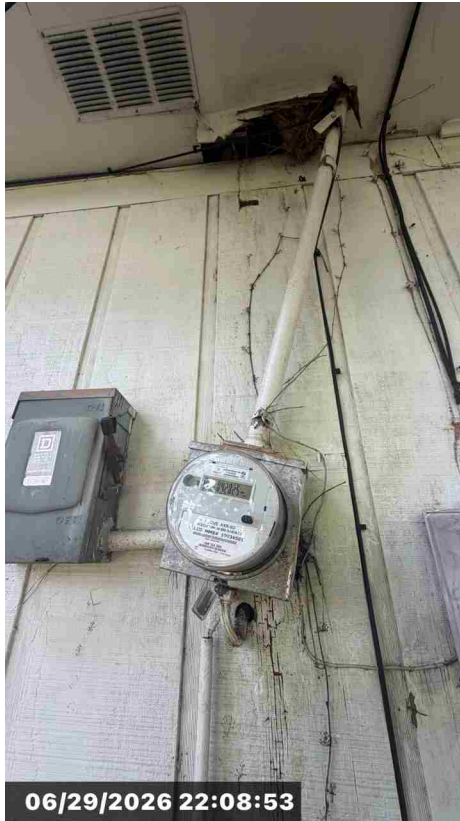
Left Elevation meter potential wind/ limb

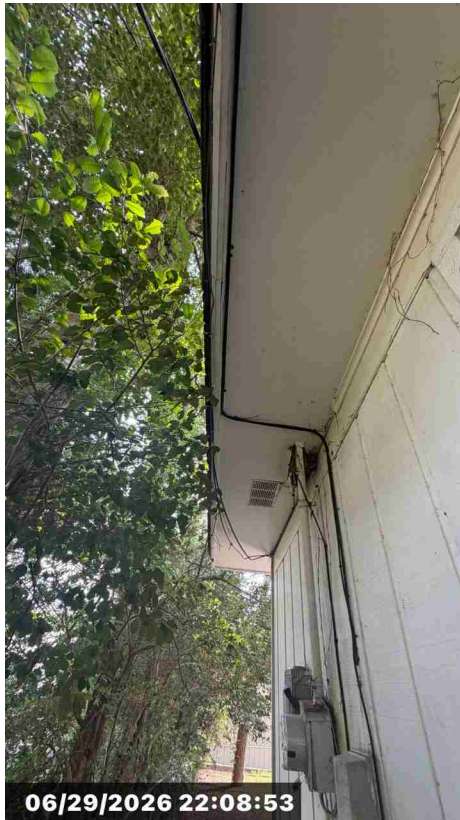
Left Elevation eave potential wind/limb

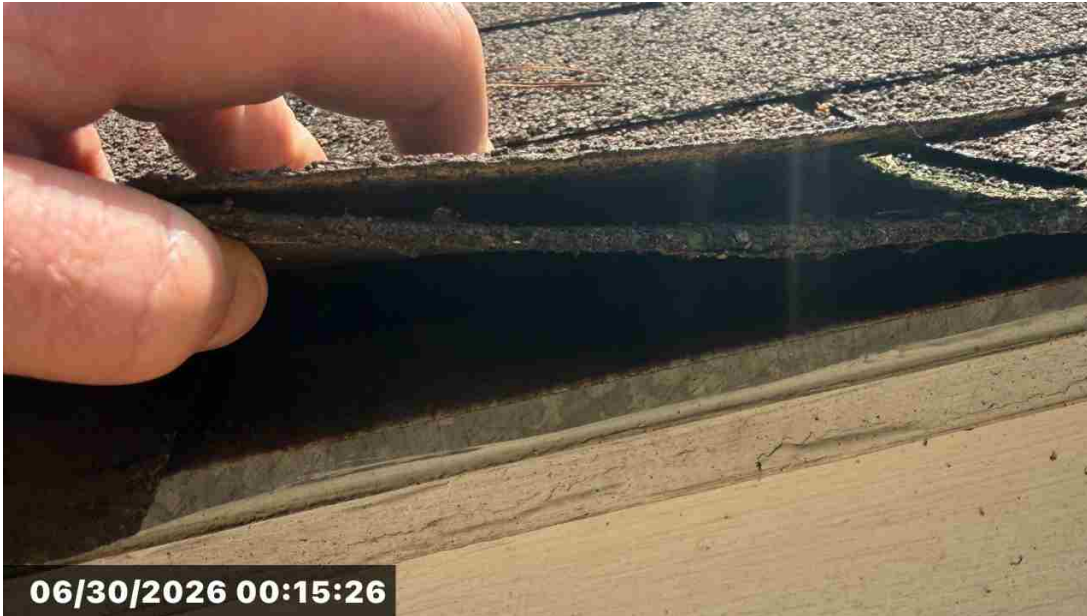
**1 layer**

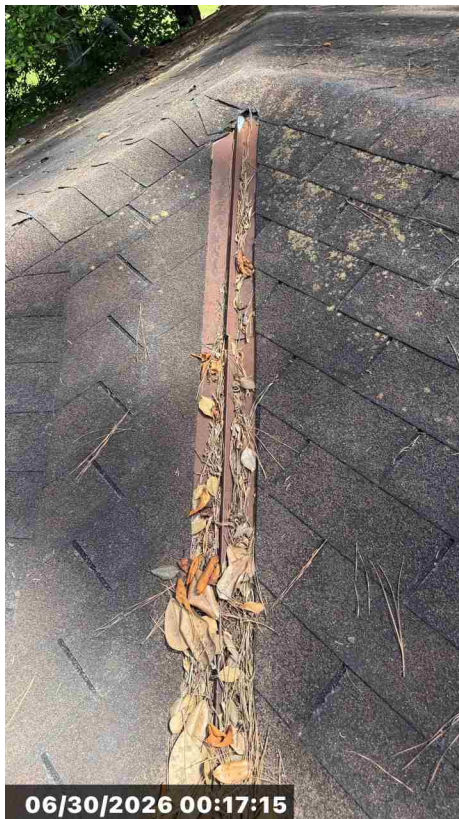
**Valleys open**

Valley: Open metal valley

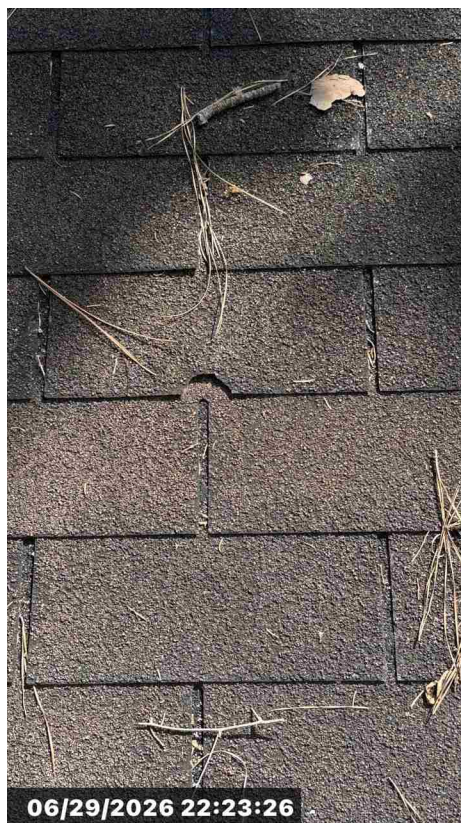
Front Slope Test Square q1 potential granule loss

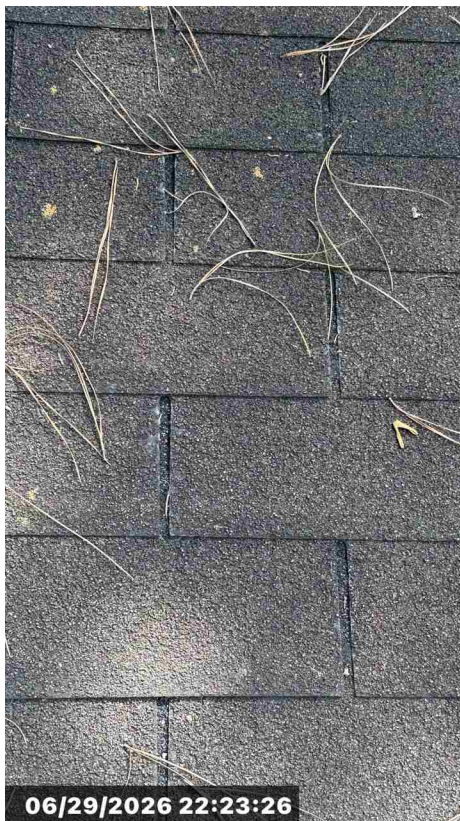
Front Slope Test Square q2 potential granule loss

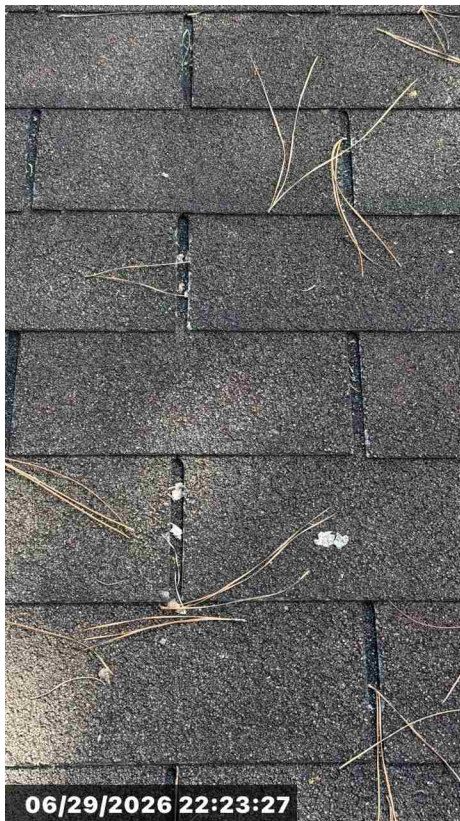
Front Slope Test Square q3 potential granule loss

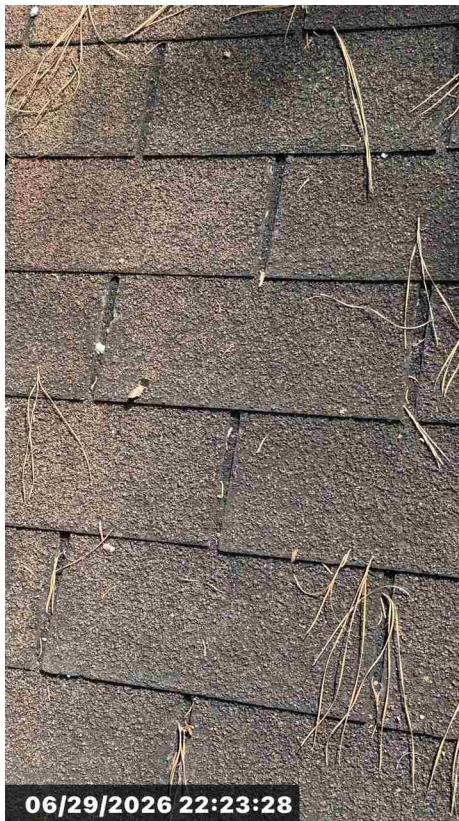
Front Slope Test Square q4 potential granule loss

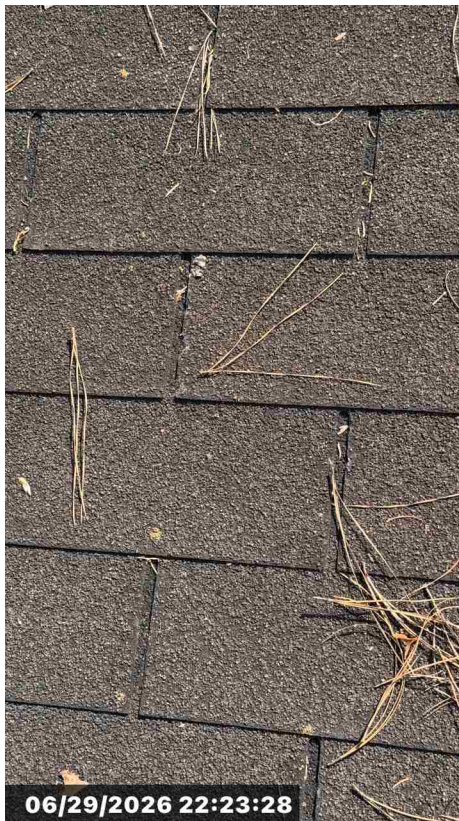
Front Slope Test Square q5 potential granule loss

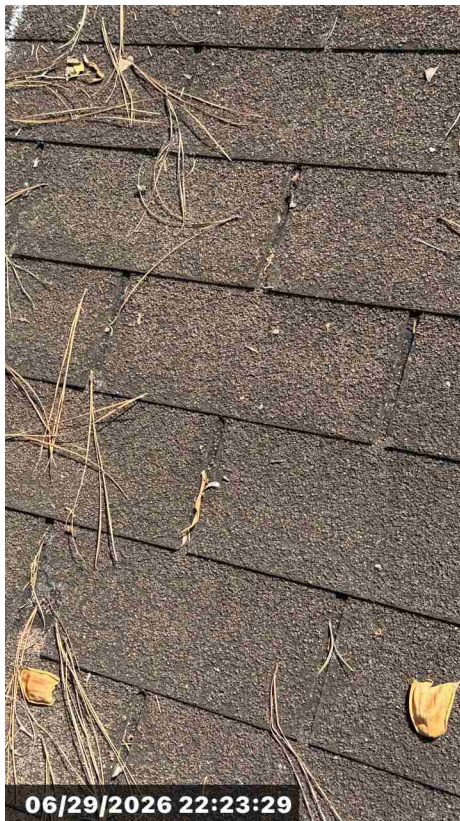
Front Slope Test Square q6 potential granule loss

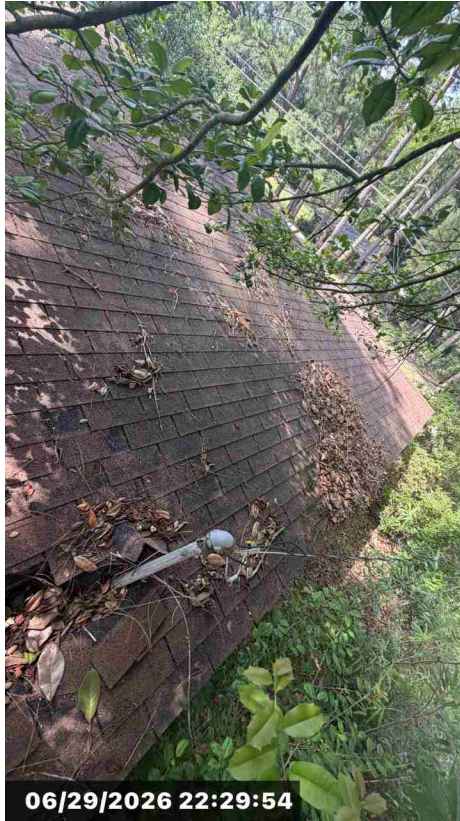
Left Slope potential wind/limb x5

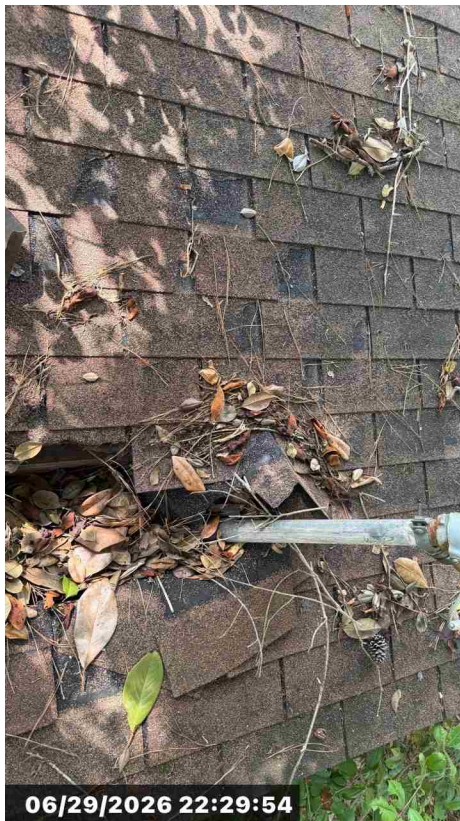
Left Slope potential wind/ limb x5

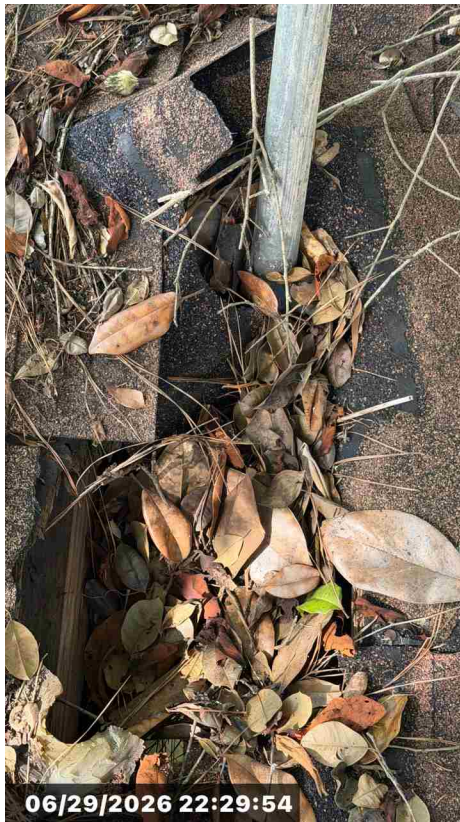
Left Slope potential wind/ limb x5

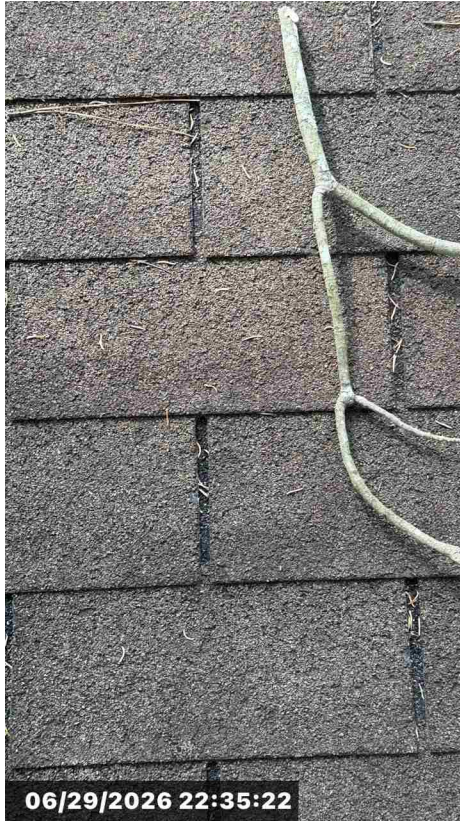
Left Slope Test Square potential granule loss

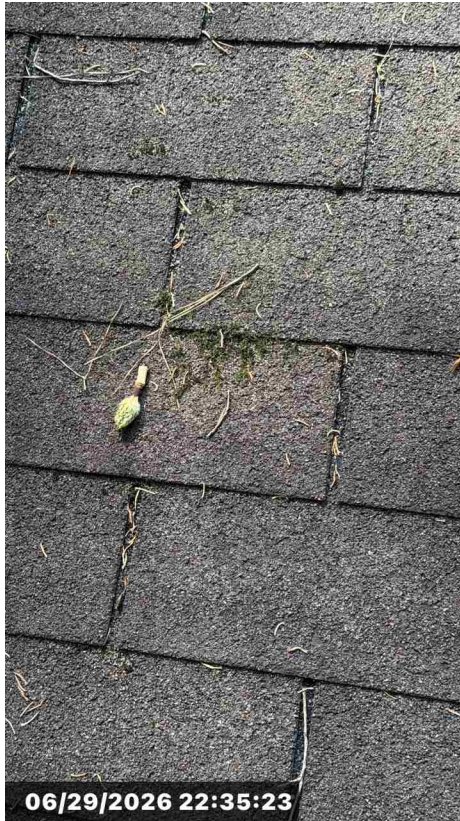
Left Slope Test Square potential granule loss

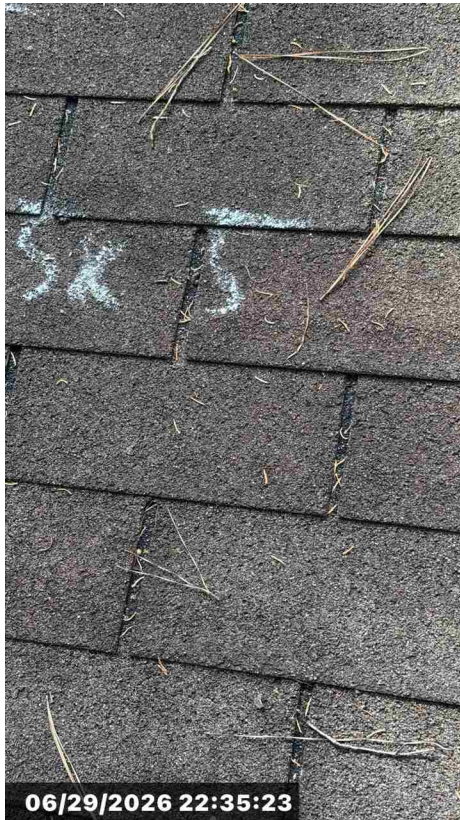
Left Slope Test Square potential granule loss

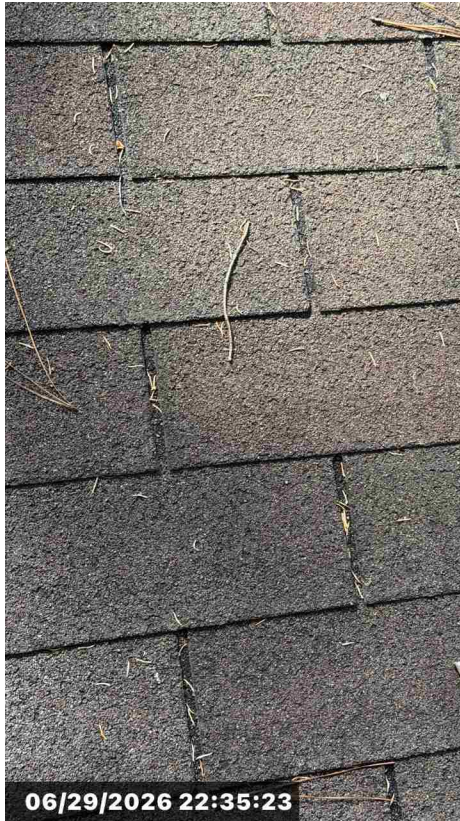
Left Slope Test Square potential granule loss

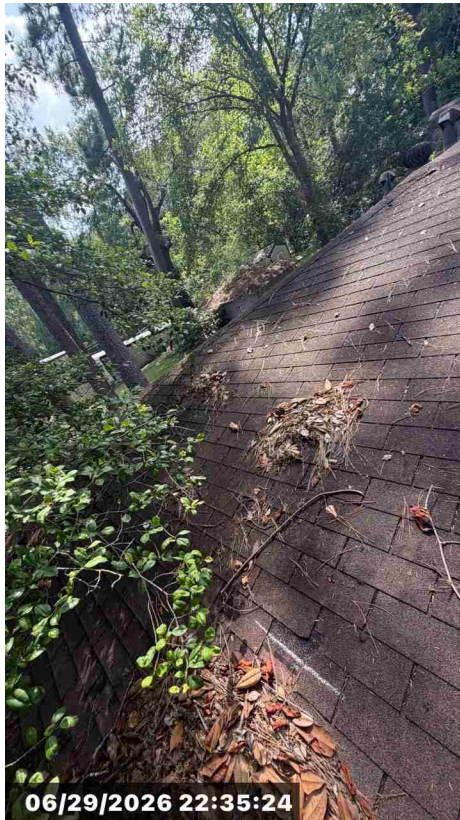
Left Slope potential wind x6

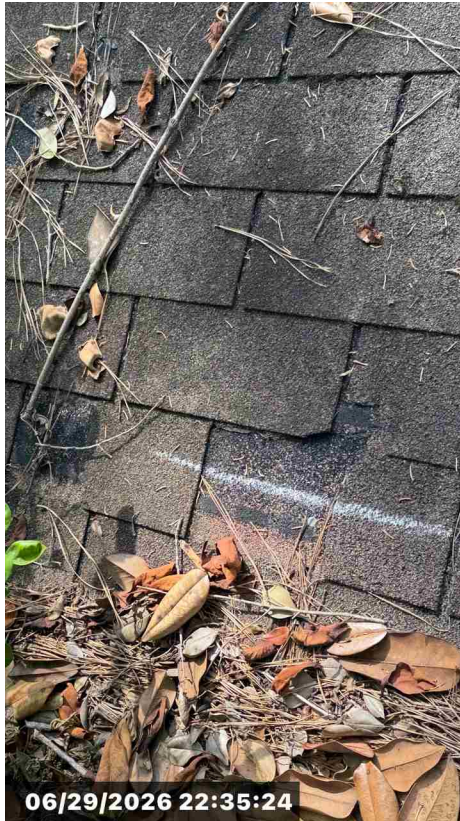
Left Slope potential wind x6

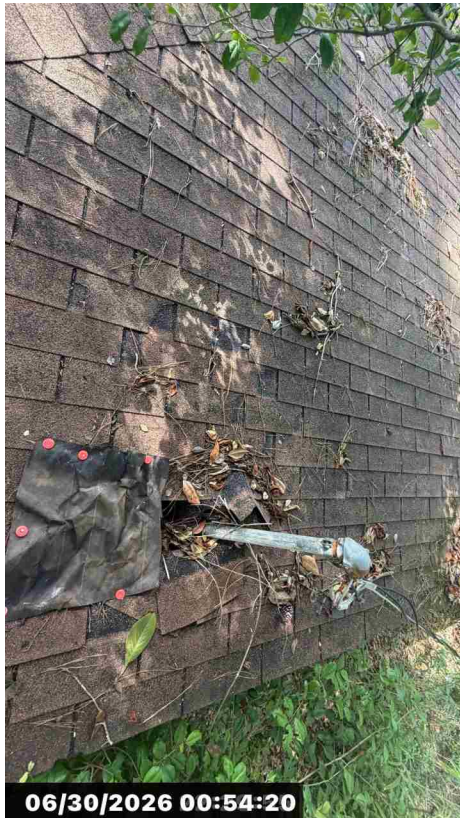
Left Slope Facet A Tarp 1 Tarp  
Tarp: Yes

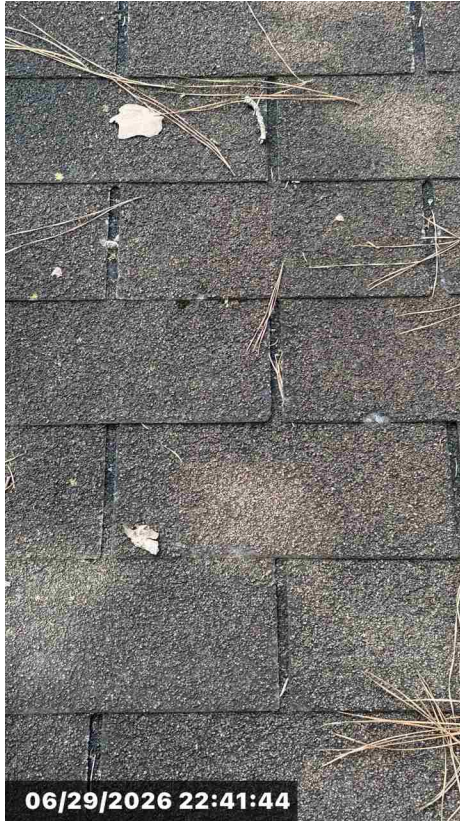
Back Slope Test Square q1 potential granule loss

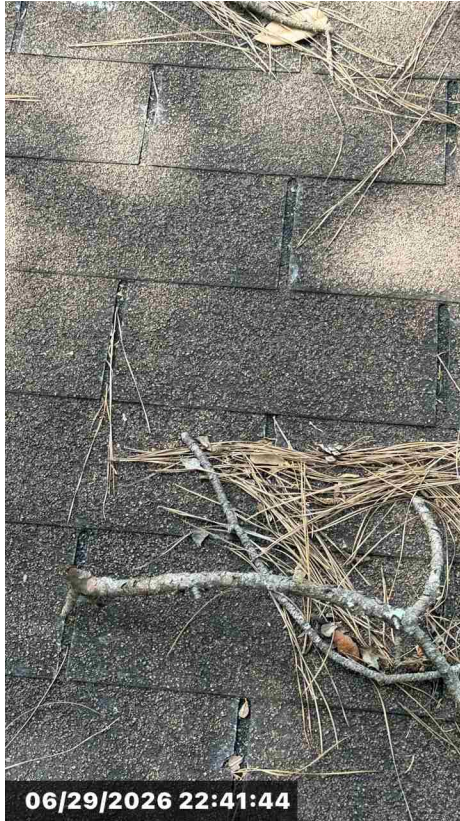
Back Slope Test Square q2 potential granule loss

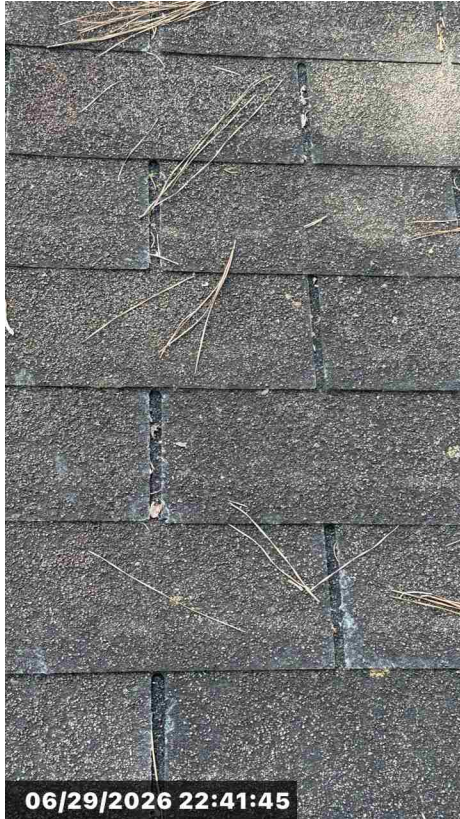
Back Slope Test Square q3 potential granule loss

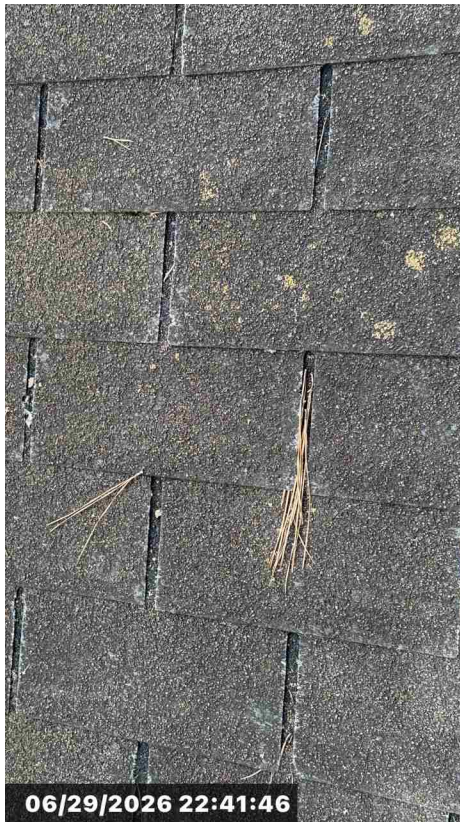
Back Slope Test Square q4 potential granule loss

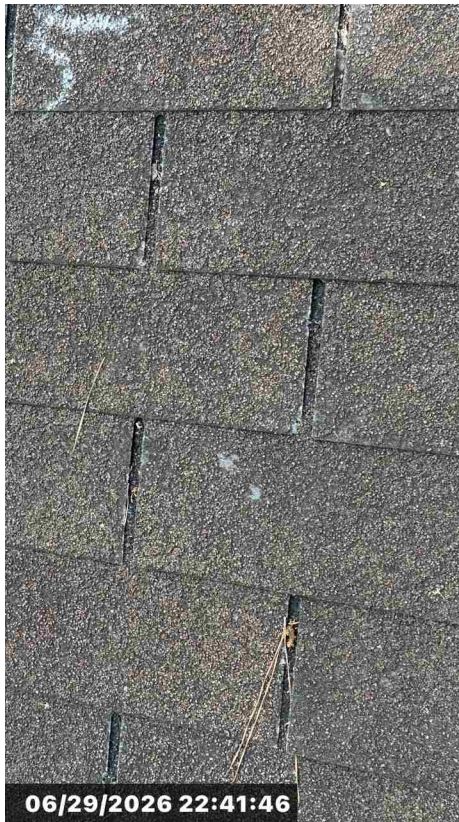
Back Slope Test Square q5 potential granule loss

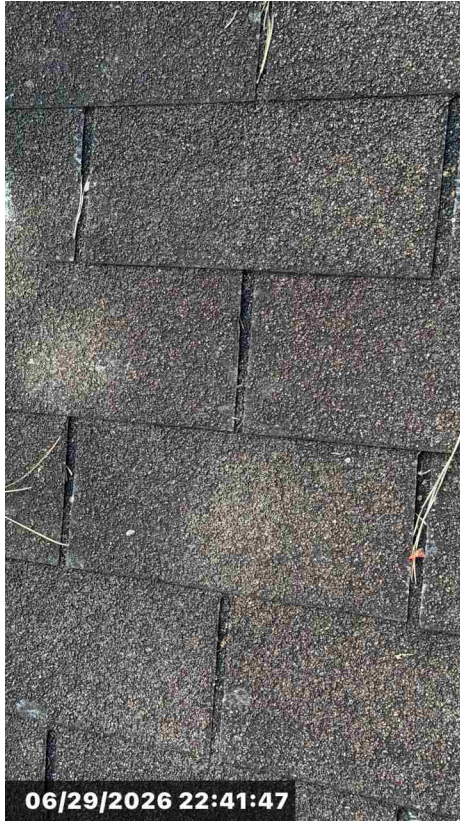
Back Slope Test Square q6 potential granule loss

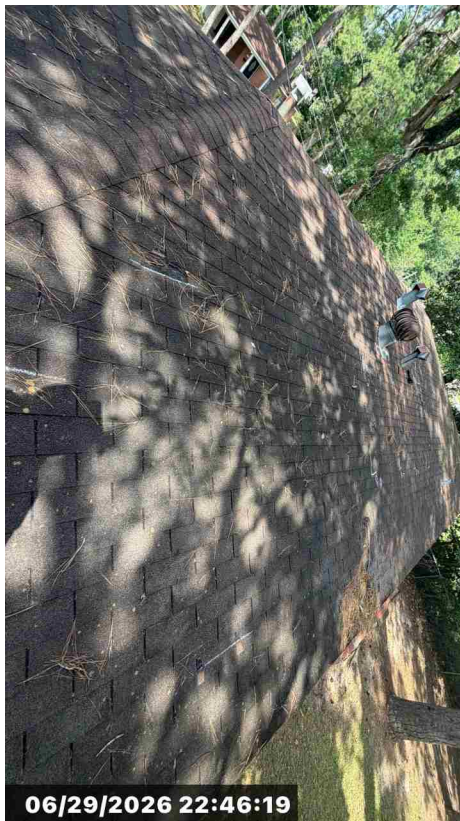
Back Slope potential wind x6

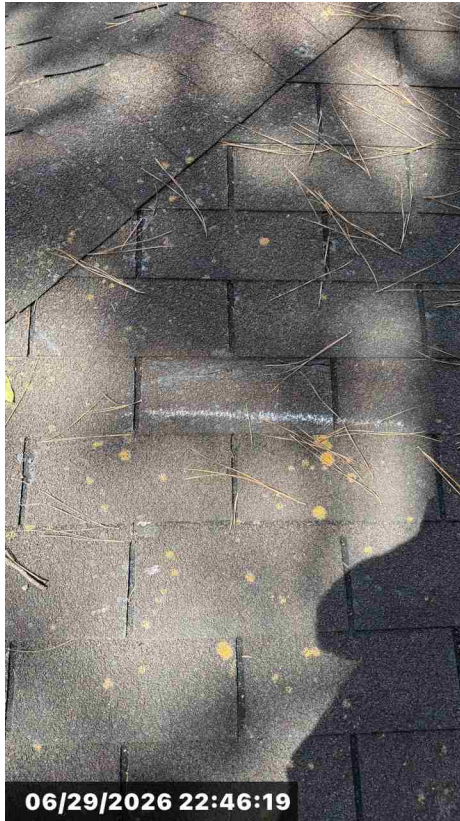
Back Slope potential wind x6

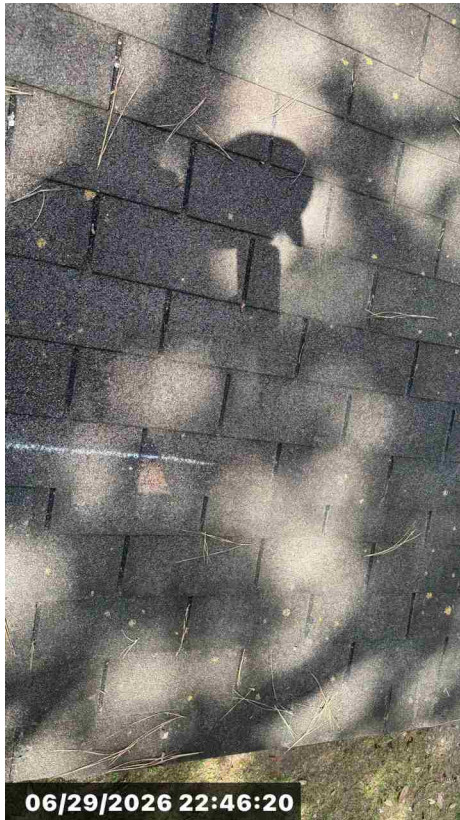
Back Slope potential wind x6

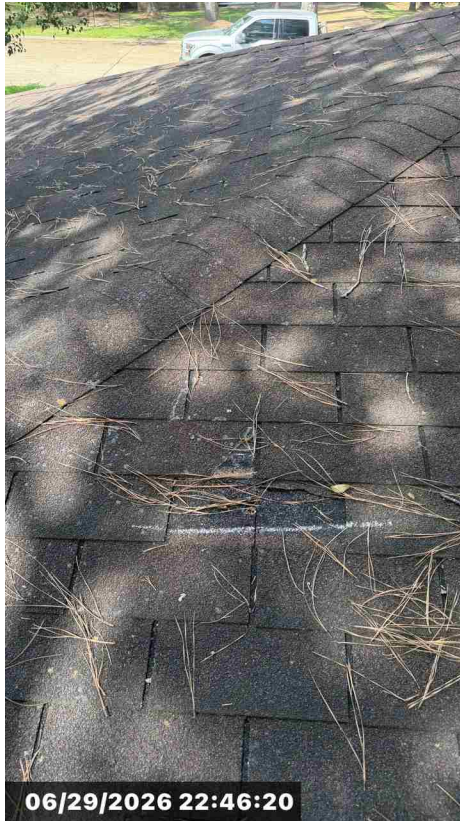
Back Slope potential wind x6

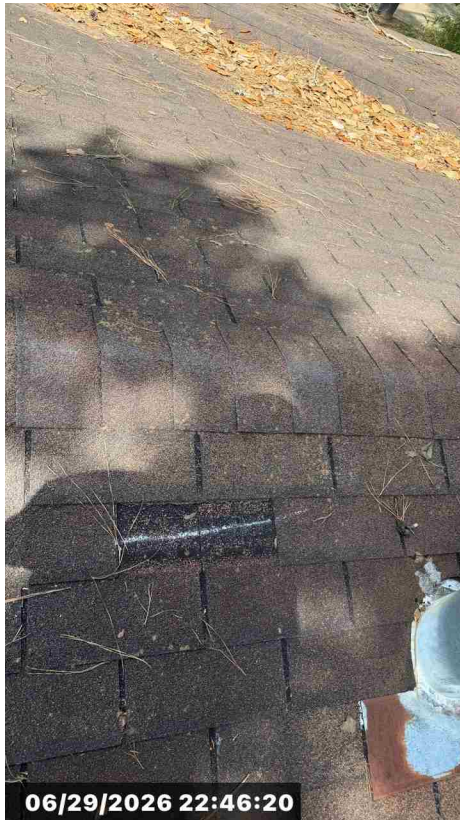
Back Slope potential wind x6

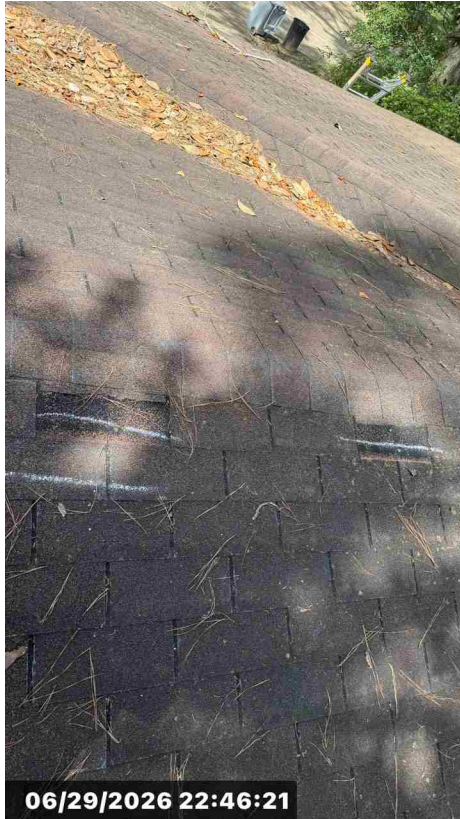
Back Slope potential wind x6

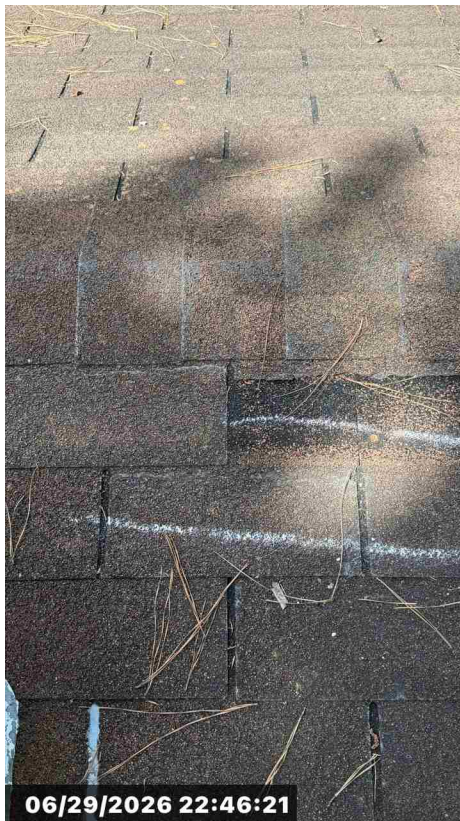
Back Slope potential wind x6

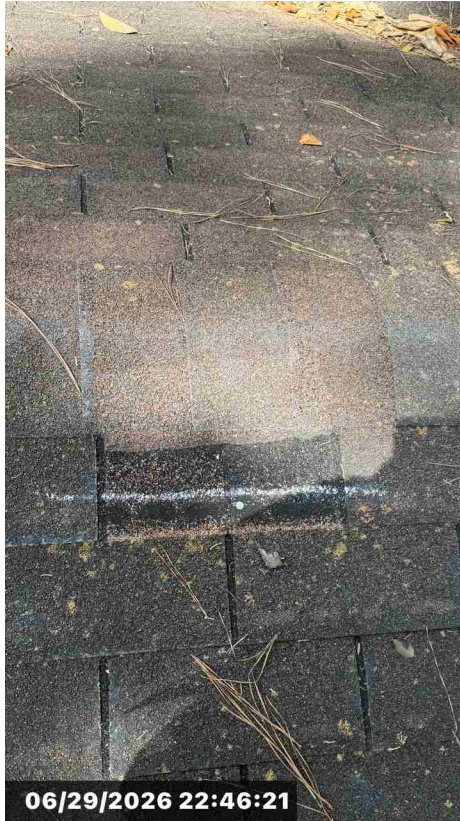
Back Slope potential wind x6

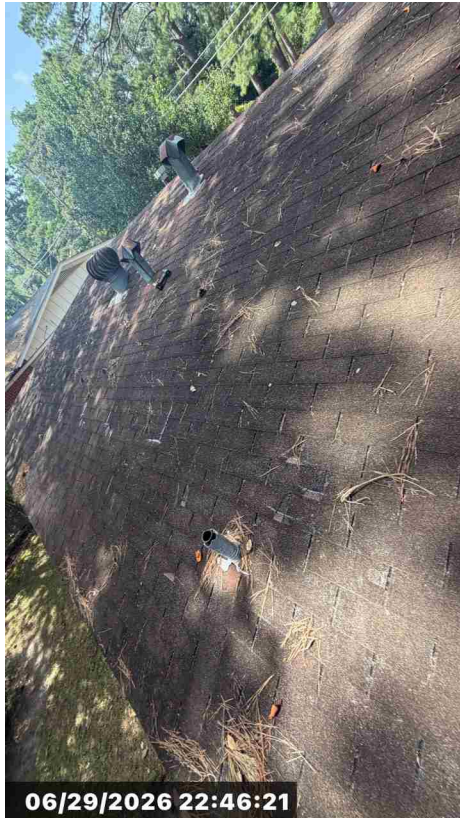
Back Slope potential limb

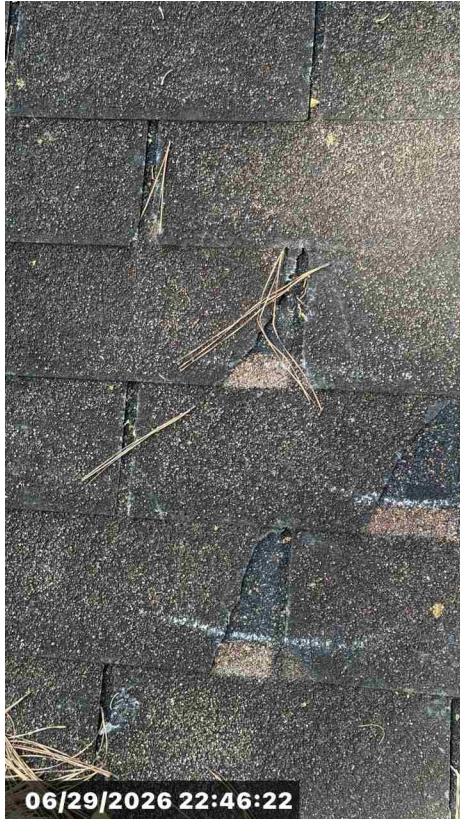
Back Slope potential limb

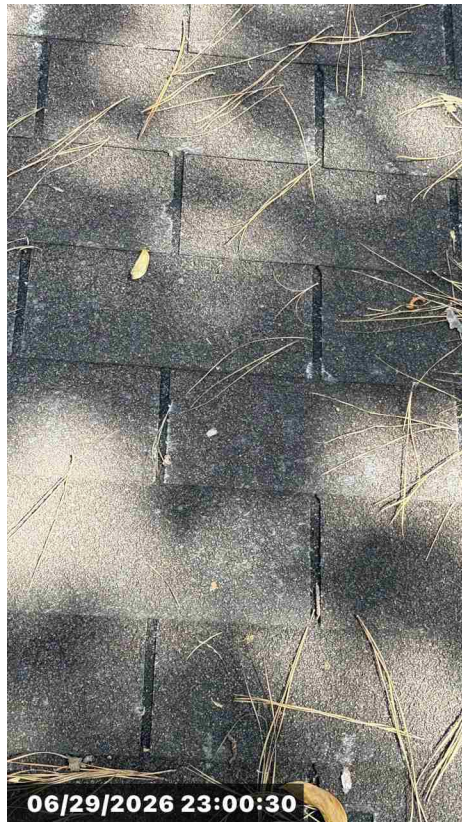
Right Slope Test Square q1 potential granule loss

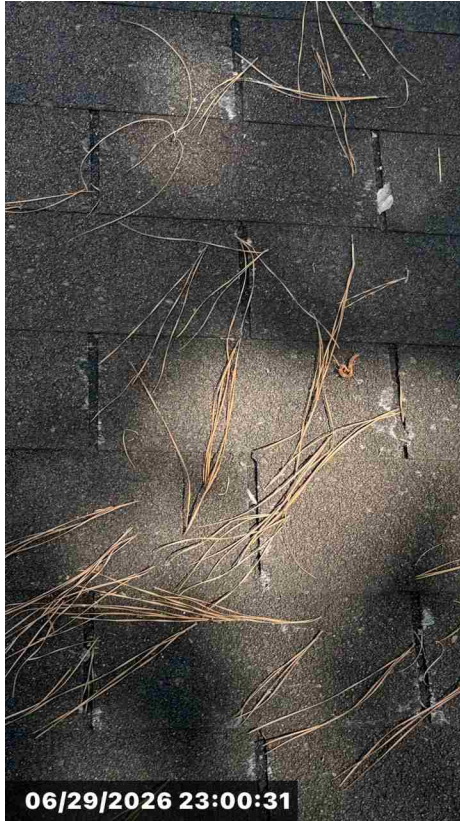
Right Slope Test Square q2 potential granule loss

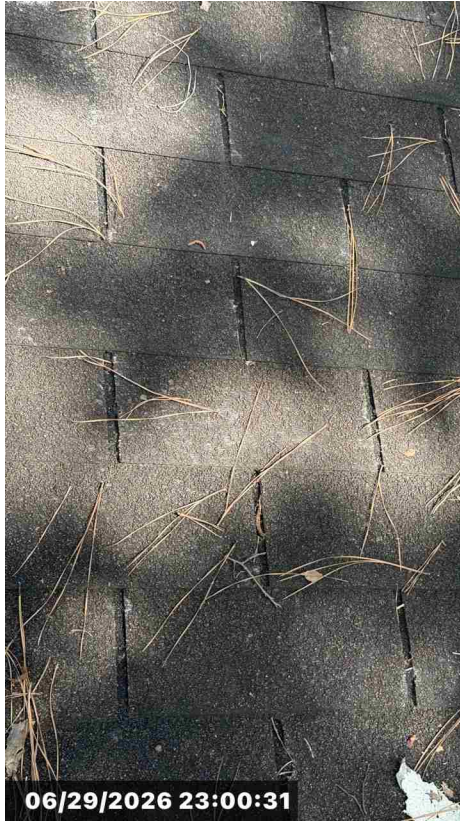
Right Slope Test Square q3 potential granule loss

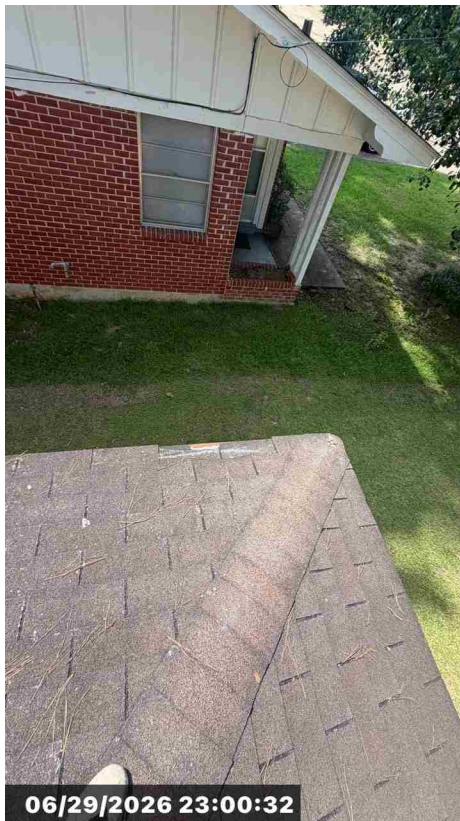
Right Slope potential wind x2

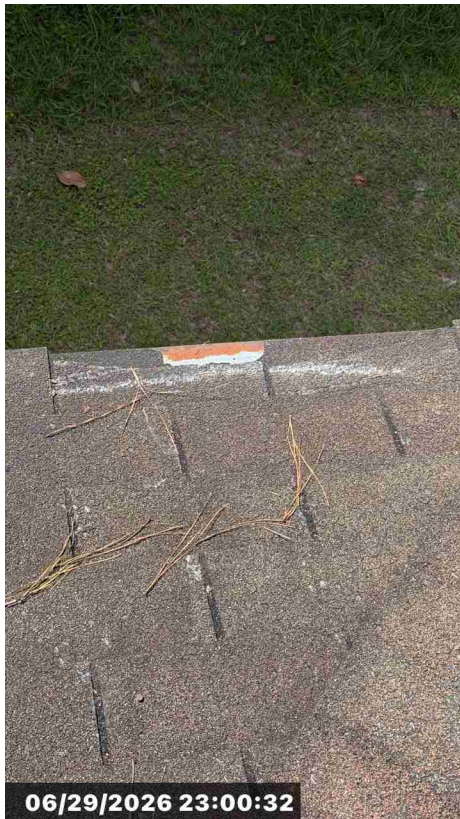
Right Slope potential wind x2
