# Investigation of failure mechanism of stator winding and stator core. Protocol for repair and acceptance testing of stator winding and stator core. Asset management strategy for stator assembly for machines above 100MVA.

Yuriy Kharchenko, P.Eng.  
Kemano G.S., Rio Tinto  
Kitimat, British Columbia  
Yuriy.Kharchenko@riotinto.com

This case study focuses on a hydro generator rated 132 MVA, 13.8 kV, and 327 rpm synchronous speed powered by Pelton turbine as a prime mover. The generator was constructed in 1956 with Roebel bar wound with two parallel circuits per phase and generator neutral grounding transformer. In 1986 this generator was rewound and the original four (4) splits core was reused. After 32 years in service, the unit experienced a ground failure of the stator winding. The proposed data-driven approach

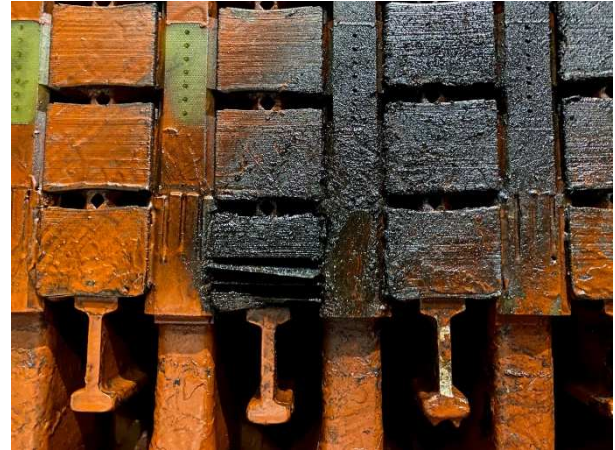
Fig. 2 Core Damage Area

After rotor removal the damage to the core was easily identified and hence a failure mode of the generator (Fig. 2). The support finger for lower core tooth packet between slots was displaced downwards and about 45% of this tooth packet laminations were destroyed by the extreme temperature and erosion. It was apparent that as soon a compression of the tooth packet laminations was decreased and the insulating layer on the laminations wore out due to vibration allowing the development of eddy current and subsequently creating hot spot in the area. The hot spot in this core tooth packet eventually led to localized core damage and bar failure in adjacent to packet slot. Migration of the laminations from burned tooth packet could also contribute to the ground wall insulation failure due to additional mechanical pressure, however inspection of side packing and bar dissection did not revealed that evidence. Bar dissection confirmed temperature and electric nature of the ground wall insulation fault due to dry and delaminated state of the insulation as well as core hot spot as a main cause.

The knife insertion test was conducted at the back of the stator core for evaluation of the overall core compression. The test revealed loose lamination at the bottom of the stator core and the burned tooth packet area, with knife penetration reaching a depth of 1.2 inches.
