# Eagle Scout Project

Renovation of Great Escape Early Learning Center Playgrounds

Jeffrey Allen

2017

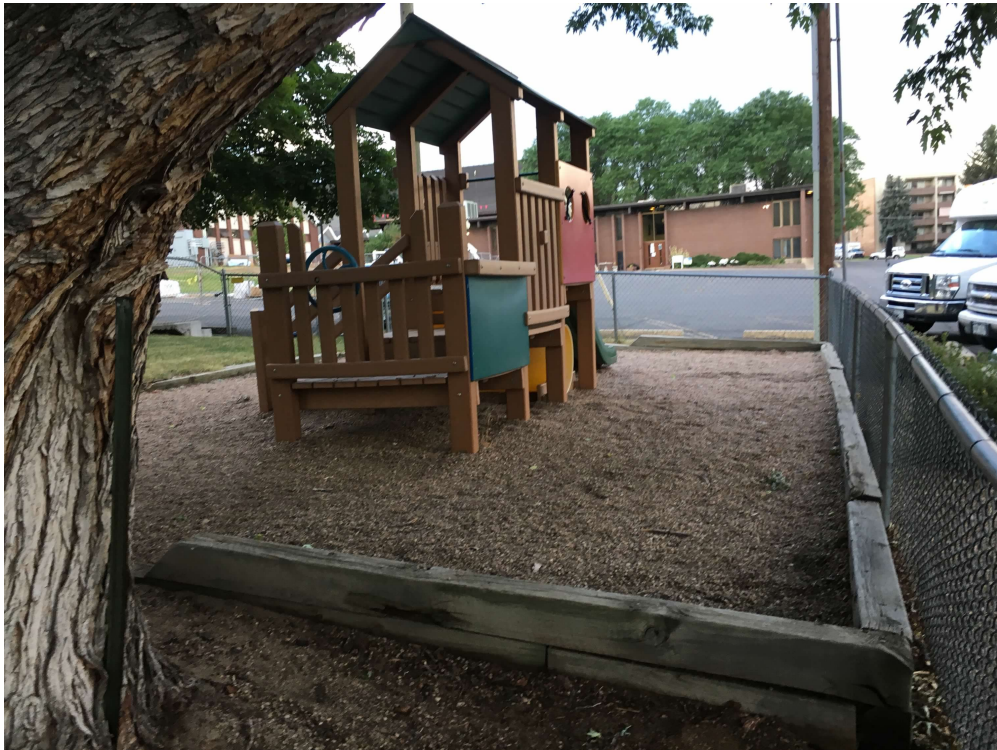
Led a team of over 40 volunteers in the complete renovation of two front playgrounds at the Great Escape Early Learning Center. The project significantly improved safety, accessibility, and structural integrity by deepening the play areas, replacing deteriorated containment borders, refreshing the safety surfacing, and restoring existing play equipment.

Figure 1: Before renovation — one of the two playground areas

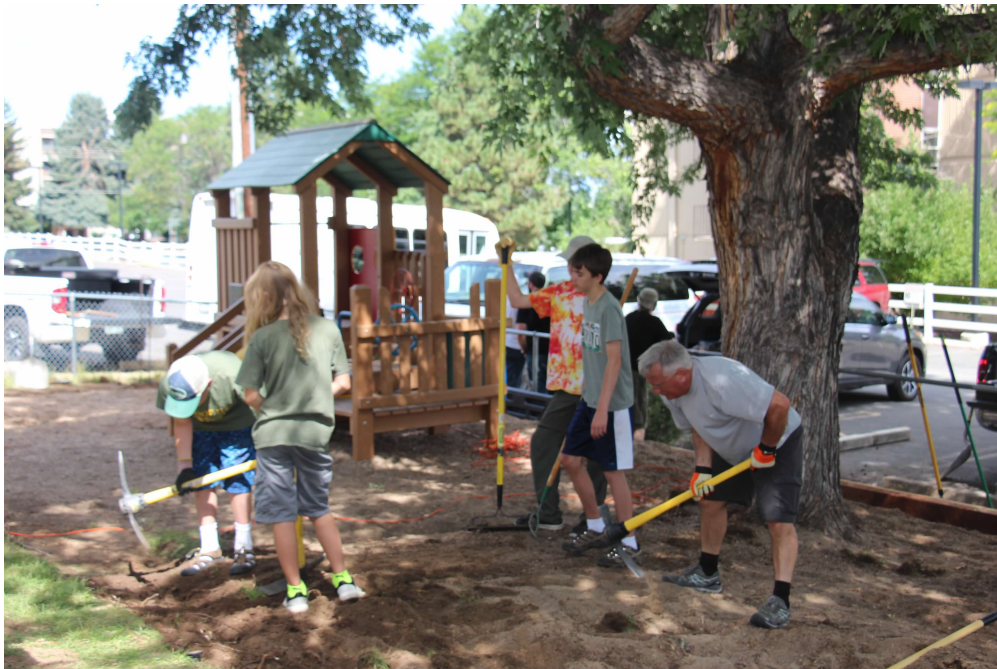
Figure 2: Excavation and regrading of playground surfaces

- Excavated and regraded both playground surfaces by removing the top layer of compacted gravel.
- Increased the depth of the play areas to accommodate additional impact-absorbing surfacing material.
- Established proper drainage slopes and created a level, stable sub-base.

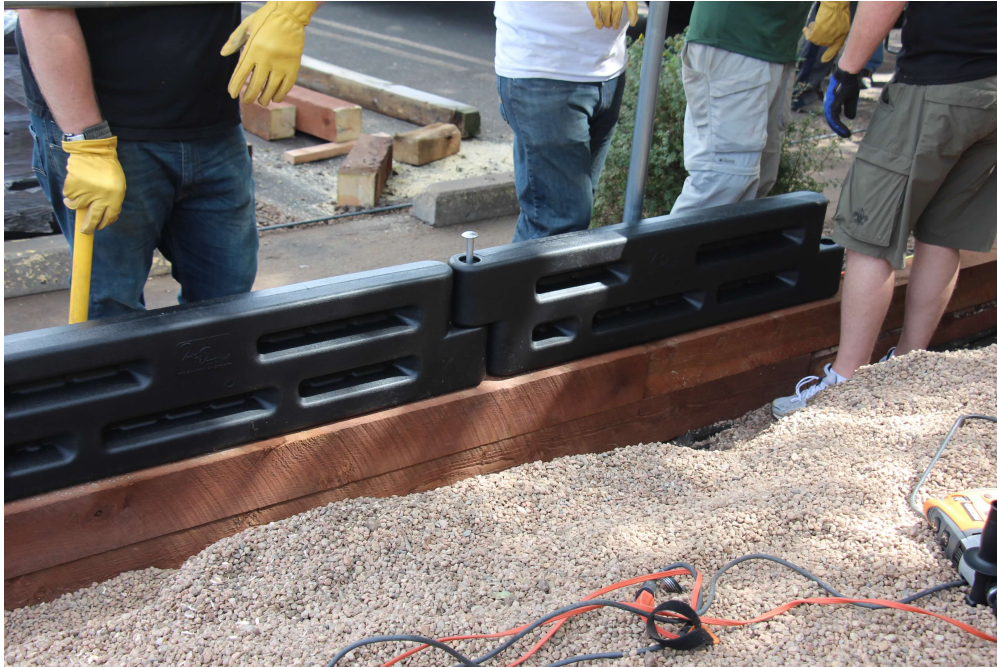
Demolished the deteriorated wooden playground borders on both play areas and installed a new, robust containment system.

Figure 3: Installation of new rebar-anchored timber borders with plastic edging

- Installed new pressure-treated landscape timbers, vertically anchored with steel rebar stakes driven into the ground for long-term stability.
- Capped the timbers with heavy-duty plastic playground edging barriers to securely contain the safety surfacing and improve edge safety.
