# MARINE ELECTRICAL INSPECTION REPORT

## Cockpit Instrument Power — Investigation & Findings

| Vessel Name | Humble Vandal |
| Inspection Date | May 30, 2026 |

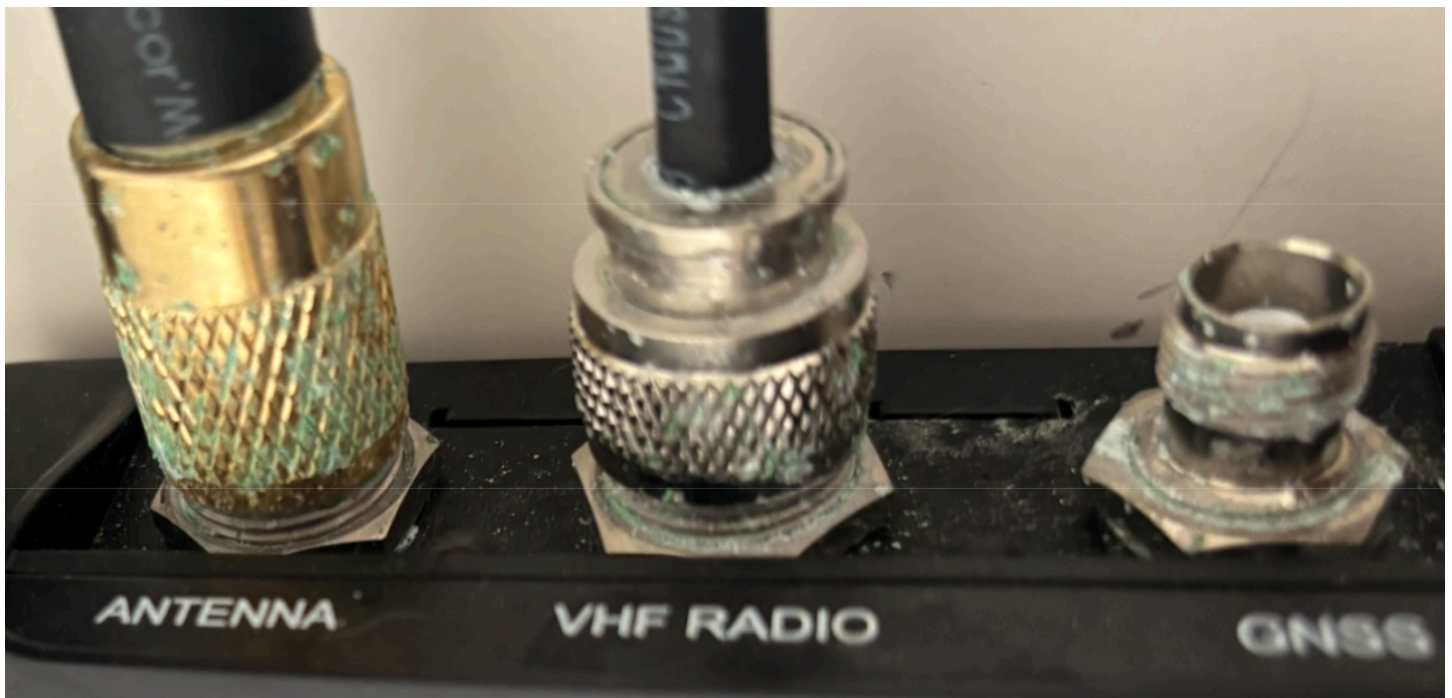
| 4 | em-trak AIS — RF connectors | All three RF connectors (Antenna, VHF Radio, GNSS) show heavy green corrosion on the connector bodies and mating threads. | HIGH | Remove connectors, clean with electrical contact cleaner, and apply corrosion inhibitor. Inspect coax cables for moisture ingress. Replace connectors if pitting is severe. |

AIS connectors corroded, possibly saltwater from spinnaker.
