June- 2011 rev 3

Antenna and Test Locations – Quick Tips

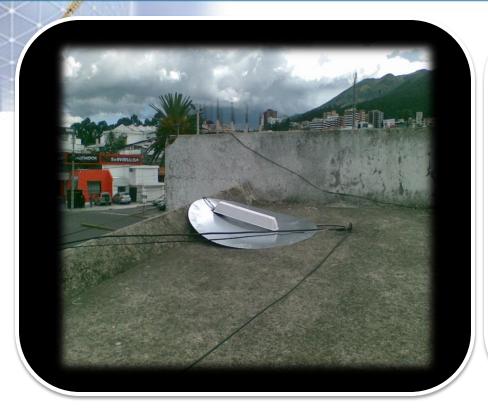
MPR 3 Antenna Inevitable Technologies

Not good electrical contact between the antenna base and the ground plane surface. Wall blocking partially the sky view

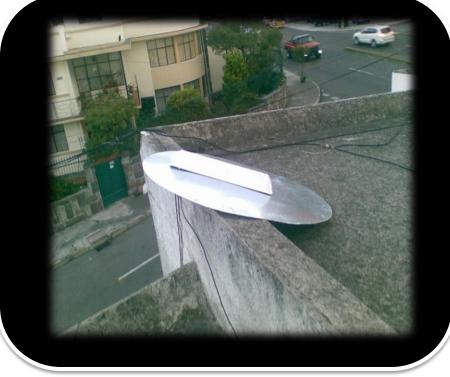
Good contact and a better sky view

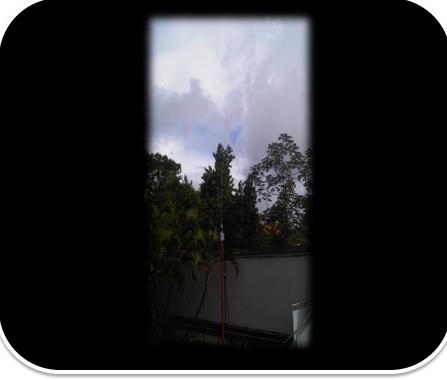
Antenna is at the top of the mounting base.

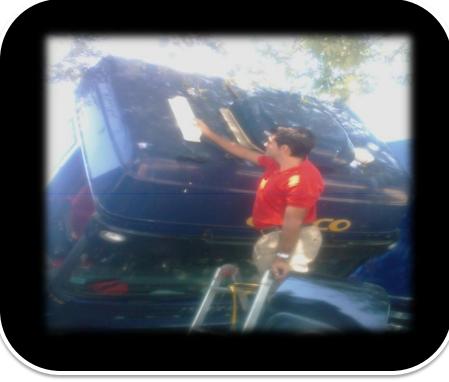
Antenna has a fiber glass roof base

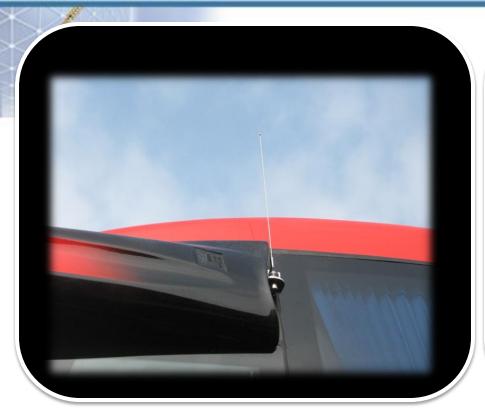
¼ wave antenna

No ground plane

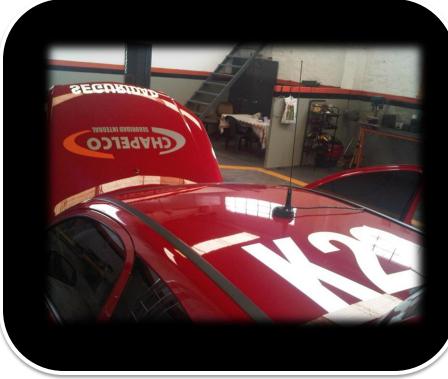
Simmetrical ground plane

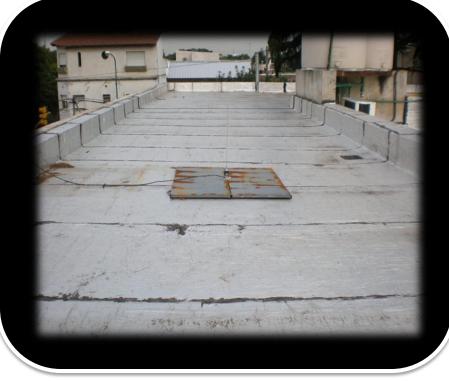
Simmetrical gronud plane No walls near the radiating area

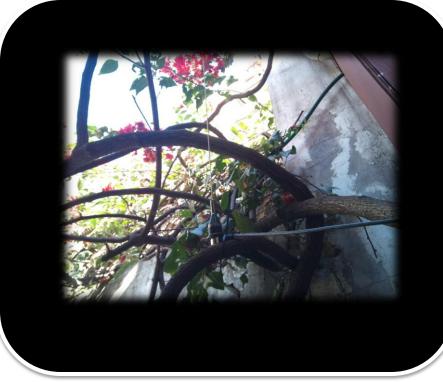
1/4 wave antenna REQUIRES GROUND PLANE

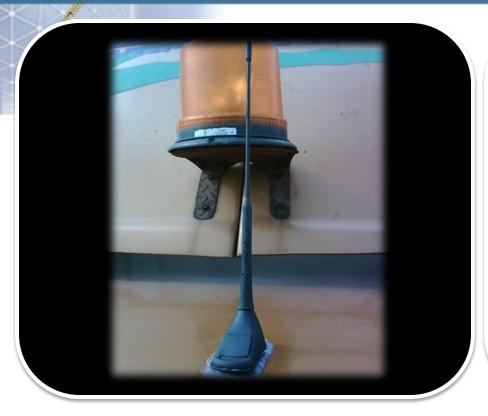
Case 5 – Hirschmann ¼ wave antenna

Antenna is ¼ wave requiring a metallic ground plane to work Vehicle roof is plastic

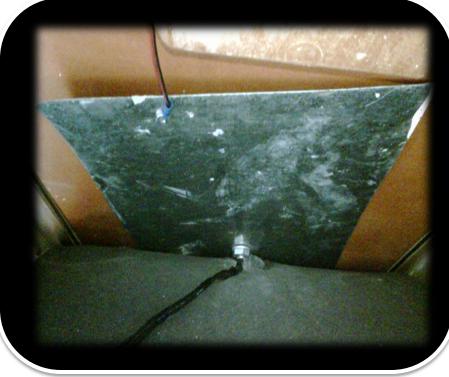
Metallic earth plane below the plastic roof connected to the vehicle earth
