## INSPECTION COATING THICKNEES

No. : JTI-2607-001/2025SK011-ICT

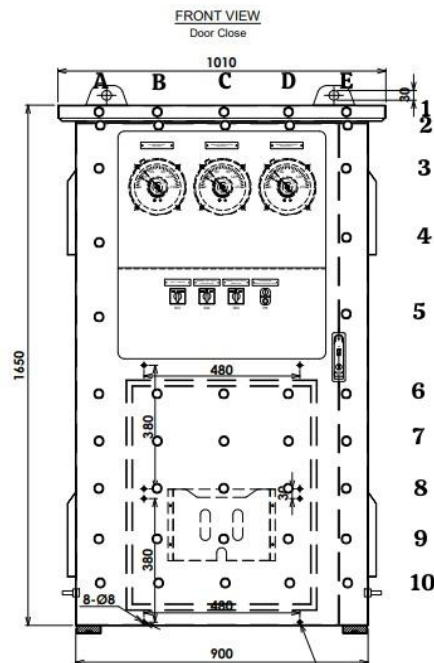
#### A. Front View

| No | A | B | C | D | E |
| 1 | 341 | 306 | 293 | 322 | 253 |
| 2 | 323 | 328 | 284 | 305 | 352 |
| 3 | 316 | - | - | - | 319 |
| 4 | 340 | - | - | - | 368 |
| 5 | 326 | - | - | - | 282 |
| 6 | 304 | 383 | 290 | 339 | 441 |
| 7 | 346 | 372 | 369 | 261 | 330 |
| 8 | 361 | 267 | 311 | 339 | 350 |
| 9 | 355 | 364 | 377 | 290 | 340 |
| 10 | 283 | 358 | 377 | 342 | 322 |

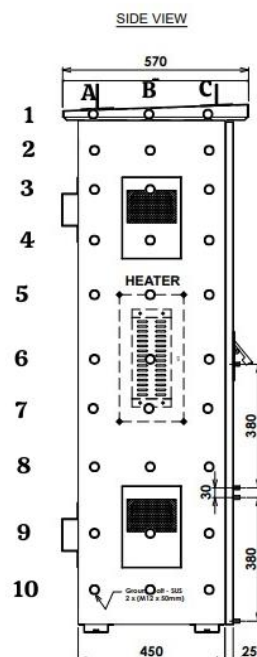
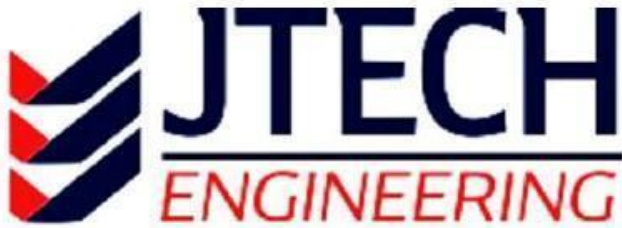
### B. Side View

| No | A | B | C |
| 1 | 321 | 242 | 376 |
| 2 | 329 | 410 | 403 |
| 3 | 385 | 282 | 332 |
| 4 | 399 | 303 | 291 |
| 5 | 483 | 412 | 362 |
| 6 | 442 | 314 | 344 |
| 7 | 334 | 379 | 255 |
| 8 | 393 | 412 | 272 |
| 9 | 382 | 278 | 389 |
| 10 | 550 | 369 | 568 |

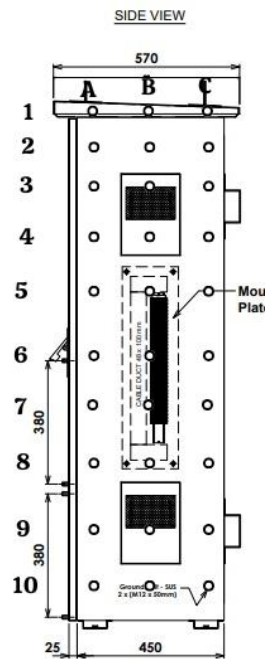
### C. Side View

| No | A | B | C |
| 1 | 400 | 338 | 304 |
