**Fwd: From Hyundai Service**

I am writing to streamline the repair plan for my vehicle (2024 Hyundai Ioniq 5, VIN ending in KM8KNDDF9RU253237) and avoid unnecessary diagnostic time.

## Smart Diagnosis

IONIQ 5 (NE EV)/2024/70KW+160KW

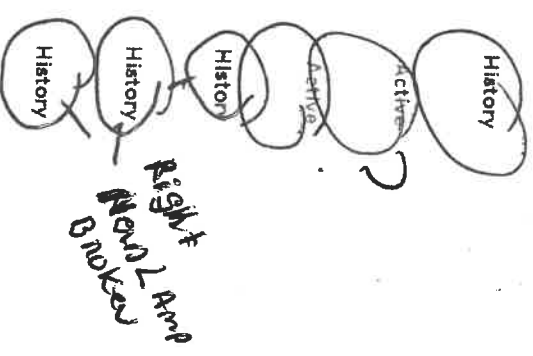
These are the codes in the system we need 4 hours of diagnosis \$1040 of diagnose the vehicle IN order to see what else the vehicle needs.

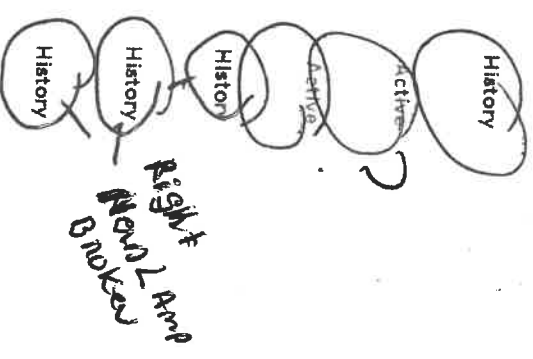
These are the codes in the system we need 4 hours of diagnosis \$1040 of diagnose the vehicle IN order to see what else the vehicle needs.
