# Hu v. Hyundai Motor America

AG Case No. NC-1-1249605441 · VIN: KM8KNDDF9RU253237

## EXHIBIT 20 — DASHBOARD PHOTOGRAPHS: BATTERY RANGE DEGRADATION TIMELINE

Consumer: Jimmy Y. Hu · Hearing: June 9, 2026 · Arbitrator: Maneesha Sharma

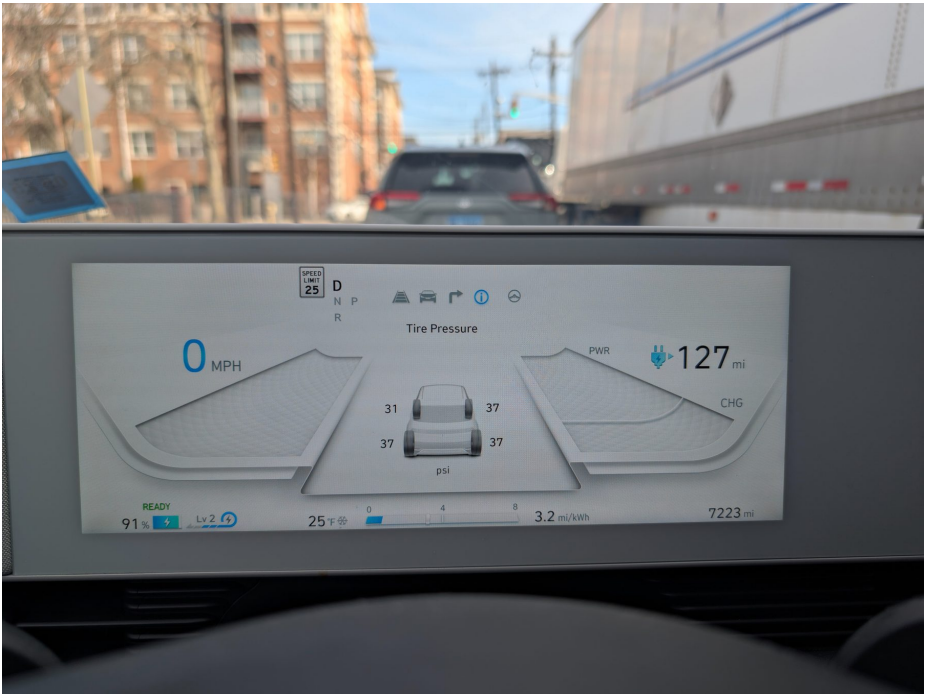
Photo 1 — Feb 19, 2025 (7,223 mi) — FIRST DOCUMENTED DEGRADATION: 127 mi at 91% Charge [CRITICAL]

CRITICAL EVIDENCE. Only 127 miles at 91% charge. At delivery (May 2024), 90% charge yielded approximately 270 miles — this represents greater than 50% loss in functional range, and is the first documented manifestation of the battery defect. Consumer first became aware of the defect at this date. The Hyundai Smart Diagnosis report (Exhibit 10) documents the underlying fault codes.

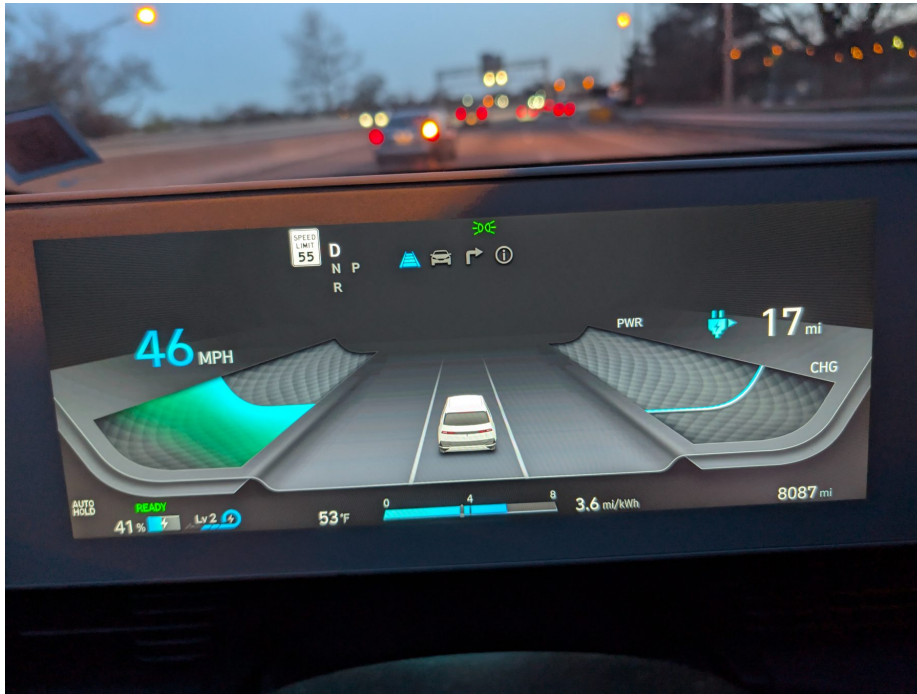
**Photo 2 — Apr 1, 2025 (8,087 mi) — Accelerating Failure: Only 17 mi at 41% Charge**

Two days before Consumer drove the vehicle to Paramus Hyundai on April 3. Only 17 miles at 41% charge — a functioning IONIQ 5 at 41% charge would show approximately 110+ miles of range. The vehicle was becoming completely unusable for any meaningful travel. This photograph corroborates the urgency of Consumer's decision to bring the vehicle directly to Paramus Hyundai on April 3, 2025.

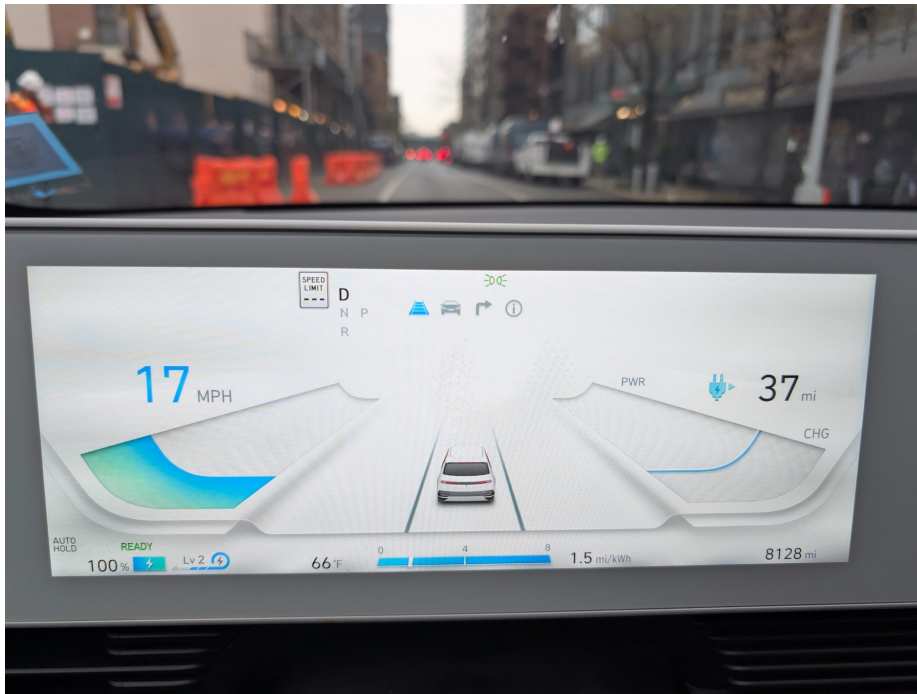
**Photo 3 — Apr 3, 2025 (8,128 mi) — PIVOTAL: Only 37 mi at 100% Full Charge — Day Consumer Drove to Paramus and Left Vehicle for Service [PIVOTAL]**

THE KEY PHOTOGRAPH IN THIS EXHIBIT. Dashboard shows only 37 miles at 100% charge with Level 2 charging confirmed complete. A fully charged 2024 Hyundai IONIQ 5 SEL AWD should display approximately 266+ miles at 100% charge. This photograph directly corroborates Repair Order #358530 (Exhibit 4), in which Paramus Hyundai confirmed 'deviations in multiple cells' via Techline diagnostics. Consumer drove the vehicle to the service center on this date, left it with Paramus Hyundai, and received a loaner vehicle. The vehicle remained at the service center for 126 consecutive days. Odometer reads 8,128 miles — consistent with RO documentation.

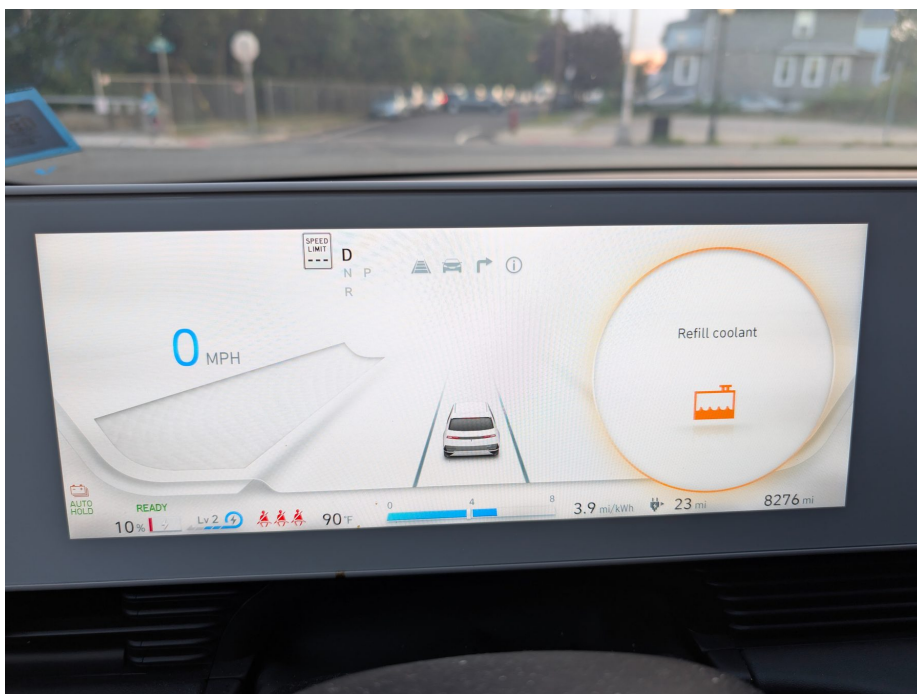
**Photo 4 — Aug 12, 2025 (8,276 mi) — 'Refill Coolant' Warning: 5 Days After Pickup**

Consumer retrieved the vehicle on August 7, 2025 after 126 consecutive days in service. Just 5 days later — August 12, 2025 — the dashboard displayed a prominent 'Refill coolant' warning with orange alert icon. The vehicle was immediately returned to Paramus Hyundai for service completed August 28–29, 2025. Odometer reads 8,276 — only 148 miles driven in 5 days post-pickup. Combined with the April–August repair period, total documented loss-of-use reaches 179+ days.
