OFFLINE ULTRASONIC CLEANING – RESTORING AS BUILT PERFORMANCE DURING TURNAROUNDS

Gwen van de Bilt, Field Supervisor, Waste and Cleaning, Shell Moerdijk

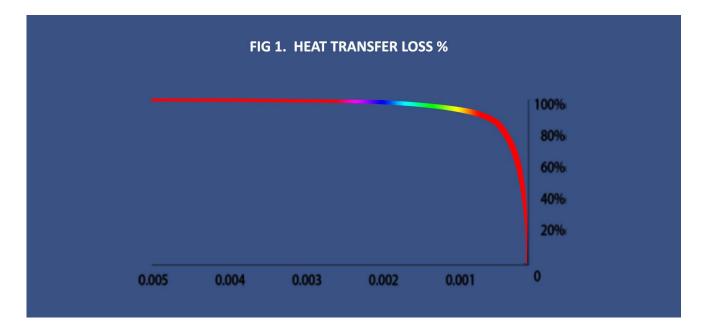
It is precisely the first few microns of fouling that are the most important to remove: i.e. 0.5 mm of fouling can cause heat transfer losses of 40-99,7%!

The impact of the fouling above the 0.5 mm is often relatively insignificant (fig. 1), so a partial removal of the fouling without cleaning to bare metal is often not effective at restoring performance.

Fig. 1 Heat transfer loss of a Stainless Steel tube (10 mm diam., 1 mm thick) in relation to the thickness (mm) of a ceramic type of fouling (k = 1)

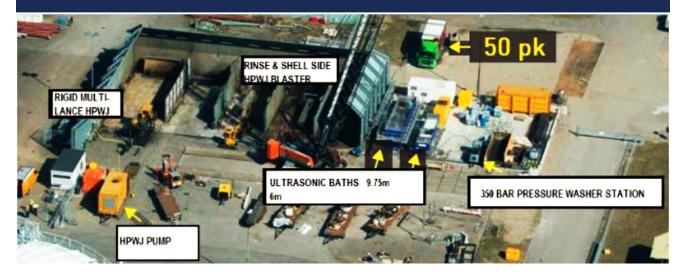
FIG. 3 WASHPAD LAYOUT FOR THE 2013 SHELL MOERDIJK MLO TURNAROUND INCLUDING TWO LARGE ULTRASONIC BATHS

One thing which we learned during the exercise is that totally blocked tubes have to be unblocked before going into the vessel. Exchangers were placed in the bath first to remove O.D. fouling and soften I.D. fouling.

As an exchanger is raised from the bath it is easy to see if there are blocked tubes and in this case the exchangers were then moved to the washpad for lancing to open the tubes.

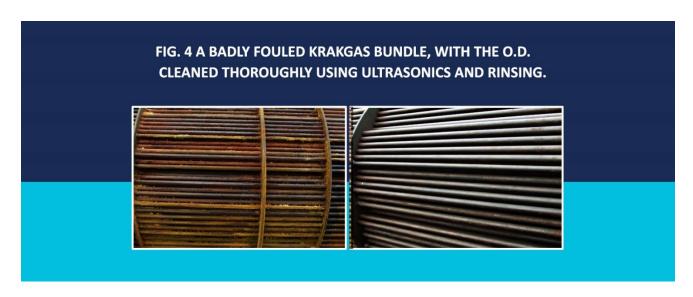
There were many different parts cleaned during the event besides heat exchangers. The results in cleaning heat exchangers was a marked improvement visually in the cleanliness of the O.D. of the tubes. Because of the ability of the ultrasonic to reach into all areas of the bundle, rinsing was effective at removal of all the fouling on the inner tubes of the bundles.
