- CBCT/CT 604 QA Test -

- CTP 404 Results -

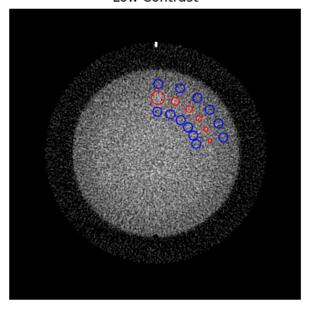
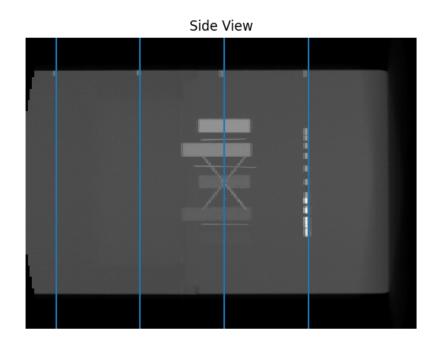
Low Contrast

- CTP515 Results -CNR threshold: 15 Low contrast ROIs "seen": 0
