Unnamed machine

DRAFT – prepared by automated analysis, pending analyst review.

Unnamed machine · motor

1800 rpm · ISO group 2 · bearing 6206

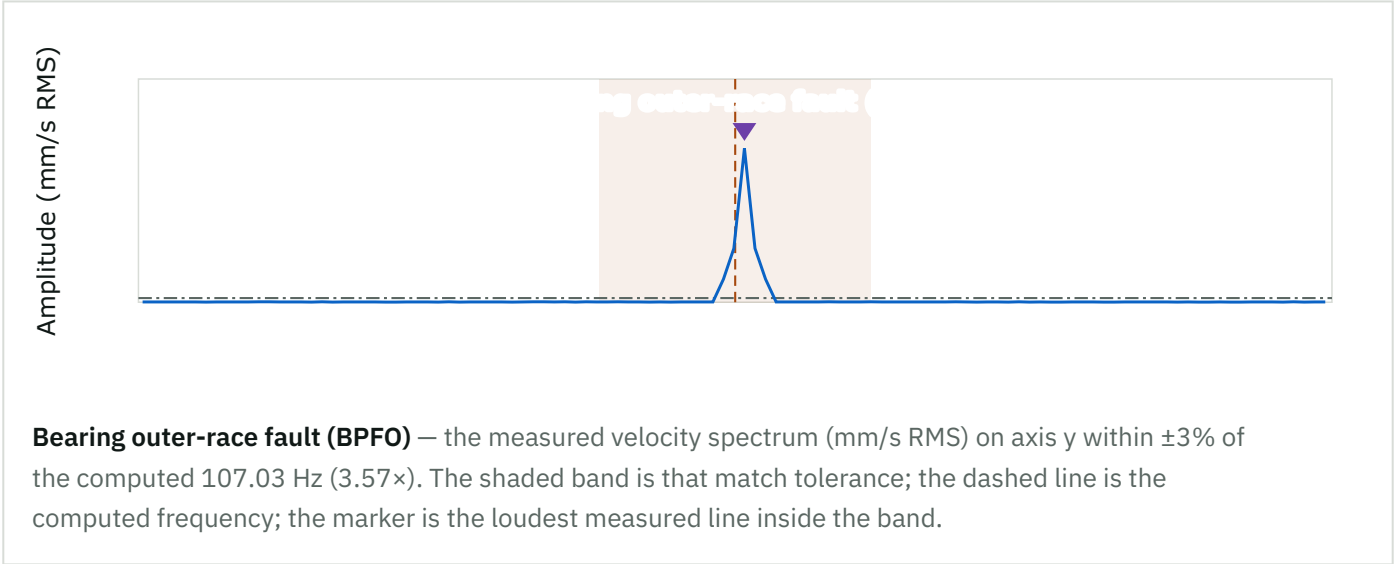
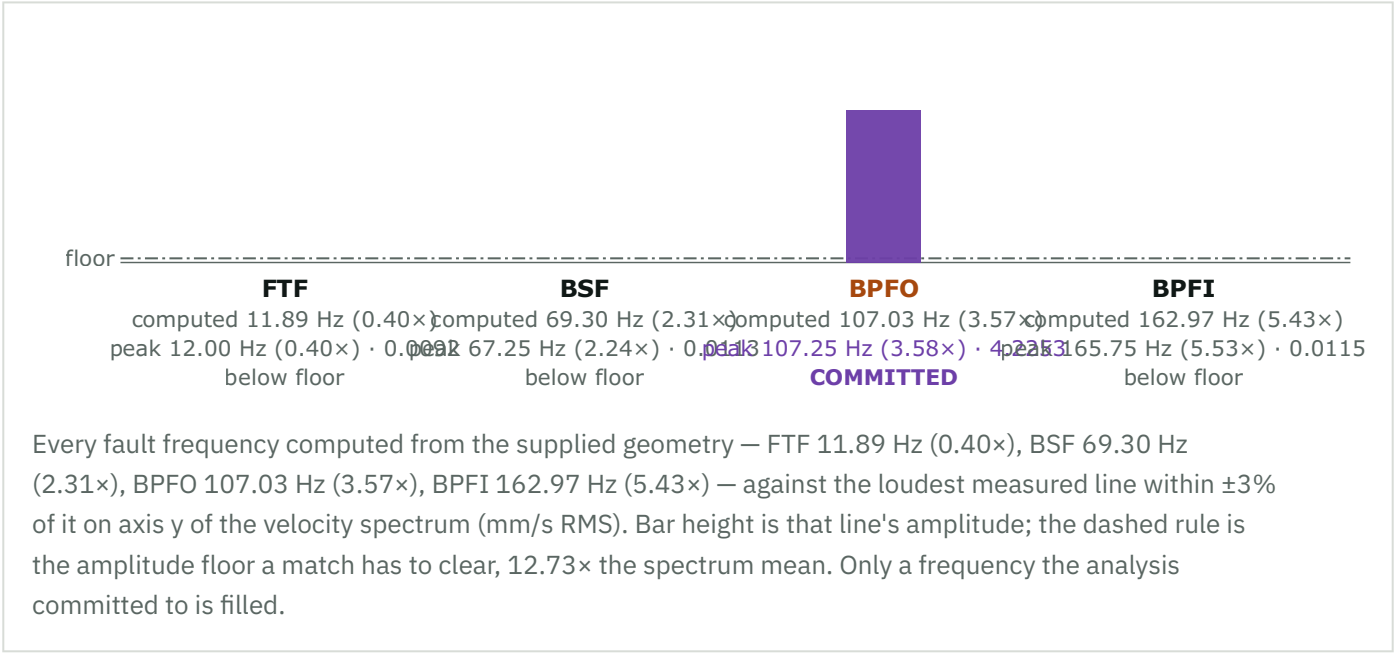
4 • EVIDENCE

| Bearing<br>outer-race<br>fault<br>(BPFO) | y | 107.03 | 3.57× | 107.25 | 3.58× | yes | — |

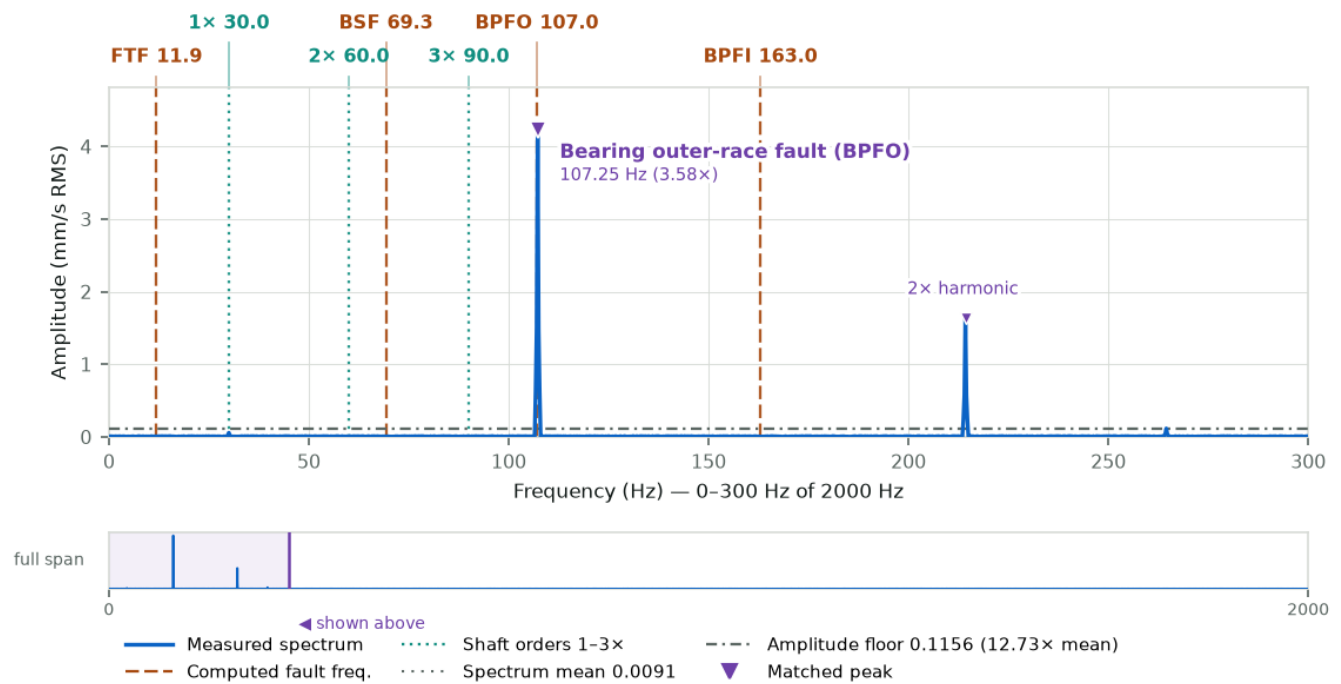
## Velocity spectrum (mm/s RMS) — Y (radial)

spectrum (mm/s RMS) is dominated by 107.25 Hz on the y-axis, with its 2× harmonic present, matching the computed BPFO of bearing 6206 at 107.03 Hz. The committed diagnosis is Bearing outer-race fault (BPFO) (high confidence).

Velocity spectrum (mm/s RMS), Y axis. Matched: bearing outer race at 107.25 Hz (3.58×).

1. Plan bearing replacement at the next maintenance window; monitor closely until then.

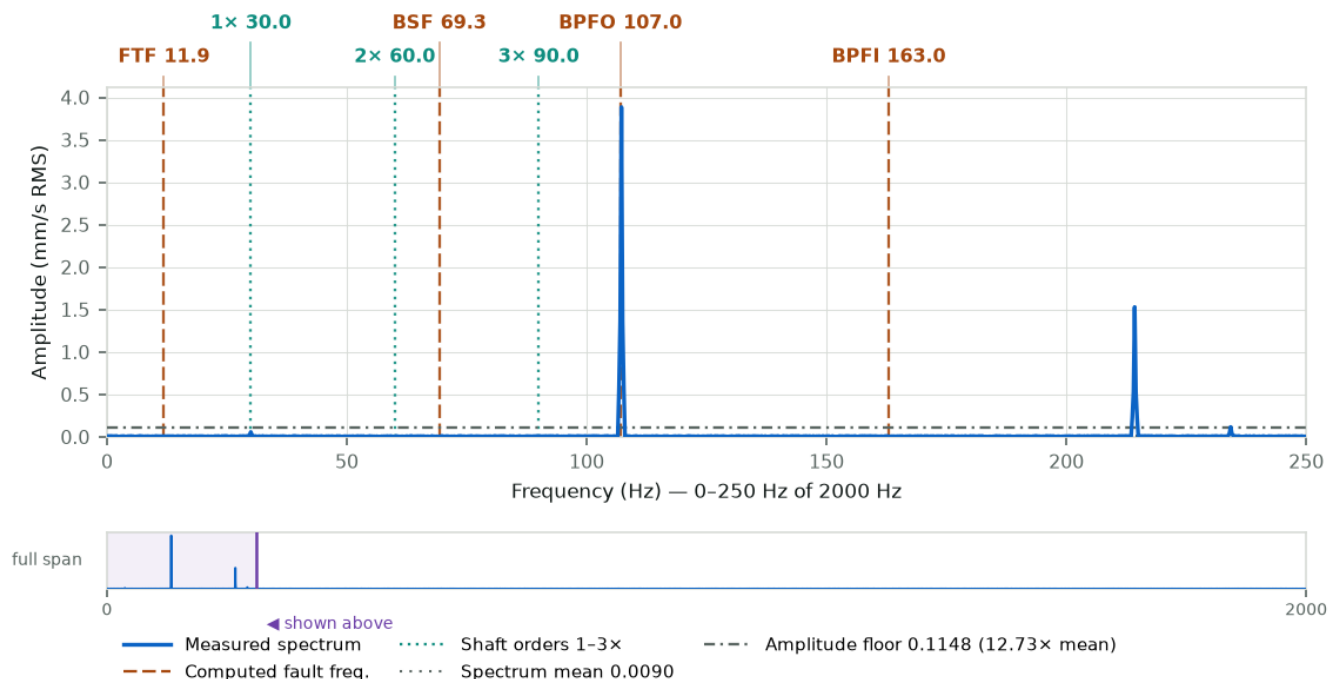
## Velocity spectrum (mm/s RMS) — Z (radial)

Velocity spectrum (mm/s RMS), Z axis. No peak on this channel matched a computed fault frequency within tolerance.

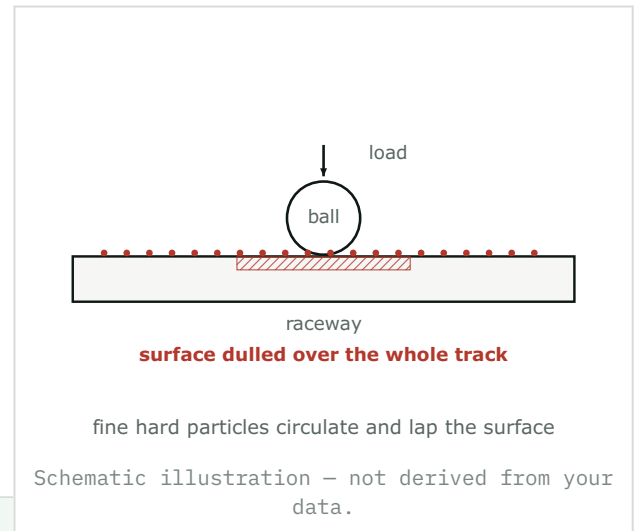
- Broadband rise across the spectrum without a clean BPFO series, since distributed roughening is not a single repeating impact.

- A matt, dullled or lapped-in raceway track rather than a discrete pit, with parallel furrows in the direction of motion where the particles are coarser than the lubricant film. How to collect: Dismounted inspection of the raceway under low magnification, in raking light.
- Wear spread around the circumference of the stationary ring rather than concentrated in one arc. Weak on its own, and arguably contradicted by our own source - #01 p.67 shows a STATIONARY inner ring carrying two localised wear zones - so distribution does not separate contamination from creep. How to collect: Map the wear extent against the recorded ring orientation before cleaning.

- Rising ferrous particle counts and cutting/abrasive particle morphology in the lubricant before any discrete defect tone appears. How to collect: Oil sample from the return line or reservoir mid-level, with particle count and analytical ferrography.

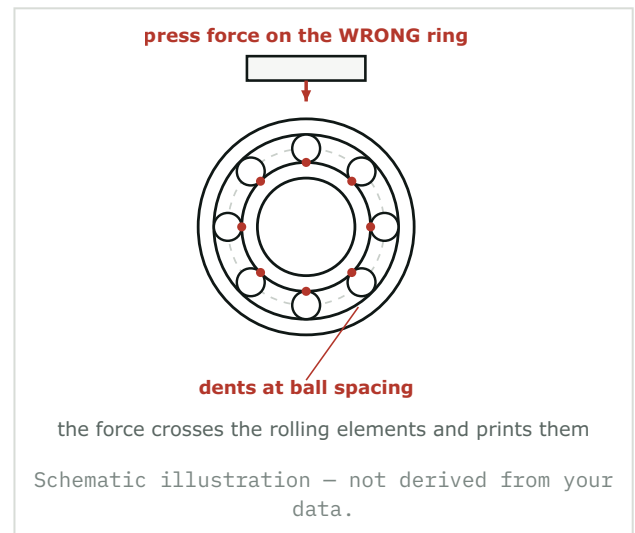
## 07 Impact during mounting, transmitted through the rolling elements

Driving a bearing onto a shaft by striking it forces the mounting load through the rolling elements instead of the ring being pressed, denting the raceway at each element position. The dents are permanent deformation rather than wear, and their raised edges later seed surface fatigue. [01 §5 Damage and actions, Surface initiated fatigue, p.65, bottom-right caption] [04 Plastic Deformation, p.10] [02 Handling and Installation Damage, p.15, figs. 41 and 42]

- Dents, or later spalls, spaced at exactly the rolling element pitch. How to collect: Measure the mark pitch and compare it with the rolling element pitch; equality is close to conclusive. [04 Plastic Deformation, Overload or true brinelling, p.10] [01 §5 Damage and actions, Surface initiated fatigue, p.65, bottom-right caption] [02 Handling and Installation Damage, p.15, fig. 42]

- STAGE-DEPENDENT SIGNATURE. Fresh dents early, spalls at element spacing later - #01's own exemplar for this cause sits under Surface initiated fatigue and shows spalls, not dents, so an inspection that finds no dents does not clear mounting impact. How to collect: Record whether the marks are unbroken depressions or broken-out spalls, and read that as stage rather than as a different cause.  
[#01 §5 Damage and actions, Surface initiated fatigue, p.65] [#04 Plastic Deformation, p.10]

- A raised lip or raised edges around the dent, which is what makes a mounting dent a future fatigue site rather than a cosmetic mark. How to collect: Inspect the dent rim under magnification, and record it separately from the dent itself.  
[#04 Plastic Deformation, p.10] [#02 Handling and Installation Damage, p.15, fig. 42]

- Roughness, vibration and noise reported immediately after an installation, rather than as a gradual change. How to collect: Compare the first post-maintenance vibration reading with the pre-removal baseline.  
[#02 Handling and Installation Damage, p.15]

- Time-since-intervention used as the discriminator - damage present from the first run after work, rather than developing over time. No cited page frames it that way or contrasts it with gradual development. How to collect: Line the damage up against the maintenance dates, not only against running hours.  
[inferred]

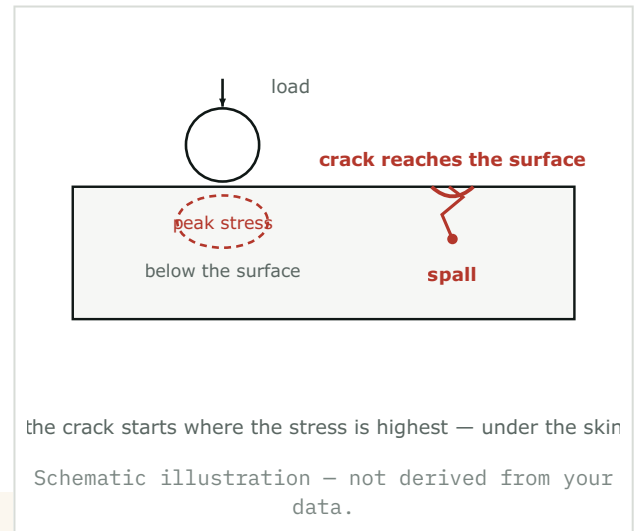
Repeated stress cycles nucleate cracks at inclusions below the contact surface, and those cracks grow until a piece of the surface detaches. This is the mechanism the bearing rating life describes, so it is the one cause on this list that is not a defect in installation or operation. [#01 §5

LAST. Weigh every other cause in this batch before this one. It is the only entry that concludes nothing was done wrong, so reaching it early ends the investigation that the other thirteen entries exist to run. #04 p.3 puts a number on the prior: subsurface fatigue is not a common issue where better quality metals are used, and most bearings will fail by another mechanism first.
