Unnamed machine

DRAFT – prepared by automated analysis, pending analyst review.

Unnamed machine · motor

**Bearing outer-race fault (BPFO)**

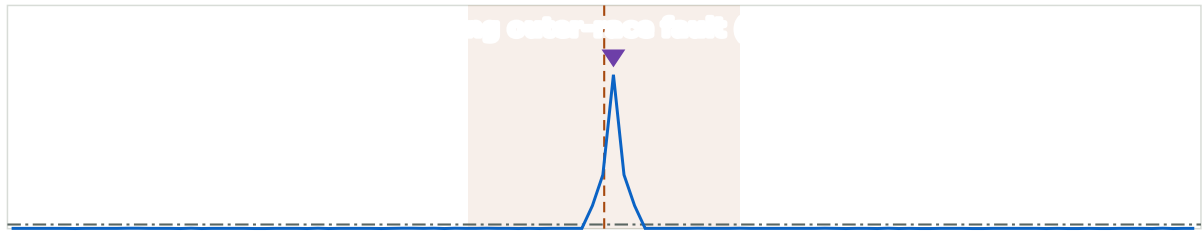
| FINDING | AXIS | COMPUTED (HZ) | COMPUTED (×) | OBSERVED (HZ) | OBSERVED (×) | 2× HARMONIC | SIDEBANDS |
|---|---|---|---|---|---|---|---|
| Bearing outer-race fault (BPFO) | y | 107.03 | 3.57× | 107.25 | 3.58× | yes | — |

**Bearing outer-race fault (BPFO)** — the measured velocity spectrum (mm/s RMS) on axis y within  $\pm 3\%$  of the computed 107.03 Hz (3.57 $\times$ ). The shaded band is that match tolerance; the dashed line is the computed frequency; the marker is the loudest measured line inside the band.

1. Plan bearing replacement at the next maintenance window; monitor closely until then.

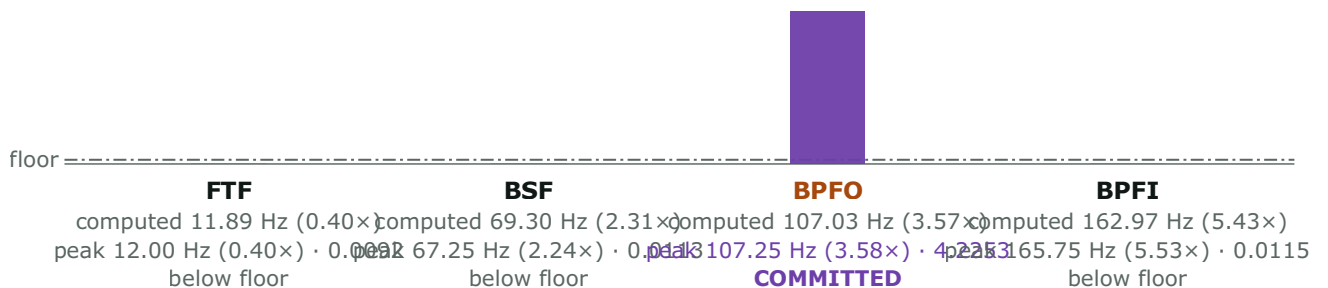
Every fault frequency computed from the supplied geometry — FTF 11.89 Hz (0.40 $\times$ ), BSF 69.30 Hz (2.31 $\times$ ), BPFO 107.03 Hz (3.57 $\times$ ), BPFI 162.97 Hz (5.43 $\times$ ) — against the loudest measured line within  $\pm 3\%$  of it on axis y of the velocity spectrum (mm/s RMS). Bar height is that line's amplitude; the dashed rule is the amplitude floor a match has to clear, 12.73 $\times$  the spectrum mean. Only a frequency the analysis committed to is filled.

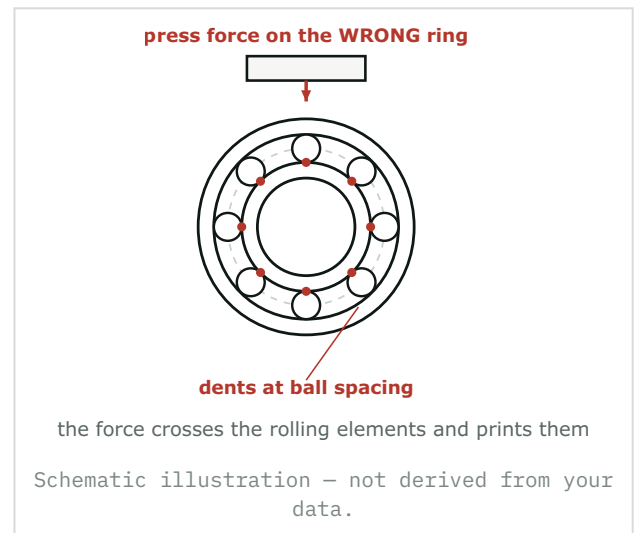
## 07 Impact during mounting, transmitted through the rolling elements

Driving a bearing onto a shaft by striking it forces the mounting load through the rolling elements instead of the ring being pressed, denting the raceway at each element position. The dents are permanent deformation rather than wear, and their raised edges later seed surface fatigue. [01 §5 Damage and actions, Surface initiated fatigue, p.65, bottom-right caption] [04 Plastic Deformation, p.10] [02 Handling and Installation Damage, p.15, figs. 41 and 42]

- Dents, or later spalls, spaced at exactly the rolling element pitch. How to collect: Measure the mark pitch and compare it with the rolling element pitch; equality is close to conclusive. [04 Plastic Deformation, Overload or true brinelling, p.10] [01 §5 Damage and actions, Surface initiated fatigue, p.65, bottom-right caption] [02 Handling and Installation Damage, p.15, fig. 42]

- STAGE-DEPENDENT SIGNATURE. Fresh dents early, spalls at element spacing later - #01's own exemplar for this cause sits under Surface initiated fatigue and shows spalls, not dents, so an inspection that finds no dents does not clear mounting impact. How to collect: Record whether the marks are unbroken depressions or broken-out spalls, and read that as stage rather than as a different cause.  
[#01 §5 Damage and actions, Surface initiated fatigue, p.65] [#04 Plastic Deformation, p.10]

- A raised lip or raised edges around the dent, which is what makes a mounting dent a future fatigue site rather than a cosmetic mark. How to collect: Inspect the dent rim under magnification, and record it separately from the dent itself.  
[#04 Plastic Deformation, p.10] [#02 Handling and Installation Damage, p.15, fig. 42]

- Roughness, vibration and noise reported immediately after an installation, rather than as a gradual change. How to collect: Compare the first post-maintenance vibration reading with the pre-removal baseline.  
[#02 Handling and Installation Damage, p.15]

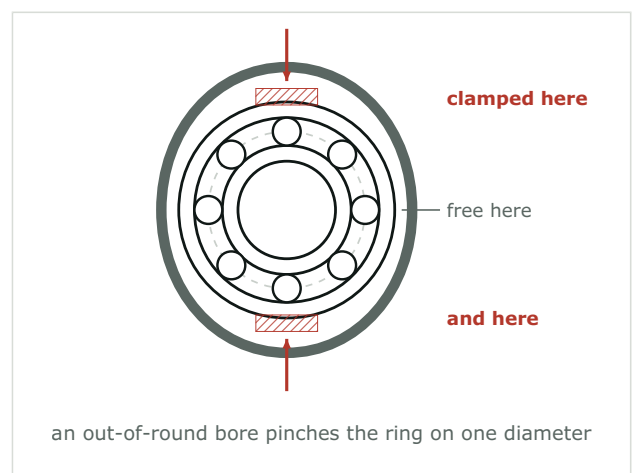
## 10 Housing distortion clamping the outer ring oval

A housing bored or bolted out of round squeezes the outer ring into an oval, creating two diametrically opposed high-load regions where the design intended one. Fatigue then appears as spalling roughly 180 degrees apart rather than in a single load arc. [#01 §3 Path patterns, Inner ring rotation - oval clamping of the stationary outer ring, p.37] [#01 §2 Inspection and troubleshooting, Table 2 solution code 15, p.19]

RING IDENTITY. Two opposed load zones 180 degrees apart is NOT specific to oval clamping - #01 gives the same signature for excessive misalignment on a double-row bearing. The discriminator visible in the source is which ring carries it: the OUTER ring points here, a double-row INNER ring points to inner\_race\_misalignment\_edge\_loading.
