# OSHA Report City Volkswagen of Evanston

Complete On: 8/23/2024

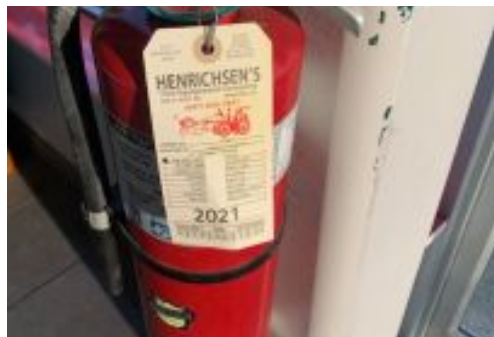
**The fire extinguishers have not had their annual inspection and are not properly identified and fully charged.**

*Found this outdated inspection in temporary showroom*

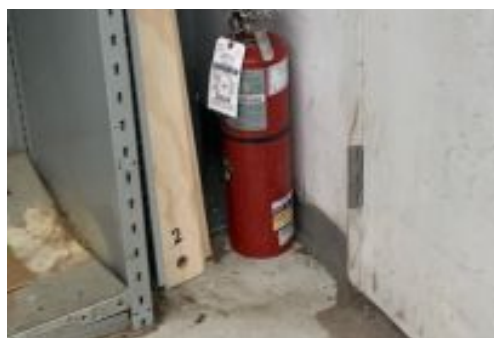
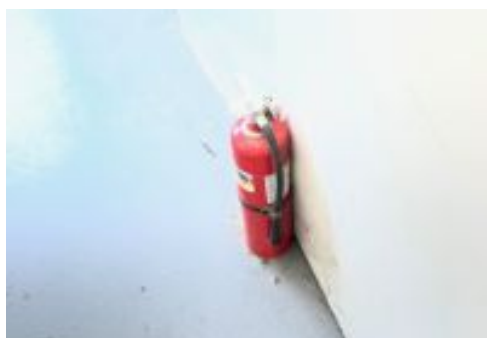
**Fire Extinguisher missing or not properly mounted in dispensing area**

*Found extinguishers not mounted*

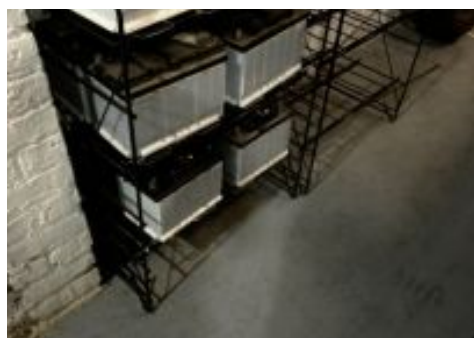
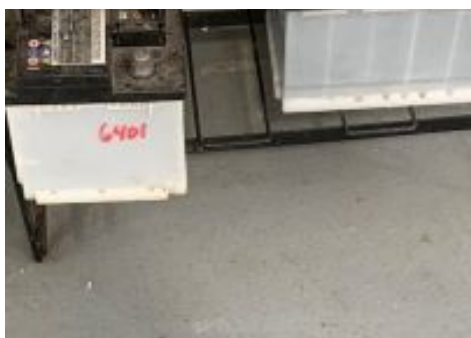
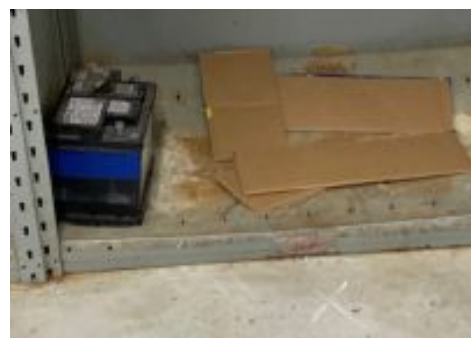
**Used Batteries not stored on acid resistant matts**

*need to install acid resistant mat under used battery racks*

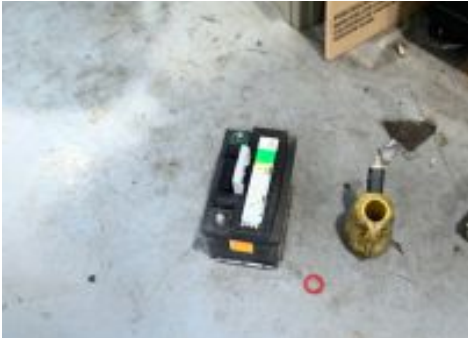
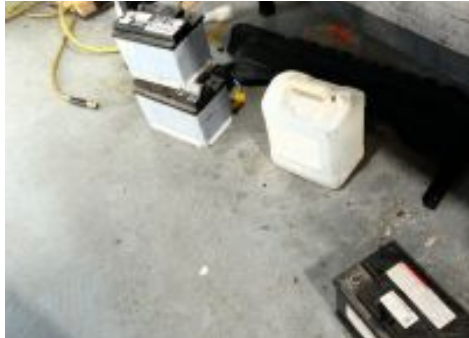
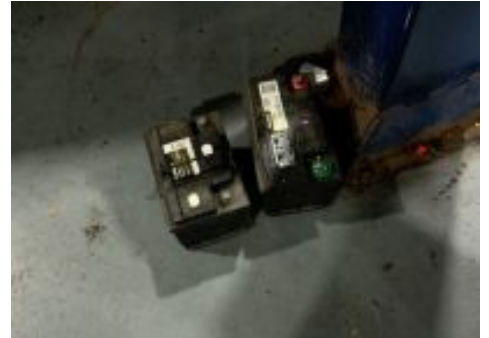
## Batteries not being stored properly

*found loose batteries around service*

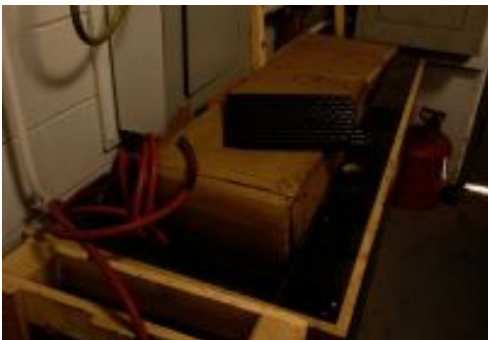
## There is not clear access of at least 36" to all electrical panels.

*Found items around breaker panels*

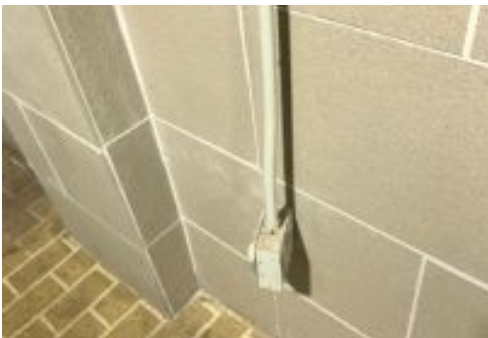
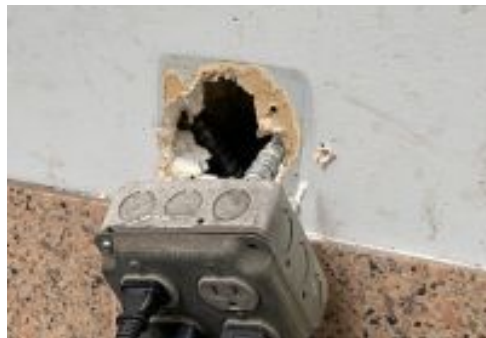
## There are other miscellaneous electrical issues to note.

*Found a couple outlet boxes pulled off wall*

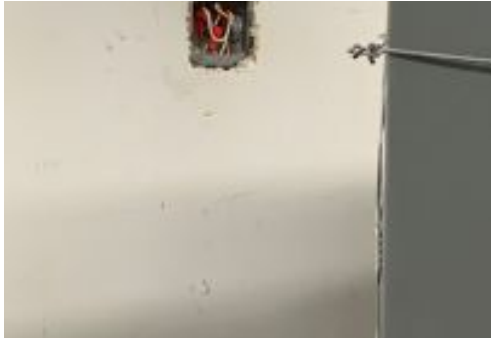
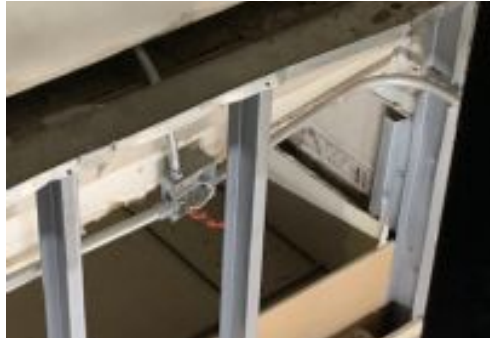
## Electrical Plugs Outlets not properly covered. Plate cover missing or broke

*found covers missing or damaged*

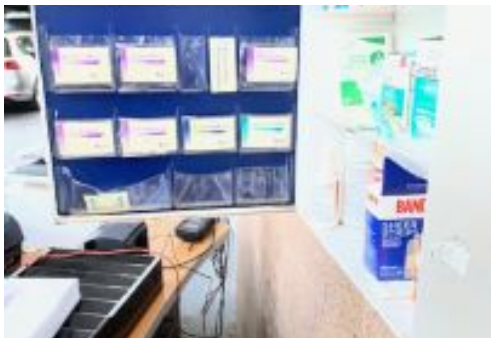
## The first aid kit is not properly stocked given the dealership work environment.

*Upstairs service first aid kit could use more inventory*

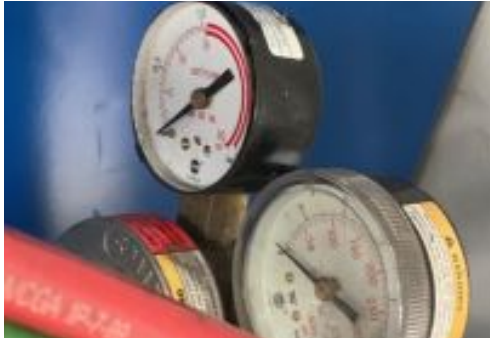
**All hoses and cutting tips for the welder / cutting torches are not in good condition without any cracks or breaks.**

*gauge cover missing on Oxy Acetylene gauges*
