# OSHA Report **Arnie Bauer** **Chevrolet** **GMC**

Complete On: 8/26/2024

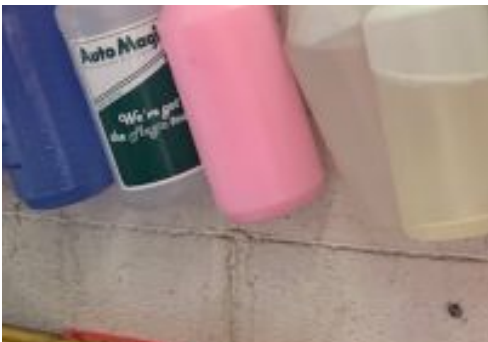
## **All secondary containers filled with chemicals are not properly labeled.**

*Found secondary containers with liquids un-labeled*

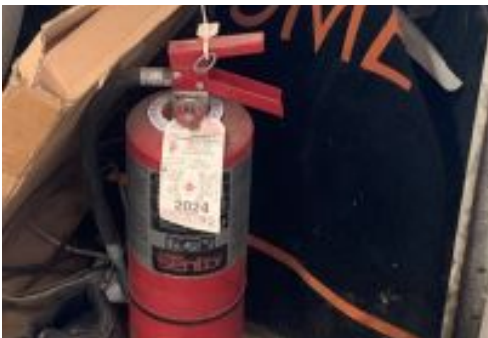
## **Fire Extinguisher missing or not properly mounted in dispensing area**

*Found Extinguishers not mounted and sitting on floor*

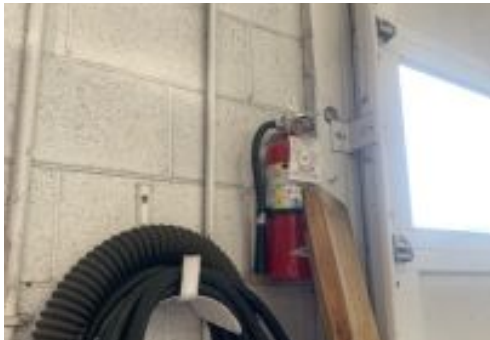
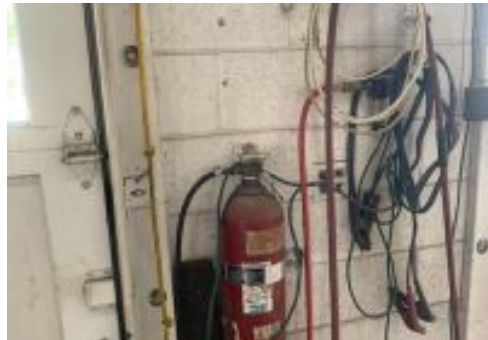
**The fire extinguisher signs above the unit are not posted properly.**

*All extinguishers need signage*

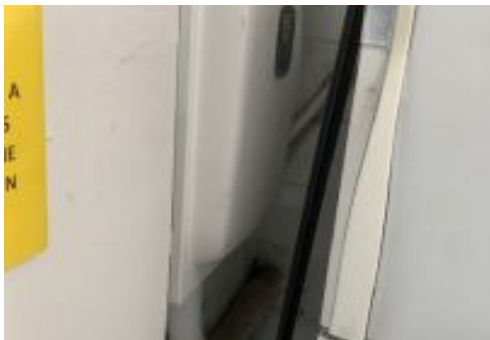
**There is not clear access of at least 36" to all electrical panels.**

*Main throw switch is blocked by refrigerator*

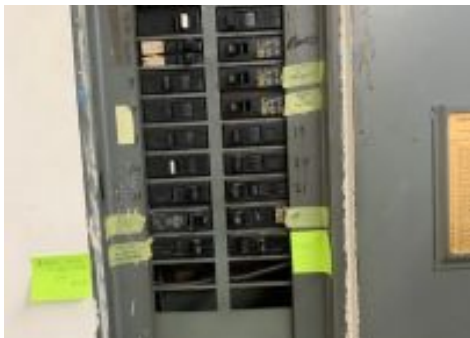
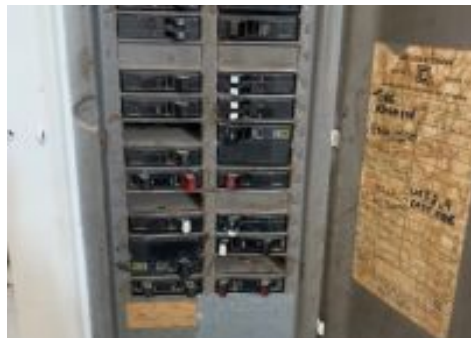
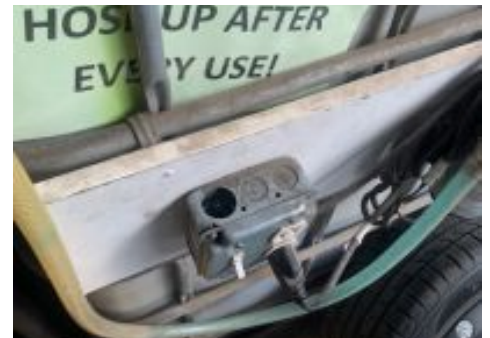
**All vacant holes are not properly sealed off on electrical panel box.**

*accounting office and service breaker panels need vacant holes sealed*

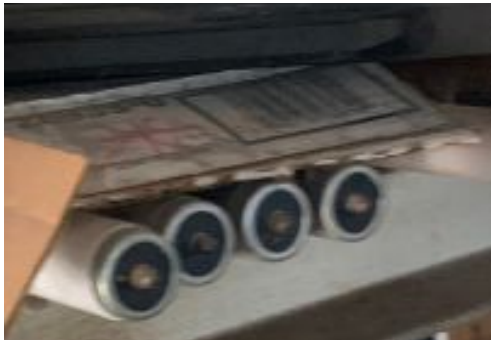
## The fluorescent tubes are not stored properly.

*potential breaking of fluorescent tubes under weight of fender flairs*

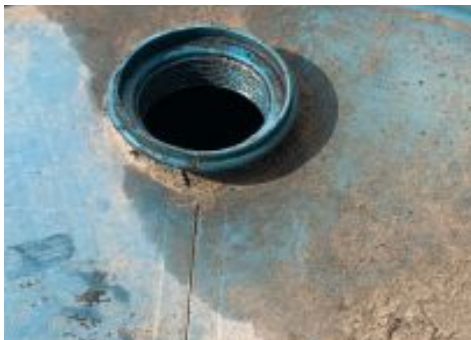
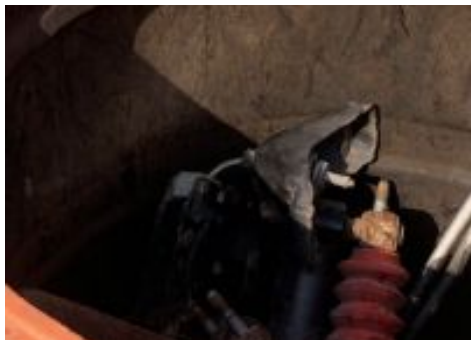
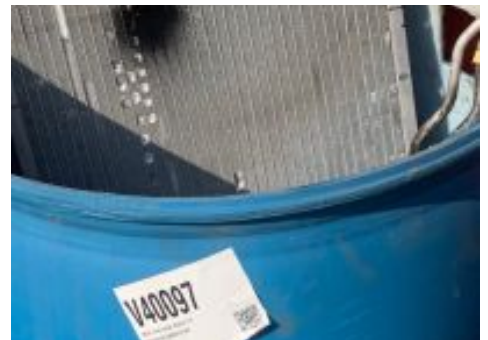
## Storage Containers not capped and or sealed properly

*found containers outside that will potentially fill with rainwater*

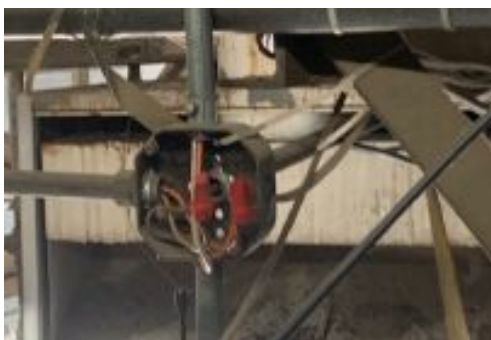
## Electrical Plugs Outlets not properly covered. Plate cover missing or broke

*Found cover missing in attic storage area*

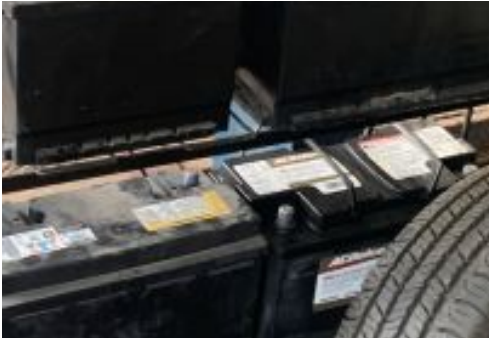
## Used Batteries not stored on acid resistant matts

*need to place acid resistant mat under used batteries*

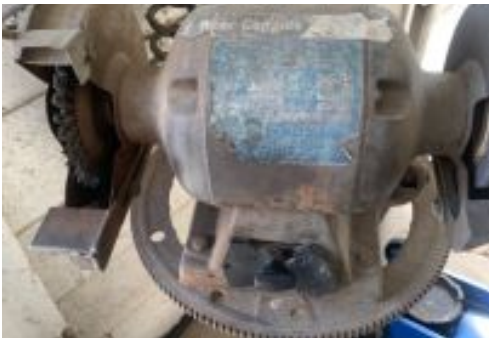
**There is no proper spacing on grinders; Tool rest 1/8" from grinding wheel. Tongue plate 1/4" from grinding wheel.**

*Grinders need tool rest adjustment*

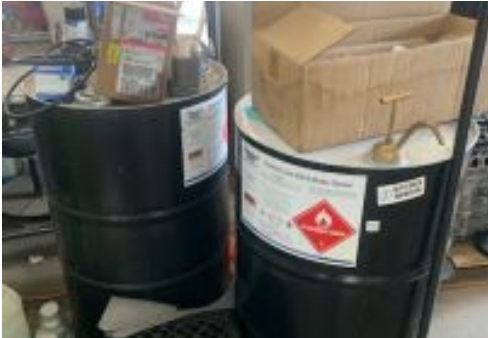
## **All tanks holding flammable material are not properly grounded.**

*Tanks holding flammable liquid should be grounded*
