# OSHA Report City Volkswagen of Highland

Complete On: 8/19/2024

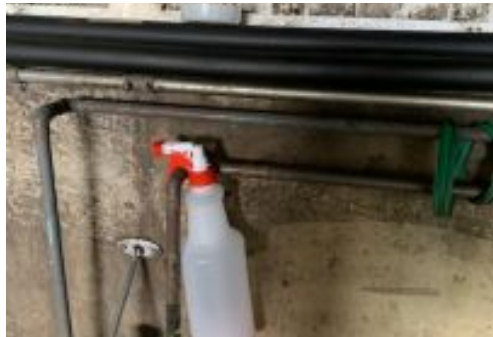
**All secondary containers filled with chemicals are not properly labeled.**

*Found a few spray bottles not labeled*

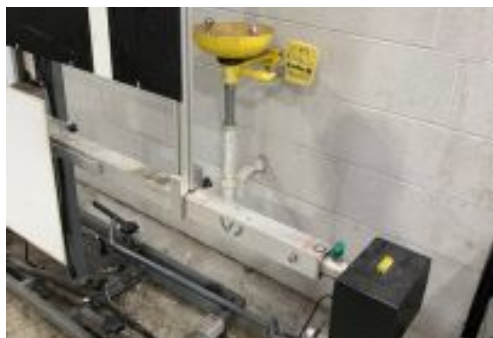
**The eye wash equipment is not readily accessible.**

*Eye wash station access is impeded by equipment*

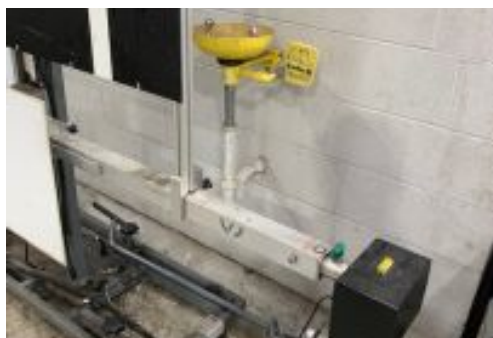
**The eye wash equipment has not been tested and cleaned and documented weekly.**

*Eye wash station needs cleaning and caps installed*

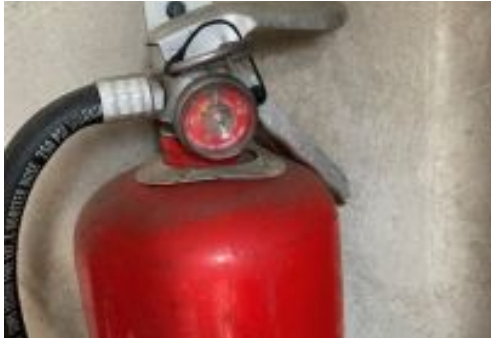
**The fire extinguishers have not had their annual inspection and are not properly identified and fully charged.**

*Fire Extinguisher in outside detail area is not charged and without proper signage*

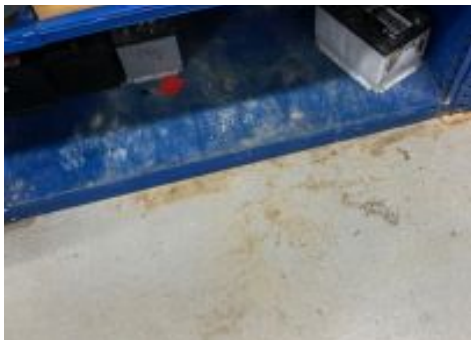
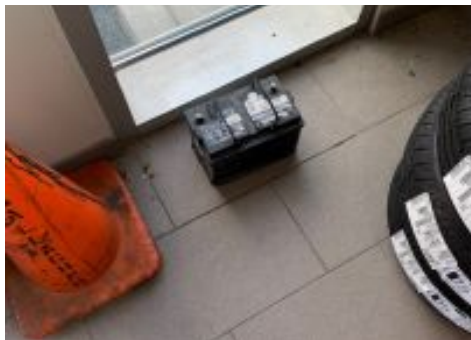
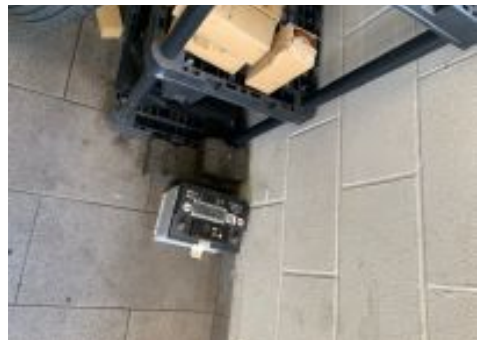
**Used Batteries not stored on acid resistant matts**

*Need to get acid resistant mat in parts dept. for used batteries also found loose batteries sitting on floor north service drive*

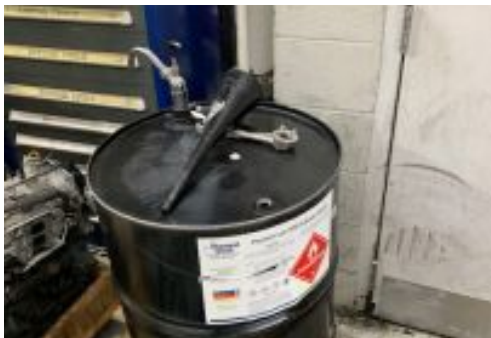
**All tanks holding flammable material are not properly grounded.**

*Found 1 tank not grounded properly in southeast service area*

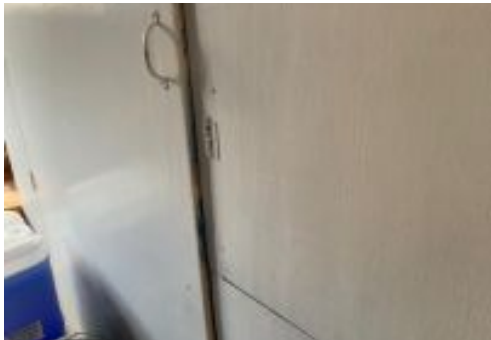
## **There is not clear access of at least 36” to all electrical panels.**

*Electrical panel in parts access is obstructed*

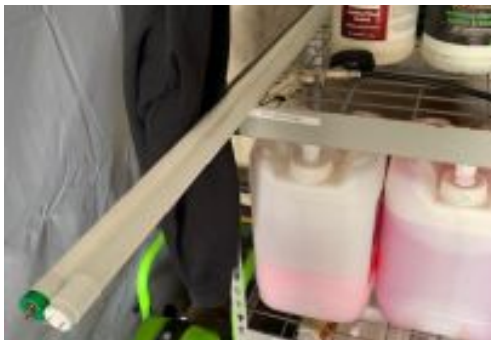
## **The fluorescent tubes are not stored properly.**

*Found fluorescent tubes in outside detail area not stored properly*

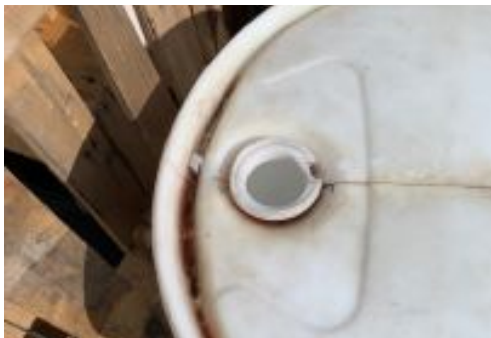
## **Storage Containers not capped and or sealed properly**

*Found container outside collecting rainwater*

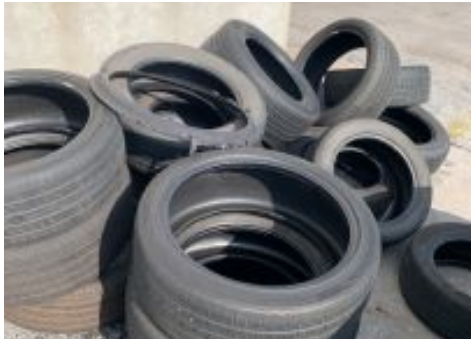
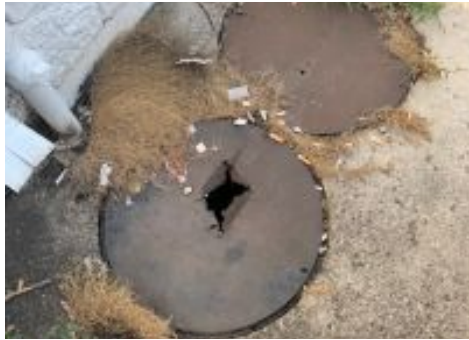
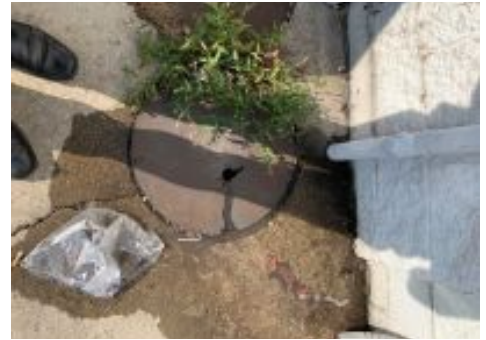
## Miscellaneous issues.

*Found used tires outside collecting rainwater (needs tarp) Found steel covers outside with rust through. could cause potential injury*
