# OSHA Report City Chrysler Dodge Jeep Ram Fiat of Brookfield

Complete On: 8/22/2024

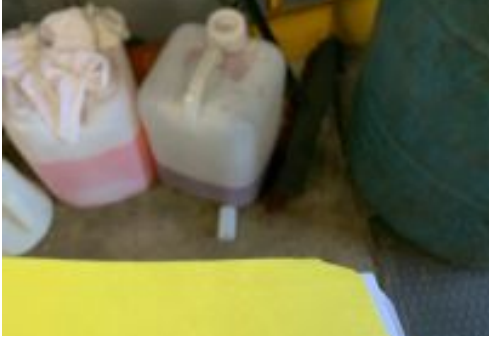
**All secondary containers filled with chemicals are not properly labeled.**

*Found a couple of secondary containers without labels*

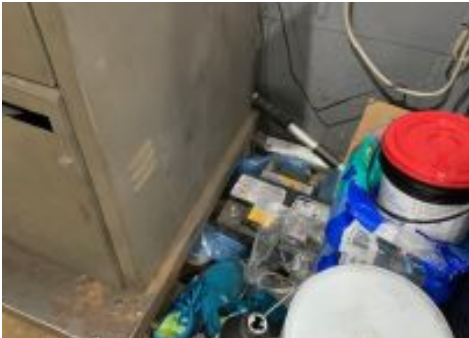
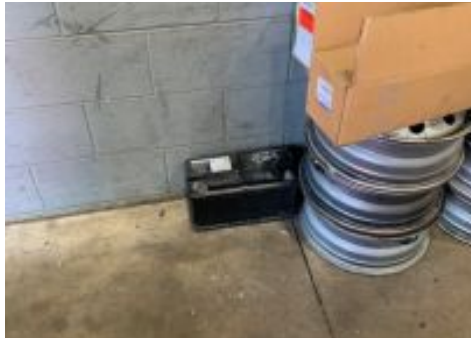
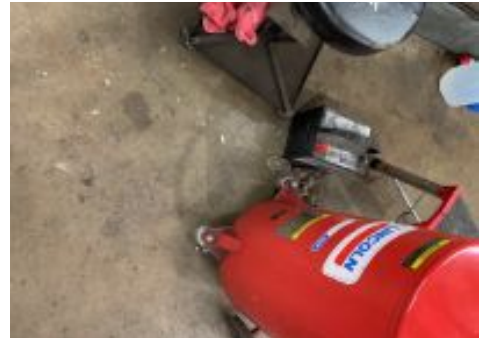
**Batteries not being stored properly**

*Found loose batteries in shop floor area*

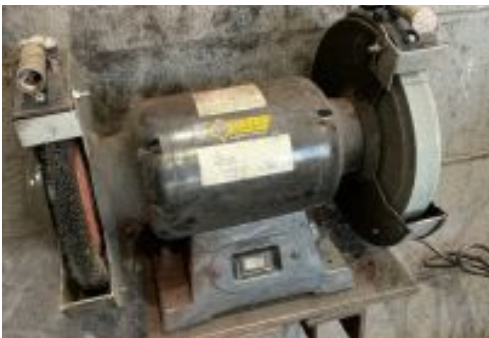
**There is no proper spacing on grinders; Tool rest 1/8" from grinding wheel. Tongue plate 1/4" from grinding wheel.**

*Tounge plates are missing from grinder. Noticed new grinder that has not been installed yet.*

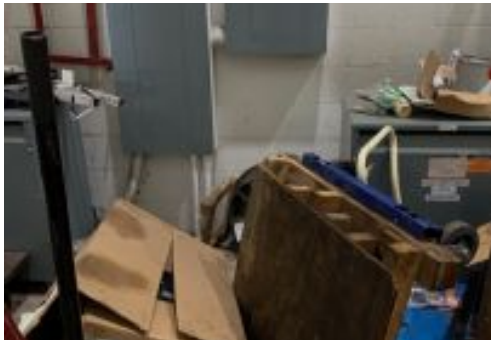
## **There is not clear access of at least 36” to all electrical panels.**

*found equipment blocking electrical panels*

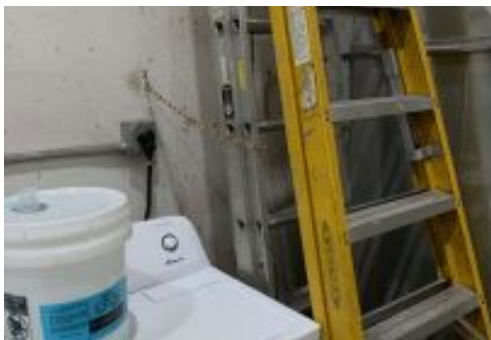
## **Ladders not stored properly, needs chained off on any ladder over 8 ft.**

*found 1 ladder unchained*

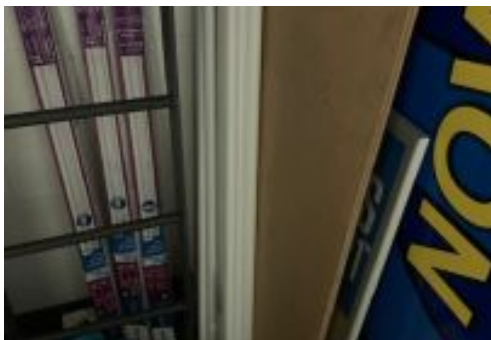
## **The fluorescent tubes are not stored properly.**

*Found Fluorescent lights unboxed*

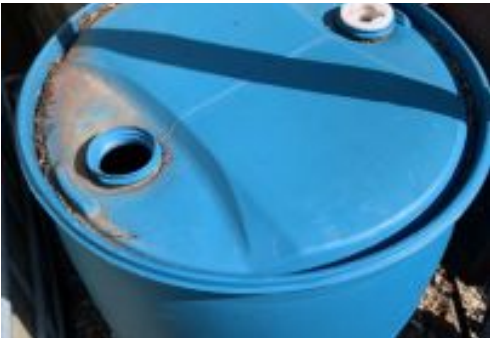
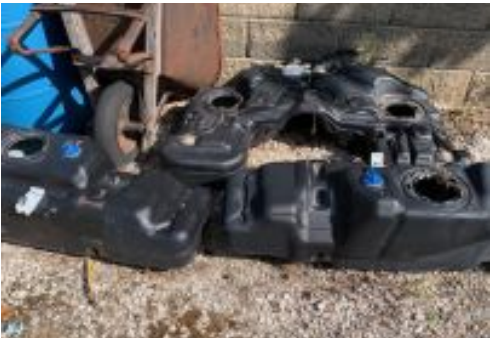
**Storage Containers not capped and or sealed properly**

*found this storage drum uncapped and collecting water also some used fuel tanks*

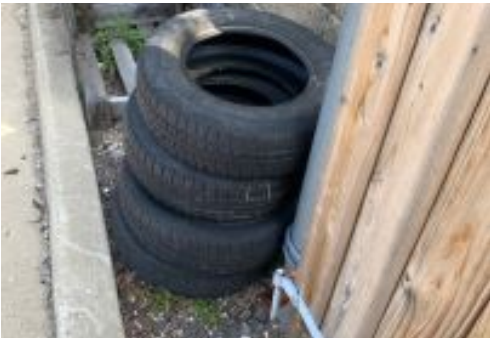
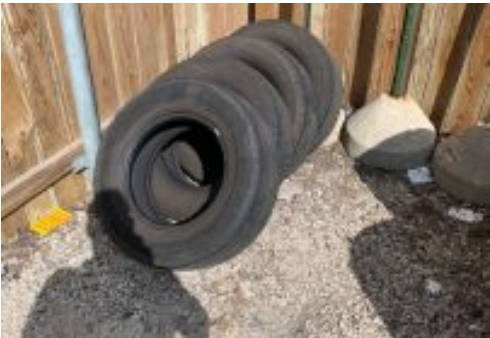
**Miscellaneous issues.**

*used tires sitting outside should be tarped to prevent water collection*
