# OSHA Report City Volkswagen of Chicago

Complete On: 8/21/2024

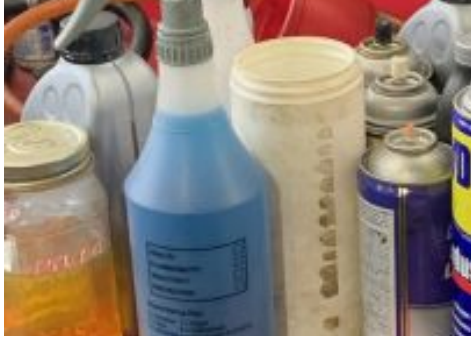
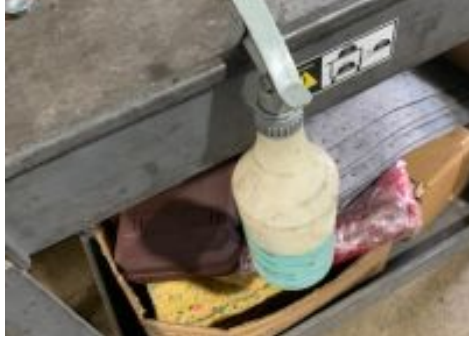
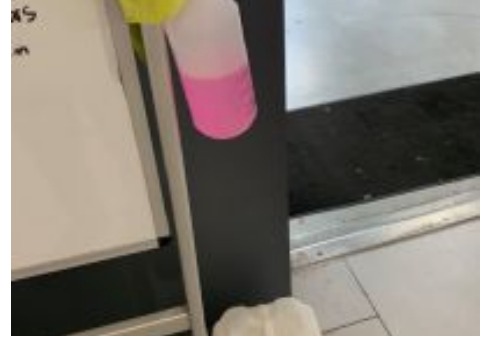
**All secondary containers filled with chemicals are not properly labeled.**

*found secondary containers not labeled with contents*

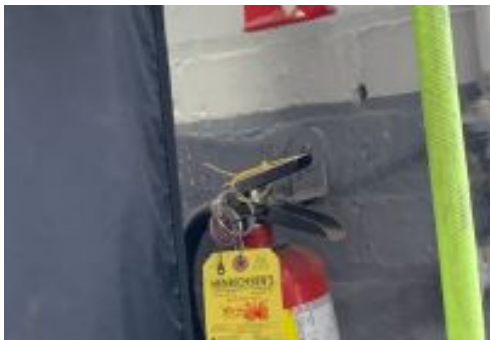
**The fire extinguishers have not had their annual inspection and are not properly identified and fully charged.**

*found fire extinguisher behind toolbox on North Wall*

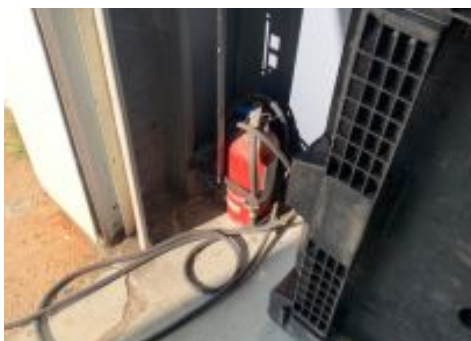
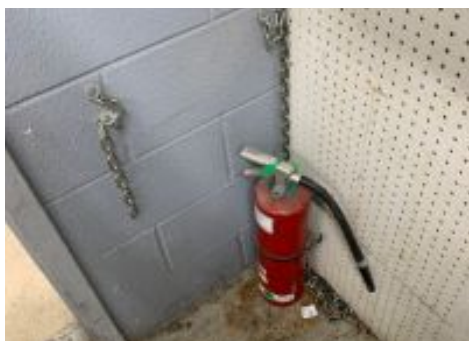
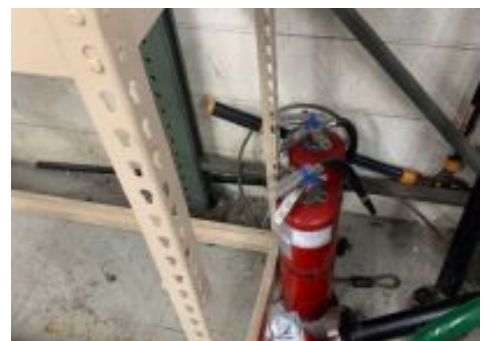
**Fire Extinguisher missing or not properly mounted in dispensing area**

*found Fire extinguishers sitting on floor*

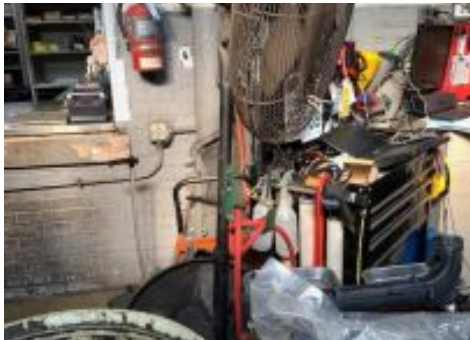
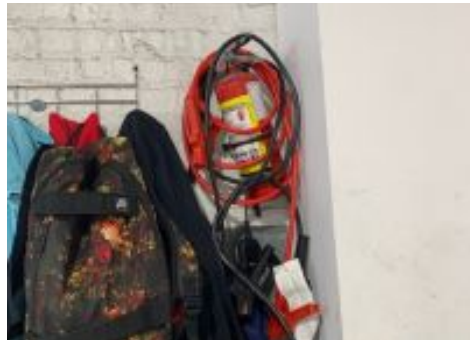
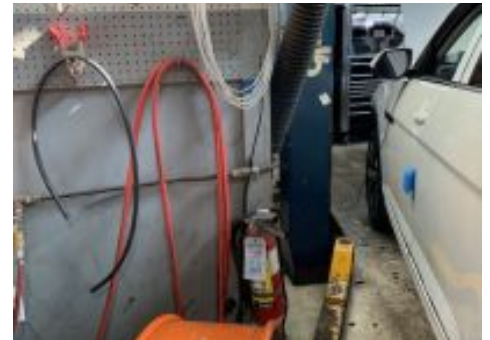
**The fire extinguisher signs above the unit are not posted properly.**

*fire extinguishers need signage*

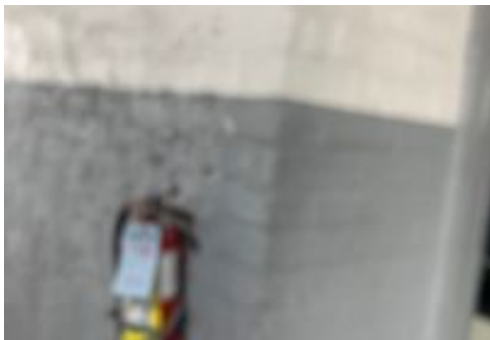
**The fire extinguisher signs above the unit are not posted properly.**

*fire extinguishers need signage*

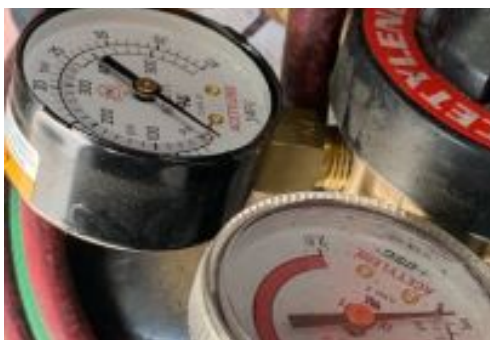
**All hoses and cutting tips for the welder / cutting torches are not in good condition without any cracks or breaks.**

*Found oxy acetylene gauge missing protective cover.*

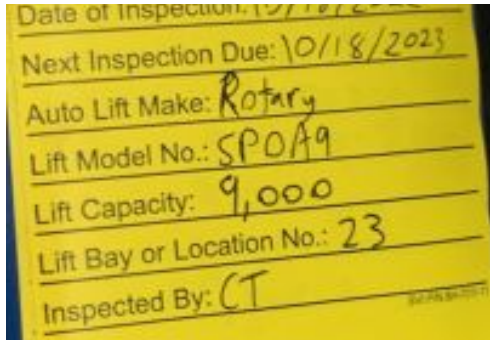
**Hoists are not being maintained within mfg. specs, and inspected and serviced AND documented under the mfg. suggested frequency. Usually annually.**

*Found hoist inspection sticker due for inspection.*

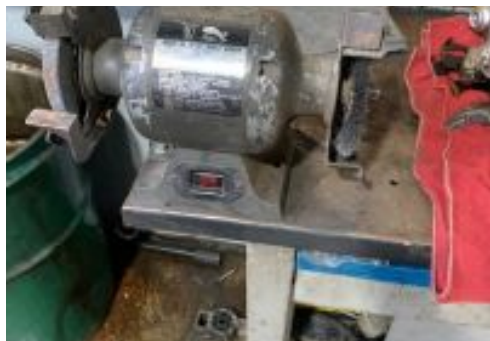
**There is no proper spacing on grinders; Tool rest 1/8" from grinding wheel. Tongue plate 1/4" from grinding wheel.**

*missing tounge plate*

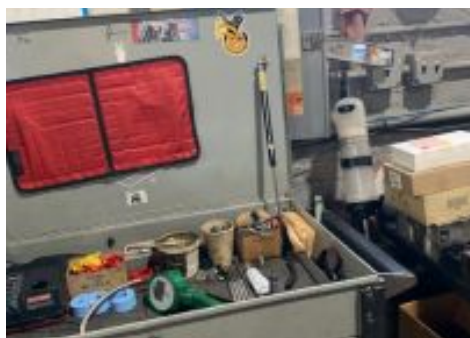
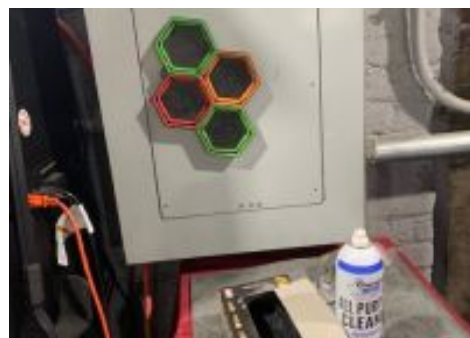
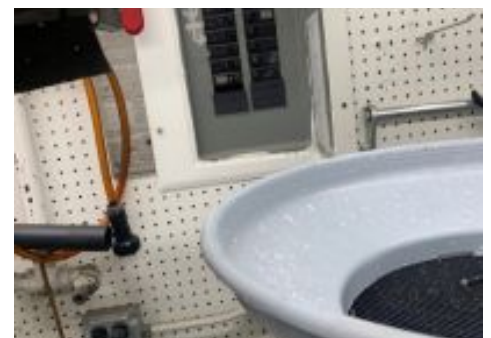
**There is not clear access of at least 36" to all electrical panels.**

*found access to electrical panels obstructed*

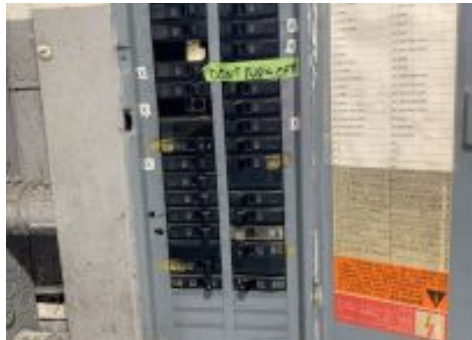
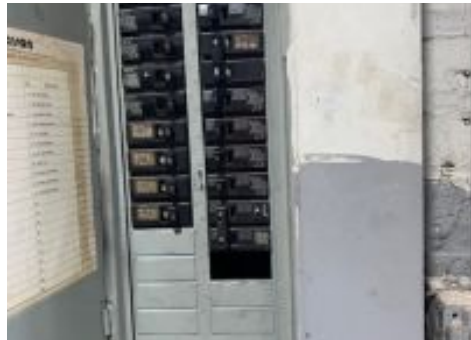
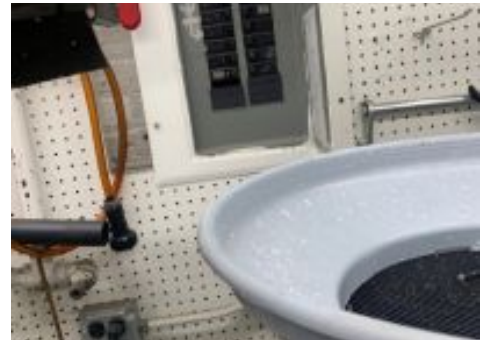
## **All vacant holes are not properly sealed off on electrical panel box.**

*need to plug open holes in breaker panels*

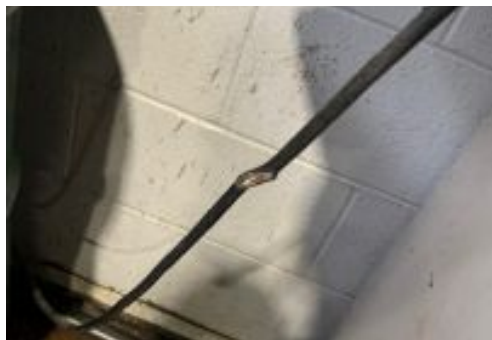
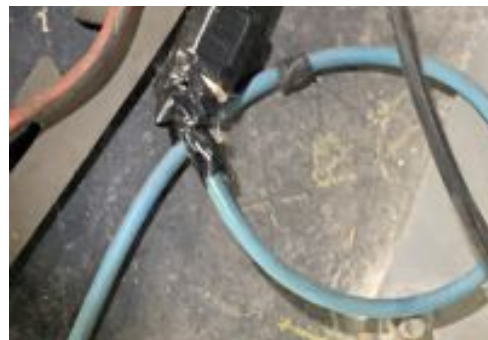
## **All electrical cords are not in good working order (none frayed, cracked, taped, or spliced or ground missing on 3 prong plugs).**

*found damaged cords in equipment area north wall and alignment area east wall*

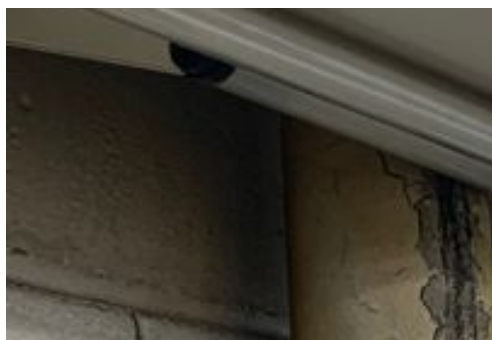
## **The fluorescent tubes are not stored properly.**

*Found loose fluorescent tubes upstairs on parts shelf*

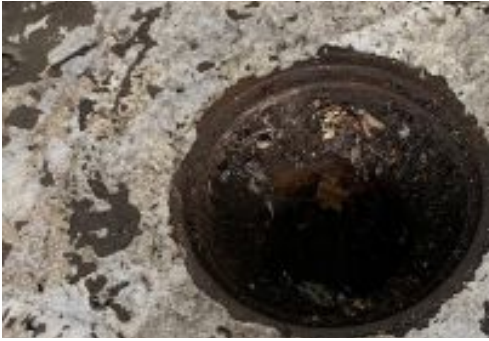
*Floor drain cover missing in service area NE garage door area*

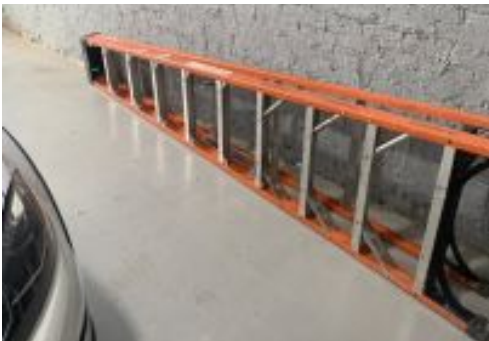
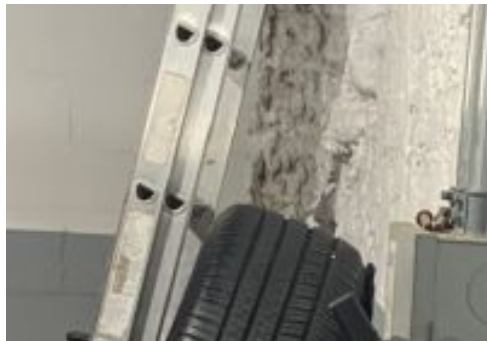
## Ladders not stored properly, needs chained off on any ladder over 8 ft.

*found ladders in East building*

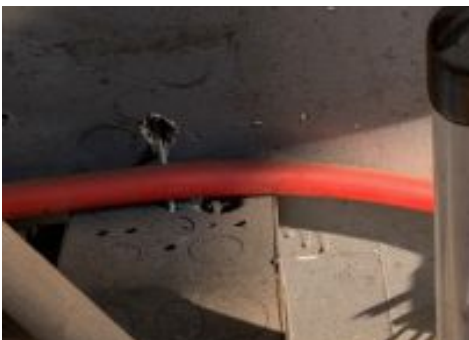
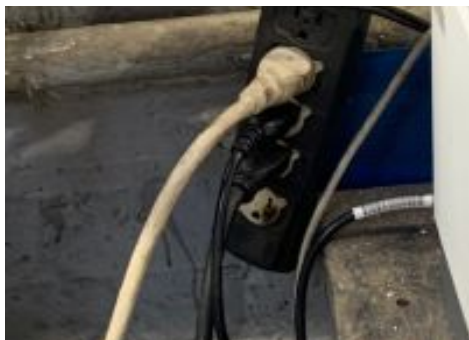
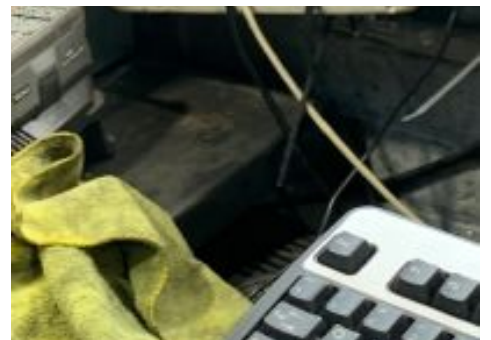
## Electrical issues misc.

*box pulled off wall strip plugged into strip in service area north wall*

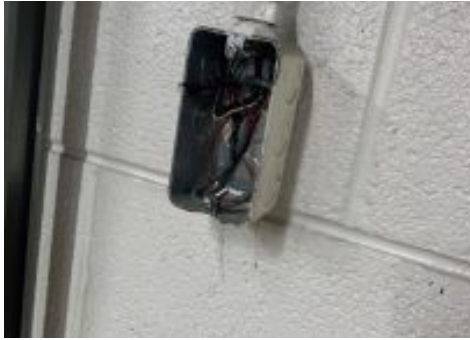
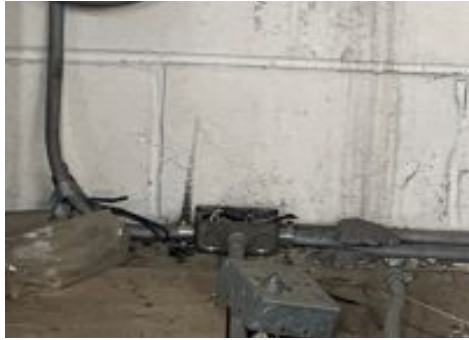
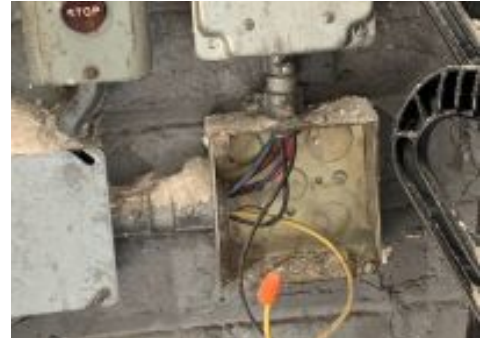
## Electrical Plugs Outlets not properly covered. Plate cover missing or broke

*found a few boxes with exposed wires, no covers*

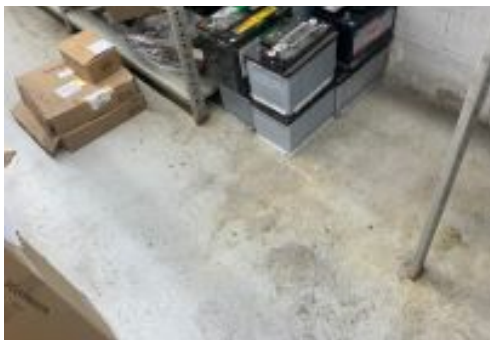
## Used Batteries not stored on acid resistant matts

*Need acid resistant mat under used batteries*
