# OSHA Report Quality Nissan and Kia of Greenwood

Complete On: 9/04/2024

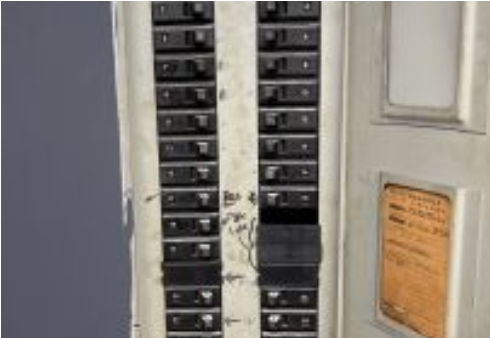
**All vacant holes are not properly sealed off on electrical panel box.**

*Kia service - empty slot*

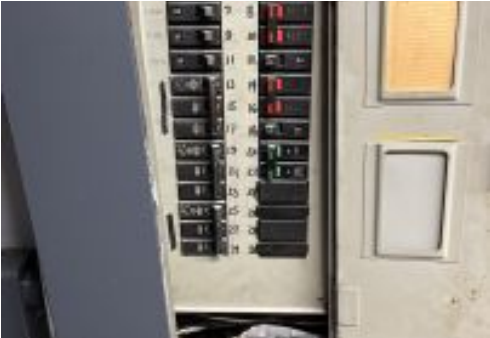
**All vacant holes are not properly sealed off on electrical panel box.**

High Risk

*Kia service - empty space on bottom with loose wiring*

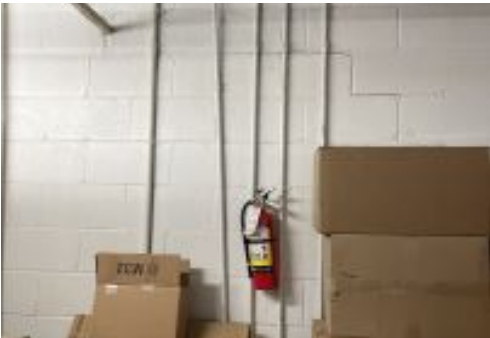
**The fire extinguisher signs above the unit are not posted properly.**

*Kia parts - no sign upstairs*

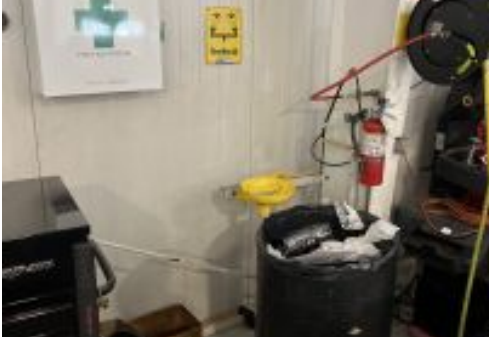
**The eye wash equipment is not readily accessible.**

*Nissan service - unable to access first aid, eye wash, or fire extinguisher*

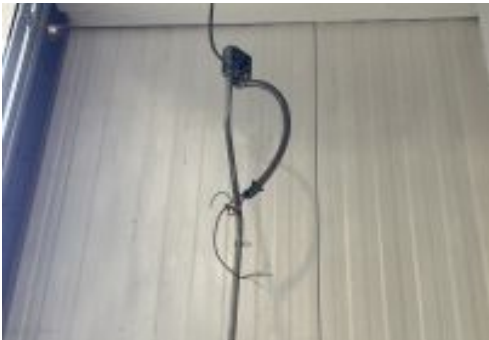
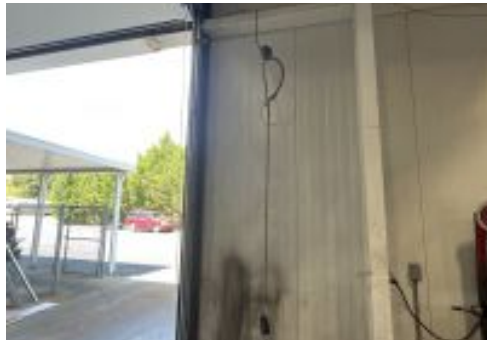
**All electrical cords are not in good working order (none frayed, cracked, taped, or spliced or ground missing on 3 prong plugs).**

*Nissan service - frayed wiring*
