# OSHA Report Quality Chrysler Dodge Jeep Ram of Greenwood

Complete On: 9/04/2024

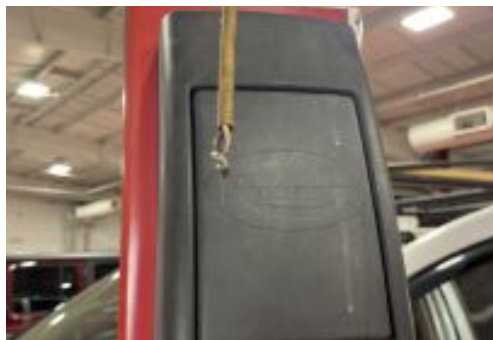
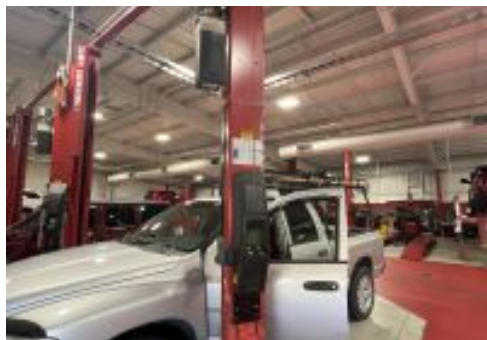
**All electrical cords are not in good working order (none frayed, cracked, taped, or spliced or ground missing on 3 prong plugs).**

*Electrical cord on last lift on right side is frayed*

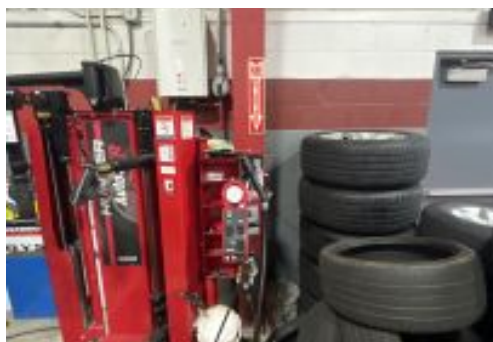
**All the Fire Extinguishers are not easily accessible.**

*Unable to get to fire extinguisher on right side of shop*

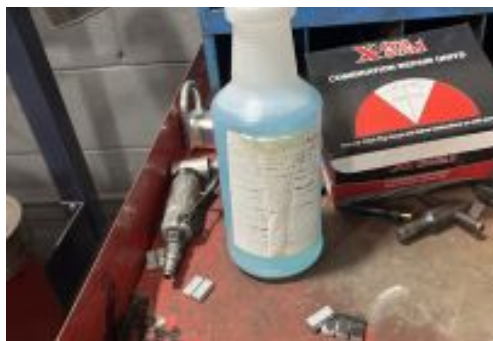
**All secondary containers filled with chemicals are not properly labeled.**

*Label not able to be read; must have labels on all secondary containers*

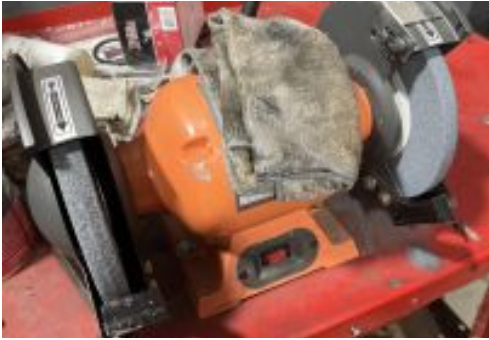
**There is no proper spacing on grinders; Tool rest 1/8” from grinding wheel. Tongue plate 1/4” from grinding wheel.**

High Risk

*All safeguards missing*

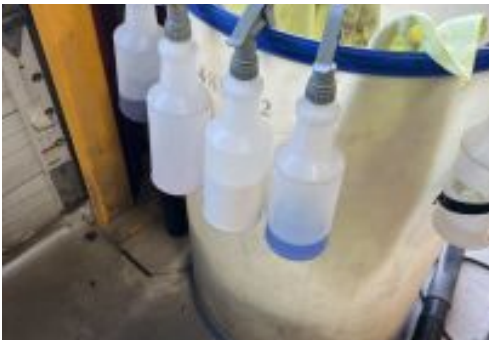
**All secondary containers filled with chemicals are not properly labeled.**

*Labeling missing on bottles in detail area; spoke with George*

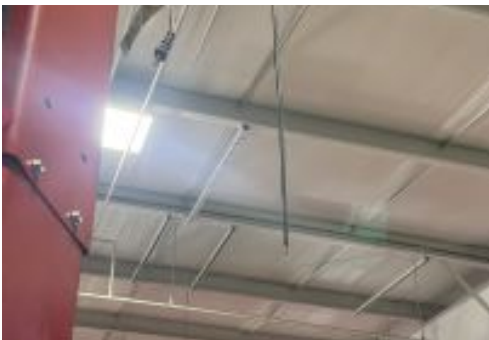
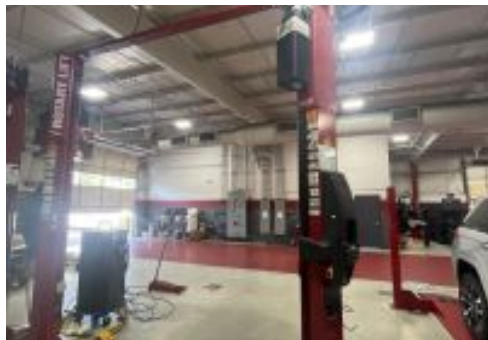
**All electrical cords are not in good working order (none frayed, cracked, taped, or spliced or ground missing on 3 prong plugs).**

*Electrical cord on lift is frayed*

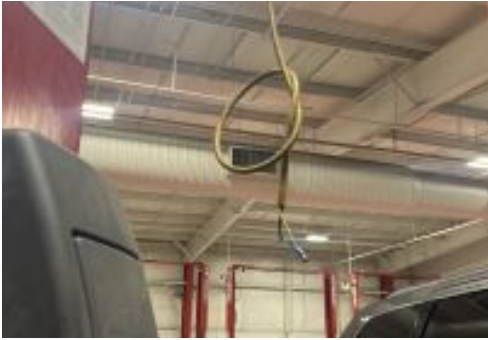
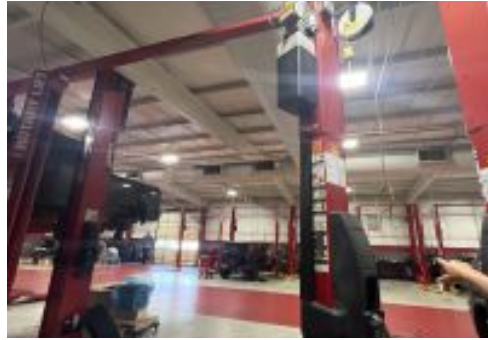
**All electrical cords are not in good working order (none frayed, cracked, taped, or spliced or ground missing on 3 prong plugs).**

*Even though not plugged in, can still be plugged in and cord is frayed*
