# Body Shop Report **Arnie Bauer** **Buick GMC** **Cadillac**

Complete On: 9/05/2024

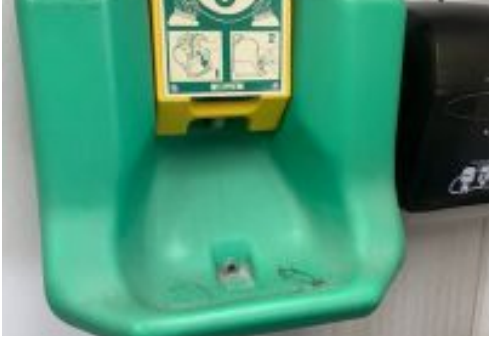
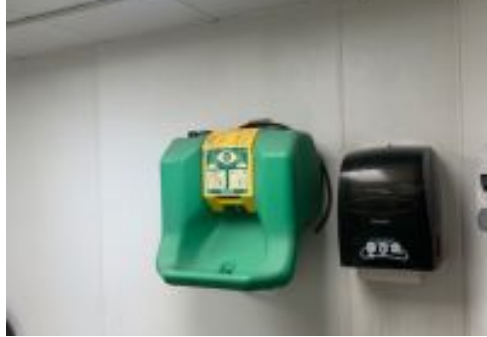
## Eye wash equipment has not been tested, cleaned and documented weekly.

*Eyewash station is completely empty. also needs signage above unit.*

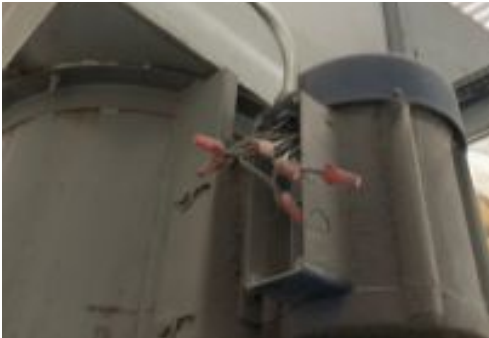
## Other additional electrical issues noted.

*electric motor cover is missing with wires exposed*

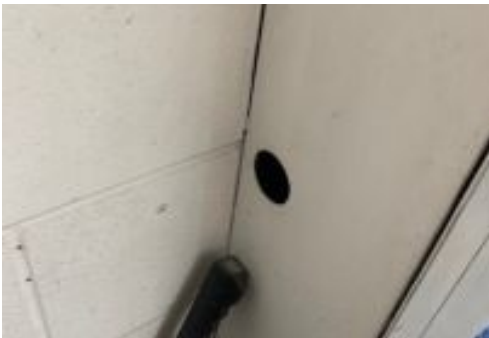
## Holes not filled or blanks being used on electrical panels

*found vacant hole on side of electric panel.*

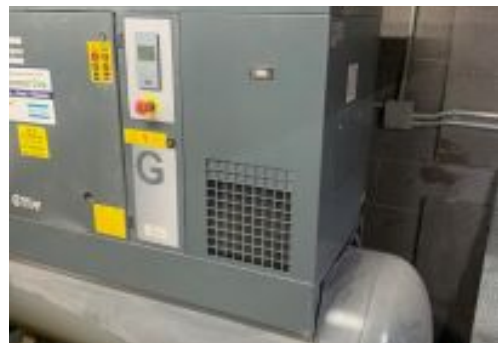
**No signs posted warning of "Automatic Start" feature of the compressors.**

*Compressor needs automatic start signage.*

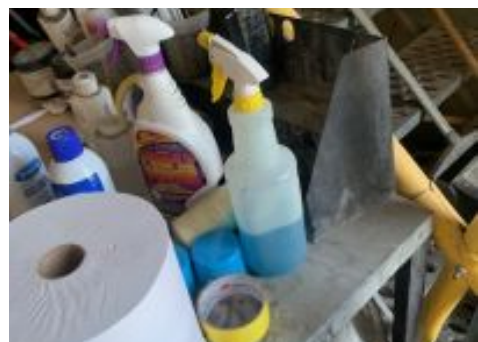
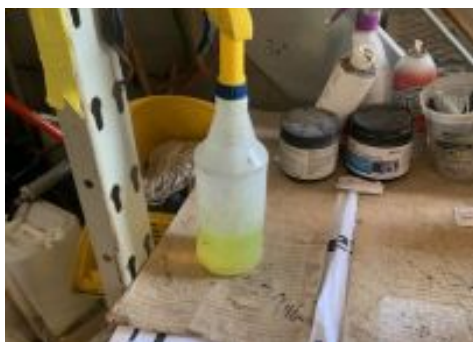
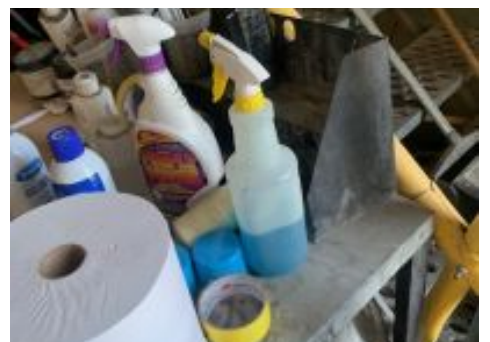
**Secondary containers filled with chemicals are not properly labeled.**

*found secondary containers with liquid needing contents label*

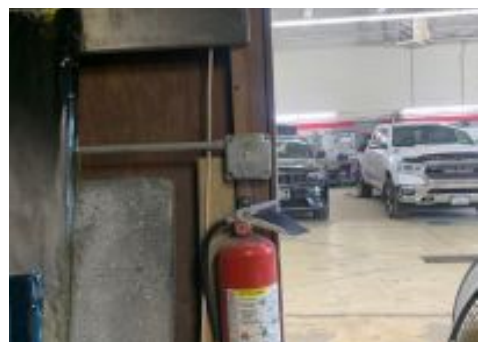
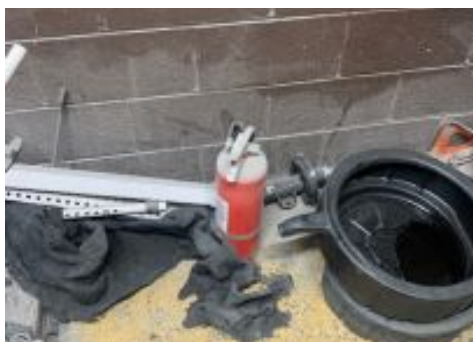
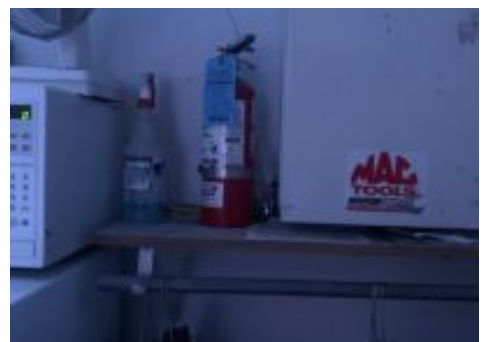
**Fire extinguishers are not easily accessible.**

*Extinguishers need proper mounting and signage above units.*
