# OSHA Report **Brilliance** **Subaru**

Complete On: 8/14/2024

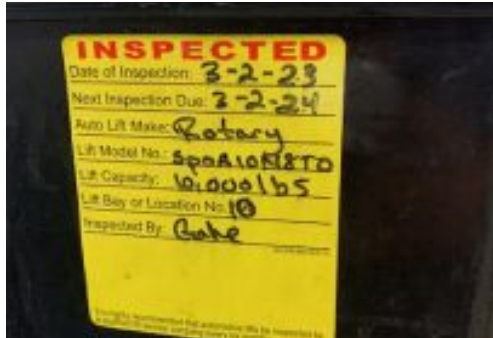
**Hoists are not being maintained within mfg. specs, and inspected and serviced AND documented under the mfg. suggested frequency. Usually annually.**

*Noticed Hoist inspection sticker shows annual inspection is overdue March 2024*

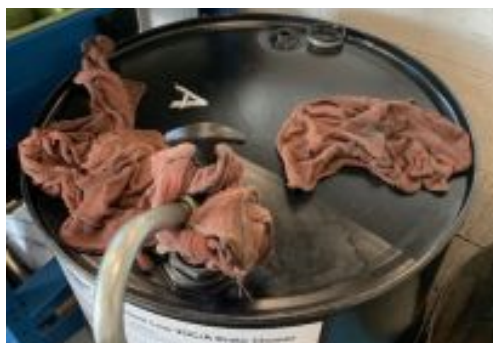
**All tanks holding flammable material are not properly grounded.**

*50 gallon steel drum w/ flammable liquid needs to be grounded*

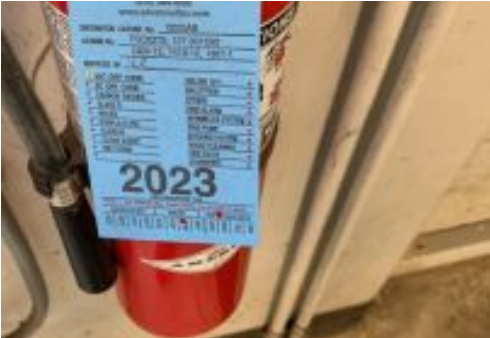
**The fire extinguishers have not had their annual inspection and are not properly identified and fully charged.**

*Found 1 Fire extinguisher overdue for inspection The rest are good thru October*
