# OSHA Report **Brilliance** **Honda**

Complete On: 8/15/2024

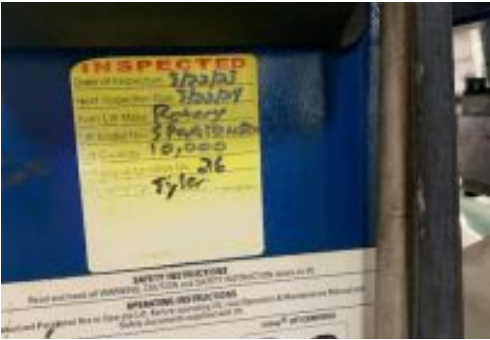
**Hoists are not being maintained within mfg. specs, and inspected and serviced AND documented under the mfg. suggested frequency. Usually annually.**

*Hoists were due for inspection March 2024*

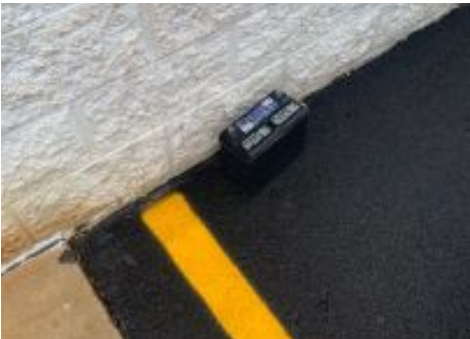
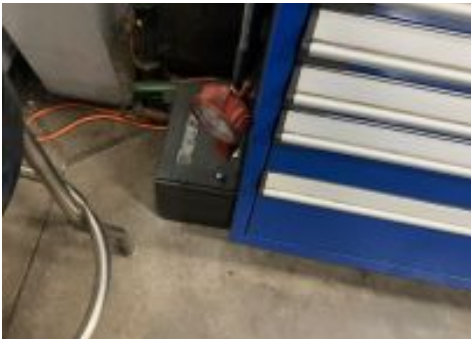
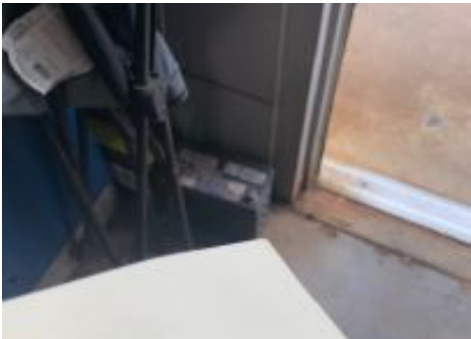
**Used batteries are not being stored in acid resistance leak proof containers and or on mat.**

*Found several used batteries around shop floor and one outside.*

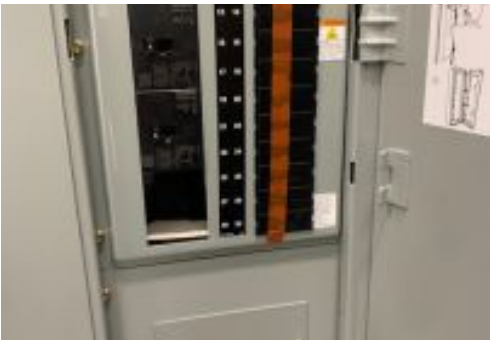
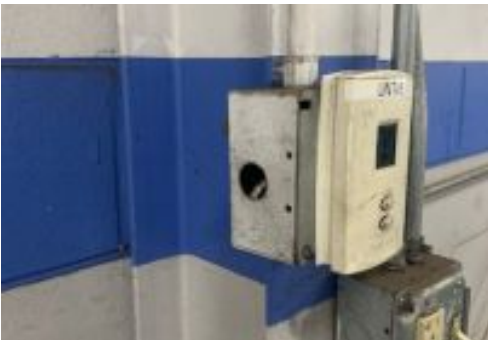
**All vacant holes are not properly sealed off on electrical panel box.**

*found vacant hole in panel box (detail area) service drive up also open hole in electric junction box in Service*

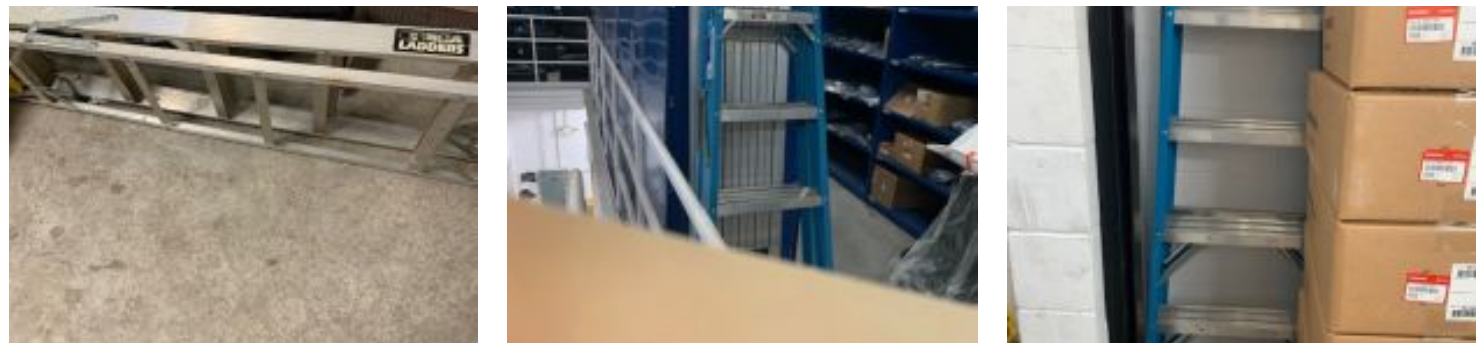
**Ladders not stored properly, needs chained off on any ladder over 8 ft.**

*Found ladders without secure chains*

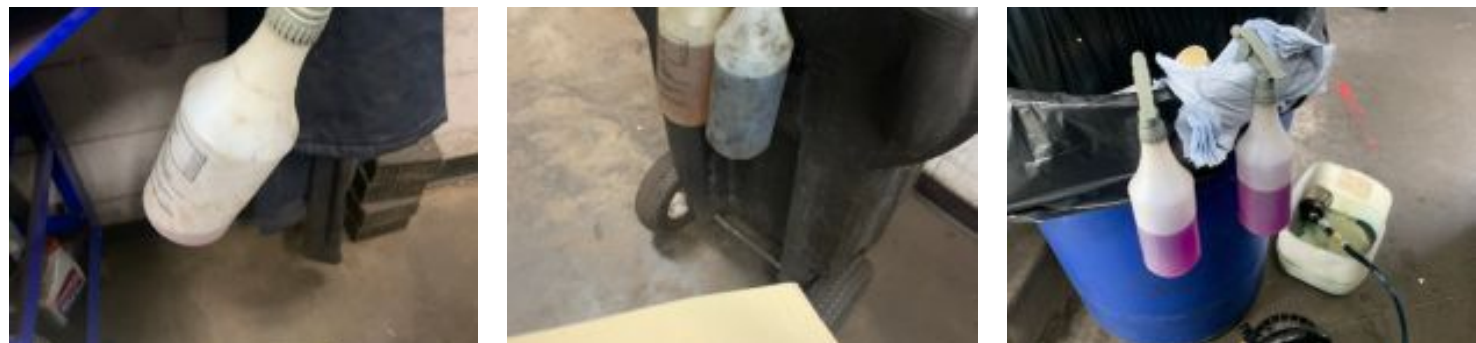
**All secondary containers filled with chemicals are not properly labeled.**

*Found several spray bottles with no label of contents.*

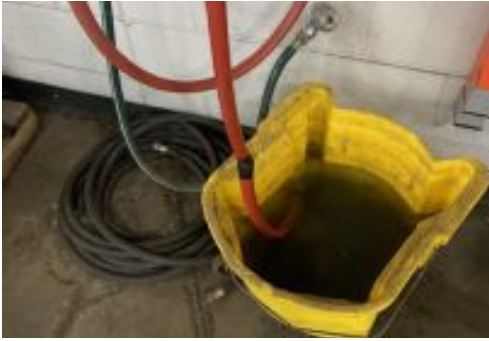
*noticed water hose with damage*
