# OSHA Report **JIM MLADY** **NISSAN LLC**

Complete On: 8/08/2024

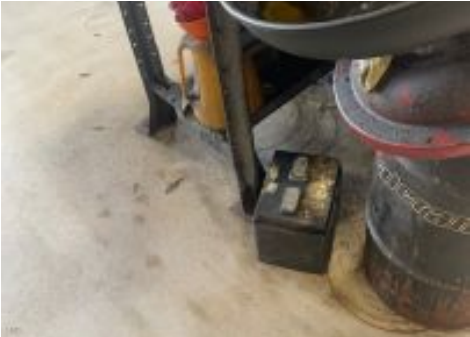
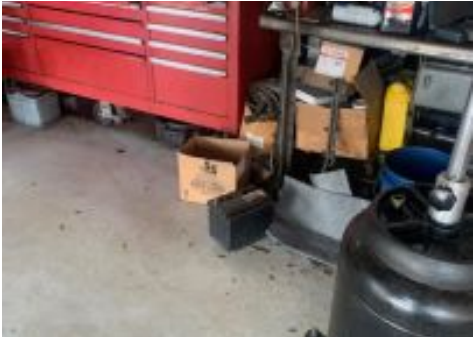
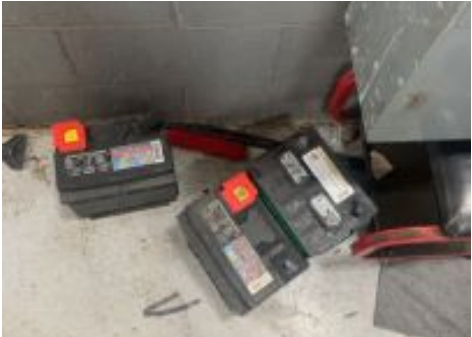
**Used batteries are not being stored in acid resistance leak proof containers and or on mat.**

*Found batteries all over shop area and parts on the floor*

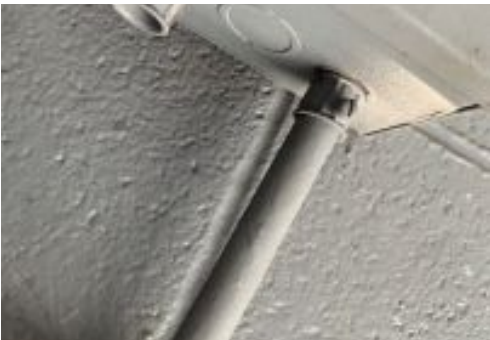
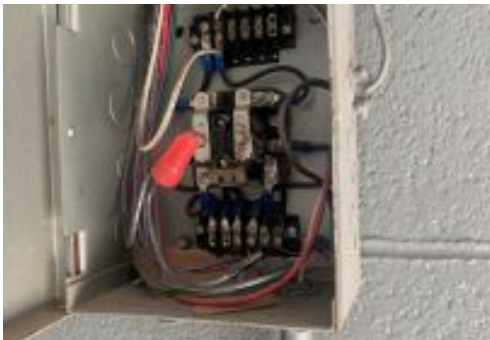
**There are other miscellaneous electrical issues to note.**

*Box has vacant hole at bottom and no cover inside box when opened*

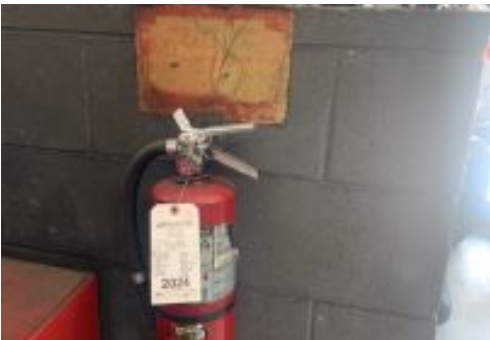
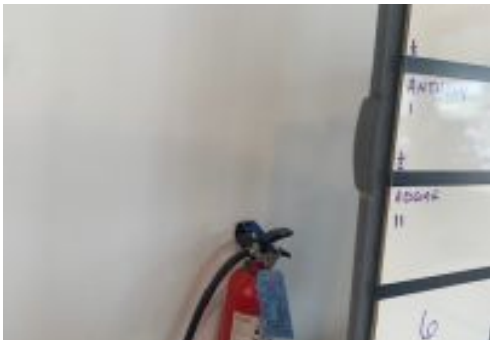
**The fire extinguisher signs above the unit are not posted properly.**

*Need new sign in service area, need sign in showroom*

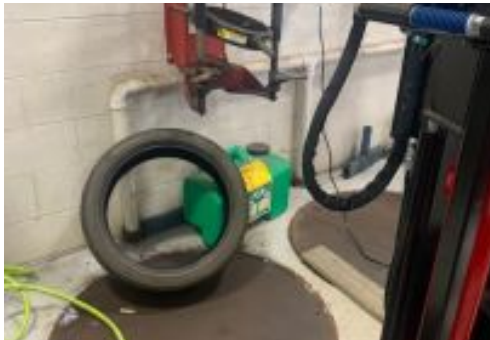
## **The eye wash equipment is not readily accessible.**

*Found Eye wash station laying on floor.*

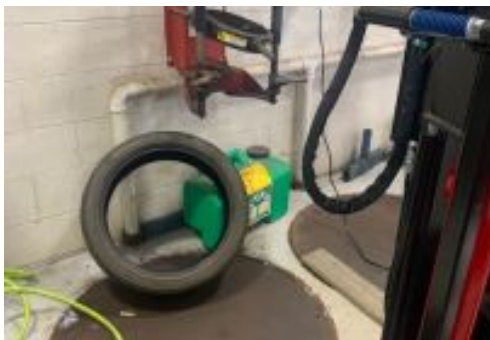
## **The eye wash equipment has not been tested and cleaned and documented weekly.**

*Weekly documentation is not being documented*

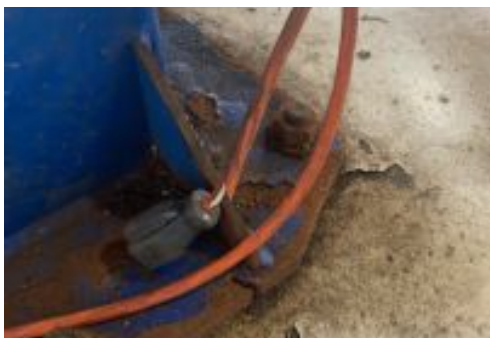
## **All electrical cords are not in good working order (none frayed, cracked, taped, or spliced or ground missing on 3 prong plugs).**

*Found extension cord with damage to outside housing*

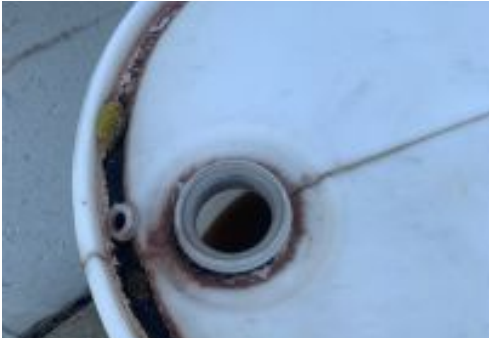
## Storage Containers not capped and or sealed properly

*Found drum outside missing cap*

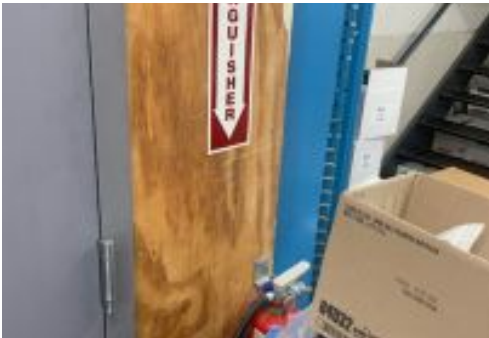
## All the Fire Extinguishers are not easily accessible.

*Fire extinguisher blocked in parts*

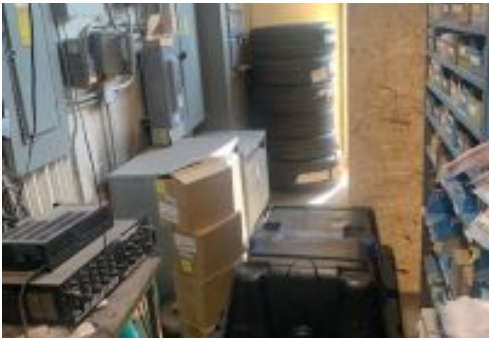
## There is not clear access of at least 36" to all electrical panels.

*this panel in parts is blocked for access*

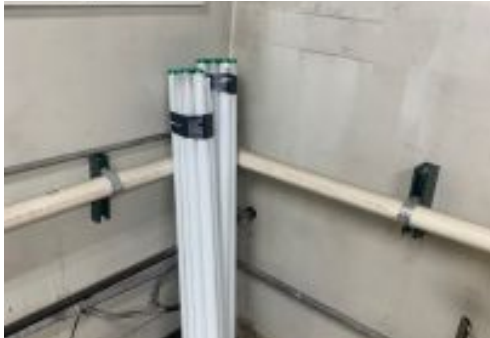
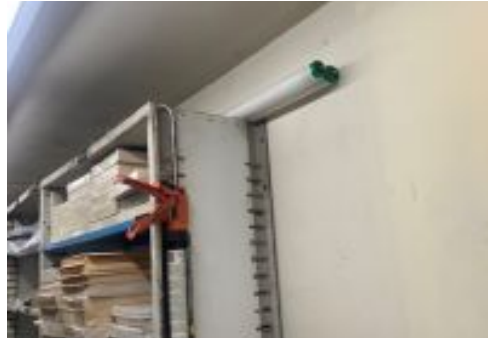
## The fluorescent tubes are not stored properly.

*Found this in closet across from parts counter and upper level.*

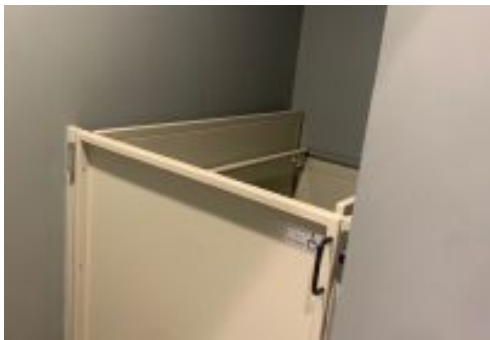
## The elevator has not been inspected.

*Need to display inspection sheet in elevator.*

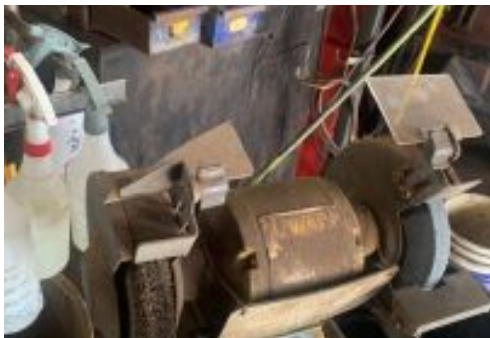
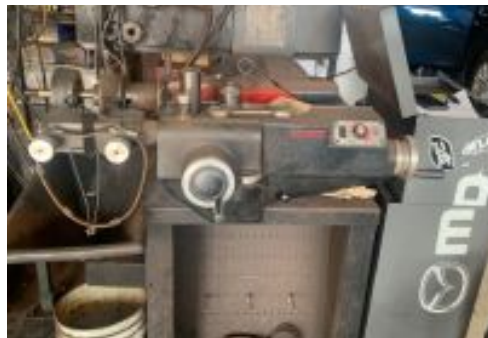
## Miscellaneous issues.

*Grinder needs new plastic eye shield Brake Lathe should have sign requiring eye protection*
