Vibration Comparison of Overhead Line Pillars at TEST Bk.15 & TEST Bk.11

Executive Summary

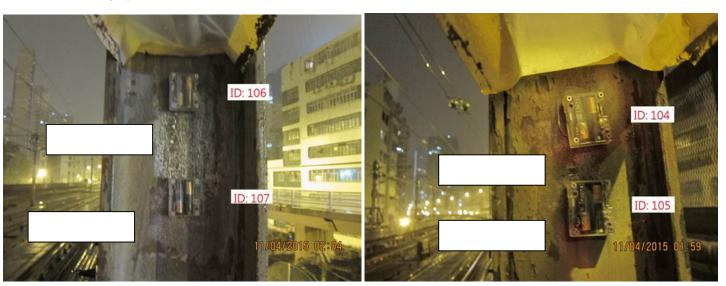
Photographs:

Note: Z axis through page, X axis is vertical, Y axis is horizontal.

From the photographs, ID104 was tilted and the vibration graphs (refer to data plots) show differences in the X and Y axis values (but same values for Z axis).

Thus, ID105 should be used instead.
