DTC	B2796/99	No Communication in Immobiliser System
-----	----------	--

2002 4RUNNER (RM887U)

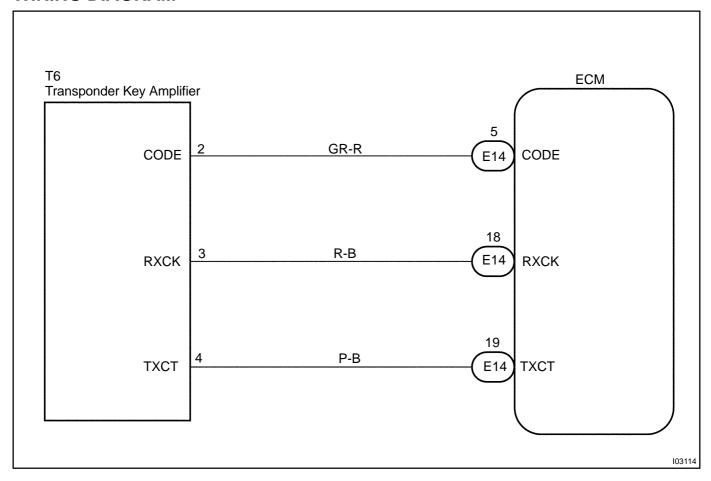
WIRING DIAGRAM

DTC No.	DTC Detection Condition	Trouble Area
B2796/99	No communication	Key Transponder key coil Transponder key amplifier Wire harness ECM

INSPE	ECTION PROCEDURE
1	Check transponder key coil (See page BE-172).
	NG Replace transponder key coil.
ОК	
2	Check harness and connector between transponder key amplifier and ECM (See page IN-28).
	NG Repair or replace harness or connector.
ОК	
3	Does it operate normally after replacement of transponder key amplifier?
	Yes Replace transponder key amplifier.
No	
Repla	ice ECM.
