# Inspection Report

**Property Address:**  
3252 SUNSHINE CANYON  
BOULDER CO

**HomeFront Inspection, LLC**

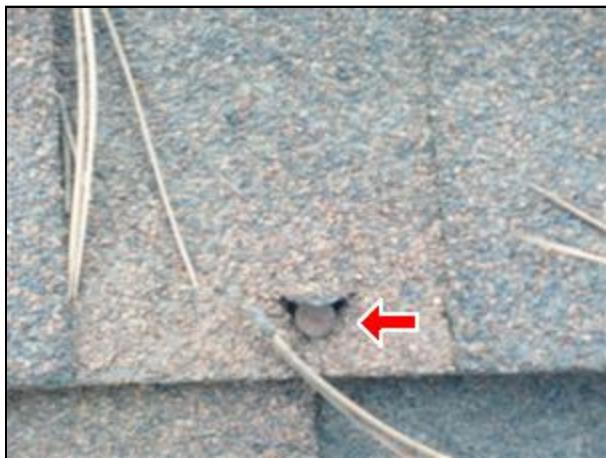
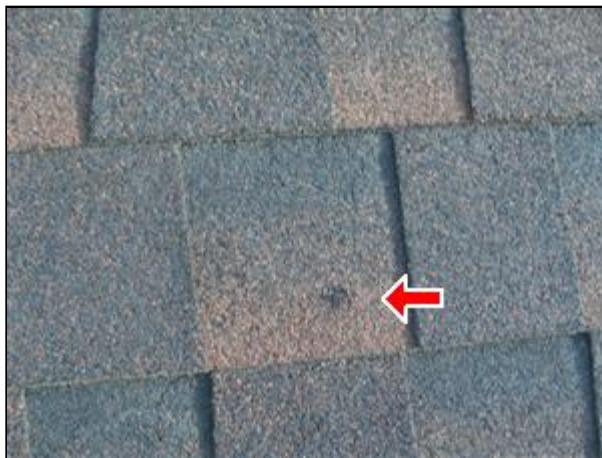
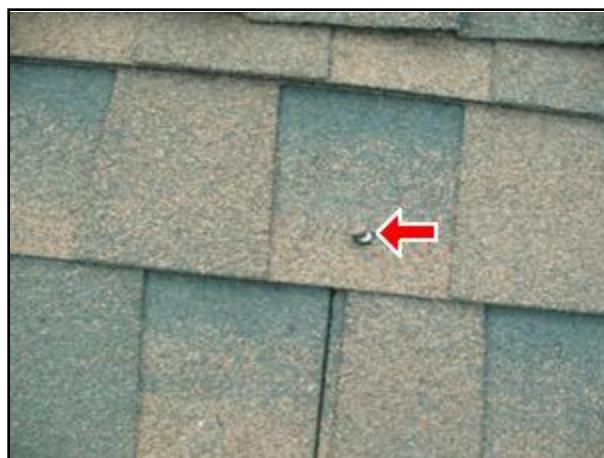
**1.0** (1) Two or more layers of roof covering exist on roof. This causes a lot of weight on roof. Recommend tear off coverings and replace as necessary. This roof has more layers of roof covering than what is normally allowed.

(2) The roof covering have nail heads popping at the in various areas. This could be because of too short nails or rotted decking. You may want to have a professional roofer evaluate. A qualified person should repair or replace as needed.

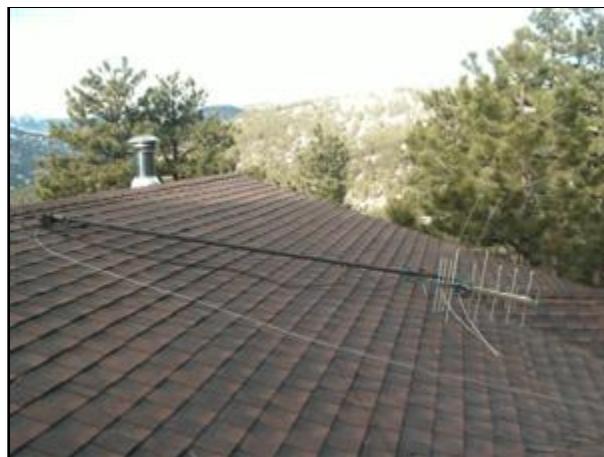
1.0 Picture 4

(3) The TV antenna is laying on the roof. Either the guy wires have come loose or it was intentionally disconnected.

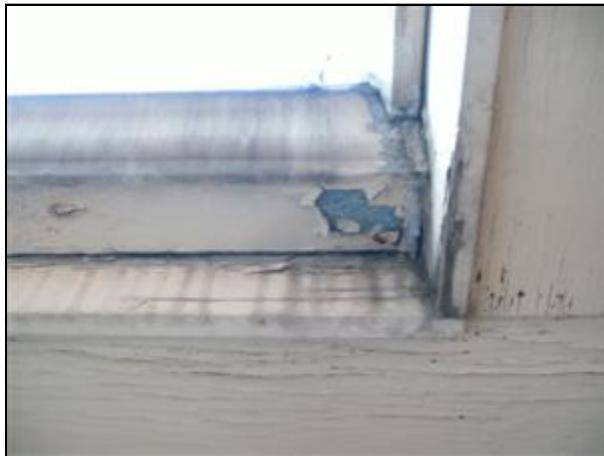
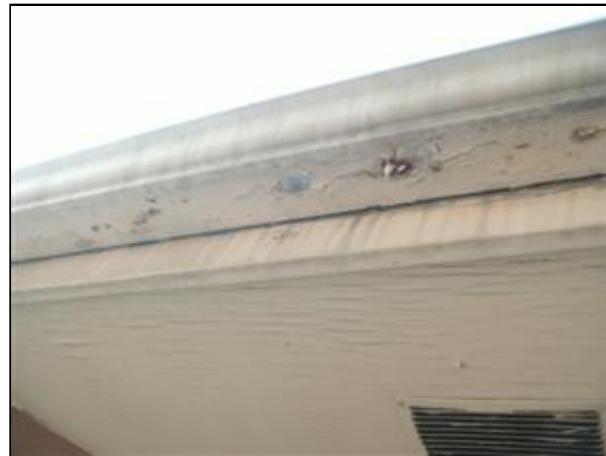
**1.1** The gutters are rusting and leaks Gutters that drain poorly or clogged can lead to many costly problems such as deterioration of fascia, soffit or roof edge. It can also cause gutters to pull loose and lead to possible water intrusion. All the gutters should be replaced. It is recommended a qualified professional replace.

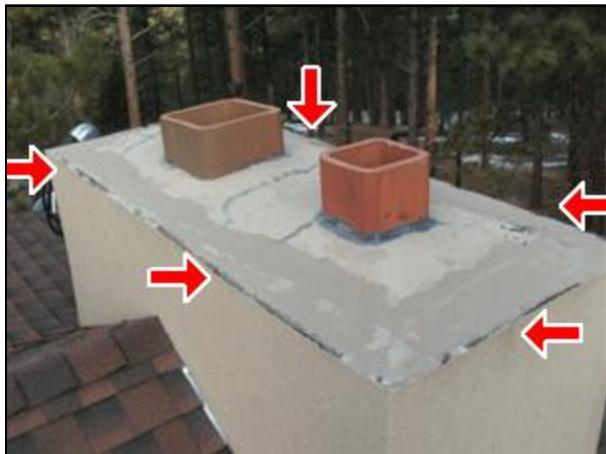
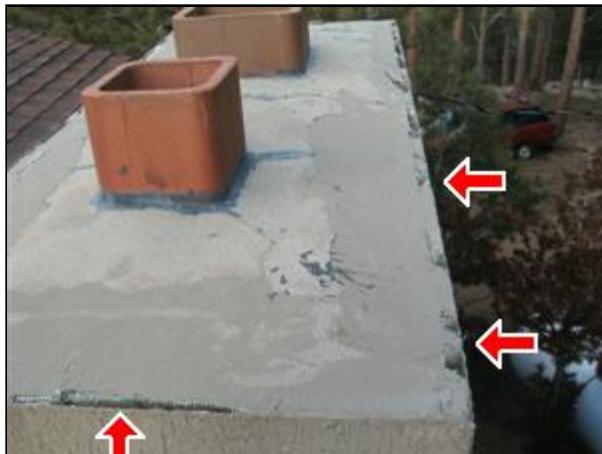
**1.3** The perimeter of the chimney is synthetic stucco which is damaged around the perimeter. This is allowing water to infiltrate inside the stucco which can cause wood decay and mold. Due to recent dry weather, I could not detect moisture at this time. It is recommended to install a metal cap that would cover the chimney with openings for the flue pipes. This should prevent the water from infiltrating.

There are not spark arresters at the top of the chimney flues. It is recommended spark arresters be installed to keep out water and prevent sparks from starting a forest fire.

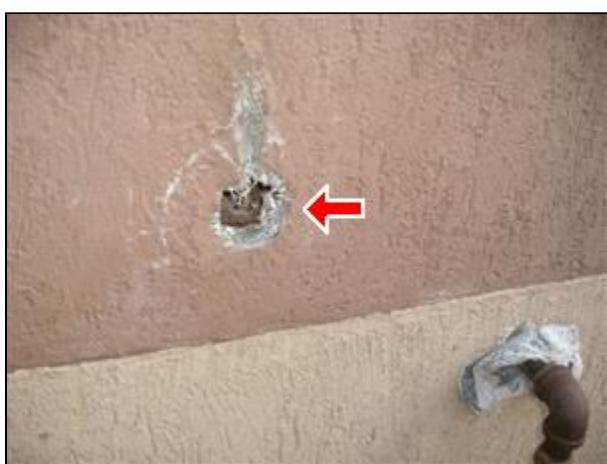
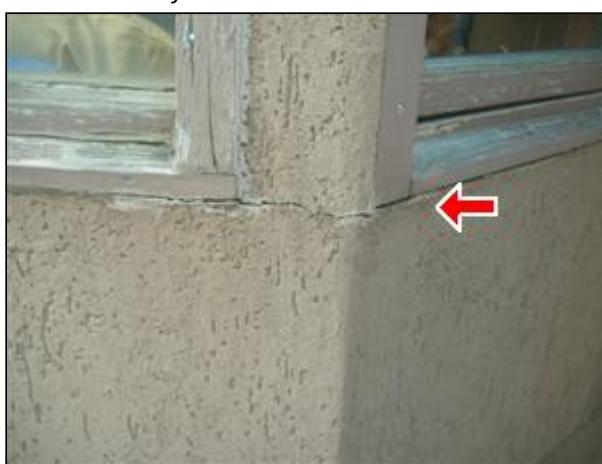
**2.1** The stucco is damaged near the electrical meter, over the garage, and the master bedroom bay window. This can allow moisture to infiltrate and cause wood decay and mold.

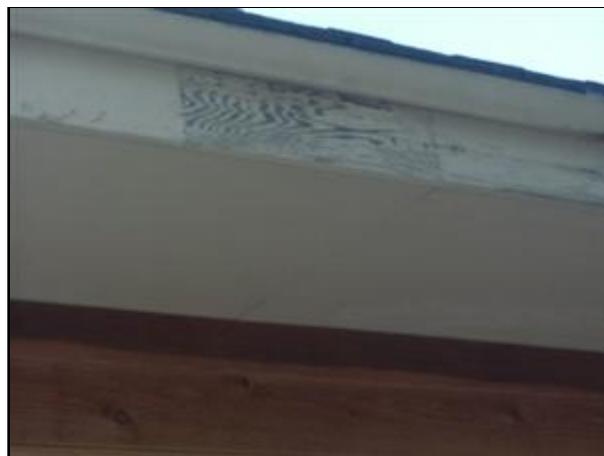
2.2 Picture 1

**2.2 (1)** The paint on eave/gable ends is/are failing. I recommend prep and paint at the perimeter .

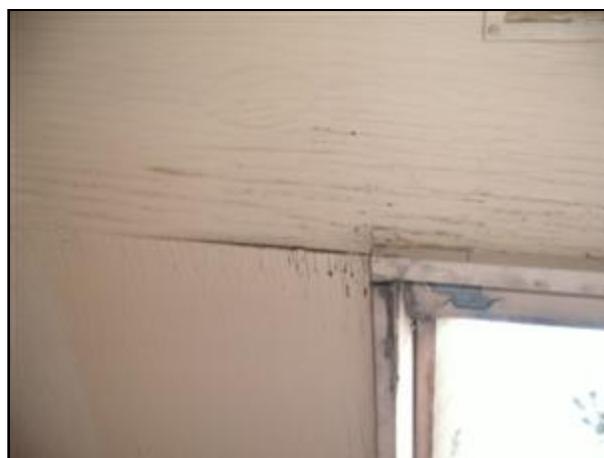
2.2 Picture 2

(2) The soffit panels at eave at the rear of home are weathered. Further deterioration may occur if not repaired. A qualified person should repair or replace as needed.

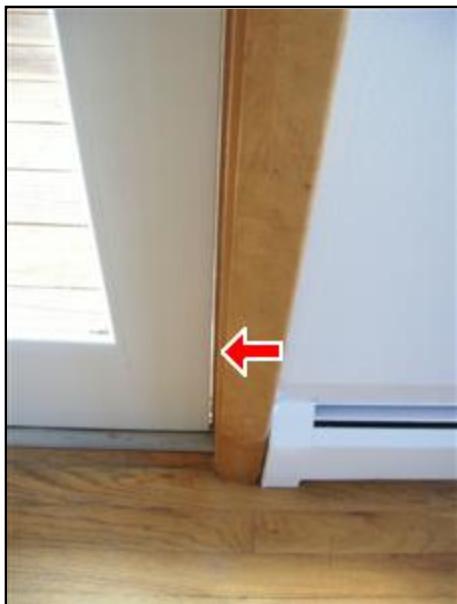
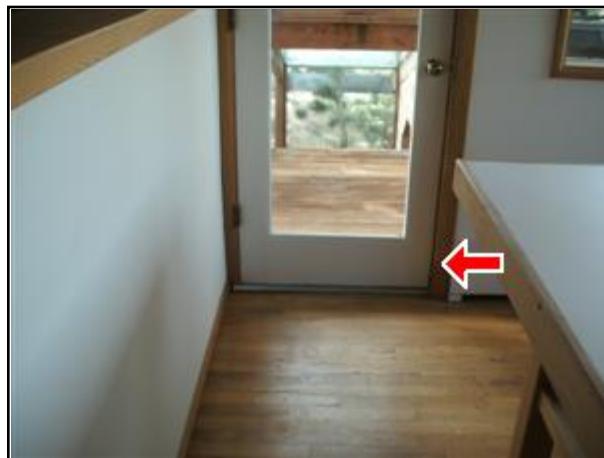
**2.3** The door at the upper level Deck reveals daylight when latched at areas missing weather-stripping.

This can cause some heat loss in winter and loss of cool air in summer if not corrected. A qualified person should repair or replace as needed.

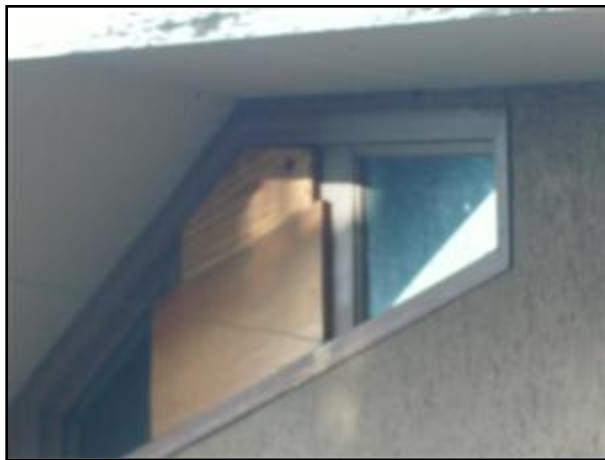
2.4 Picture 1

- 2.4 (1)** One window has been boarded up at the rear gable end. It is recommended to install a gable vent in this place to aid in the ventilation of the attic.

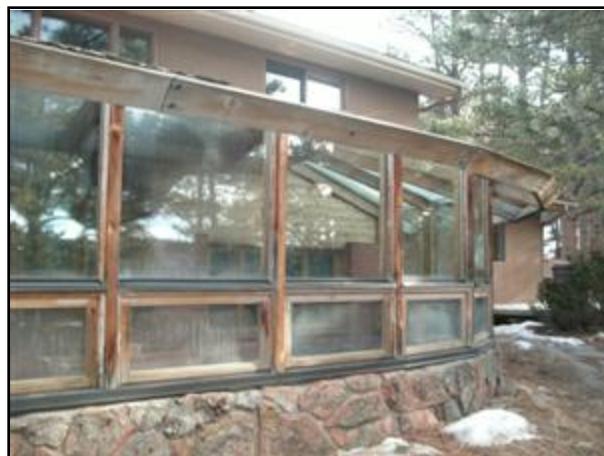
2.4 Picture 2

- (2) The windows of the green house have lost their seal and are cloudy. Because this is a green house this is considered cosmetic as this does not effect the heating or cooling of the house. Repair or replace as desired.

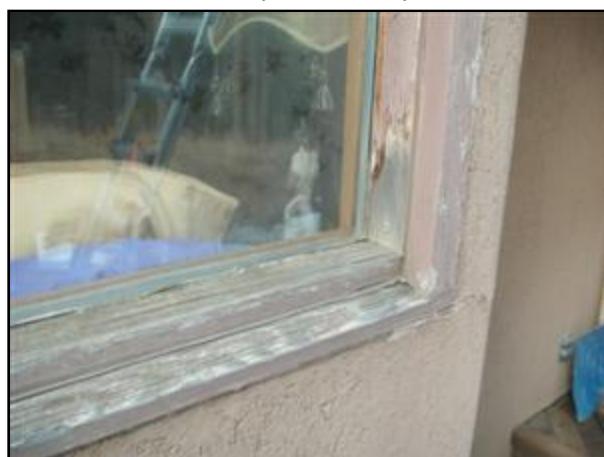
2.4 Picture 3

- ⚠️ (3) The wood trim/sill is peeling paint at all or most windows. Further deterioration may occur if not repaired. I recommend a qualified contractor inspect and repair as needed.

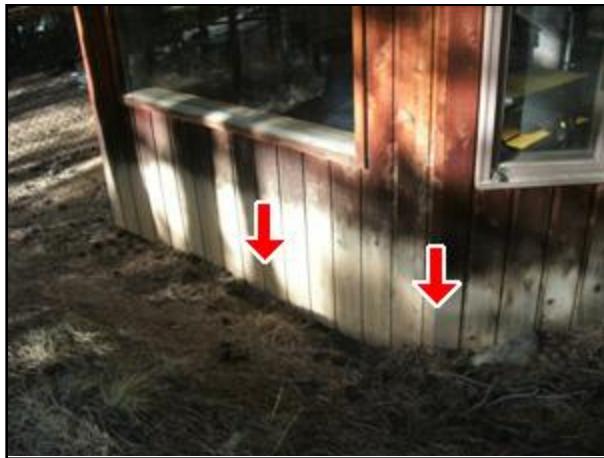
2.6 Picture 1

**2.6 (1)** There is a negative slope at the front of home and rear of home and can cause or contribute to water intrusion or deterioration. I recommend correcting landscape to drain water away from home.

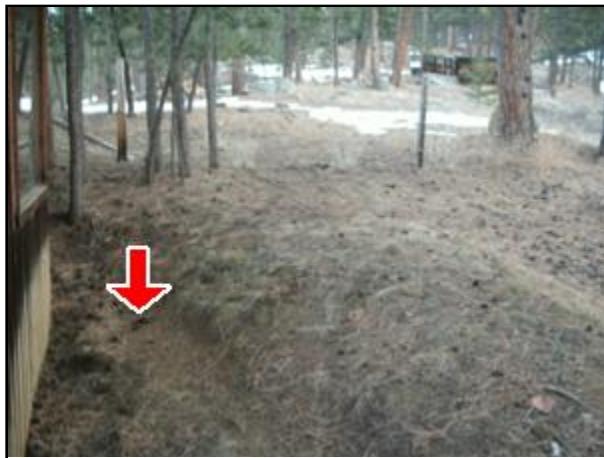
2.6 Picture 2

(2) The house is located on a side of a hill. Water will drain toward the house and could lead to water infiltration. It may be necessary to install a ditch to drain the water away from the house. It is recommended a qualified professional do the work.

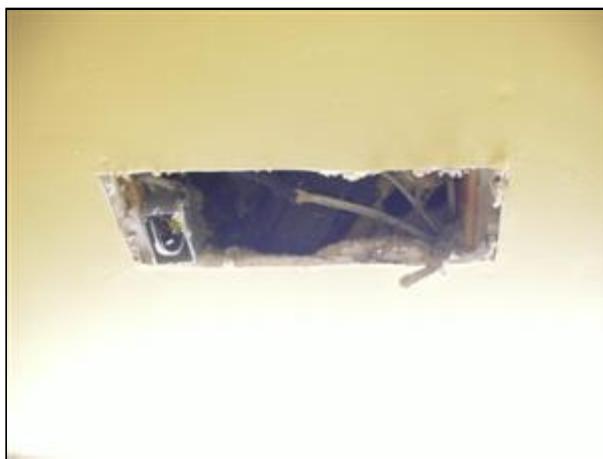
**3.0** The fire protection ceiling in garage that separates garage from heated space is damaged and has been repaired improperly and does not afford the intended fire protection. This is considered unsafe until corrected. A qualified person should correct for safety.

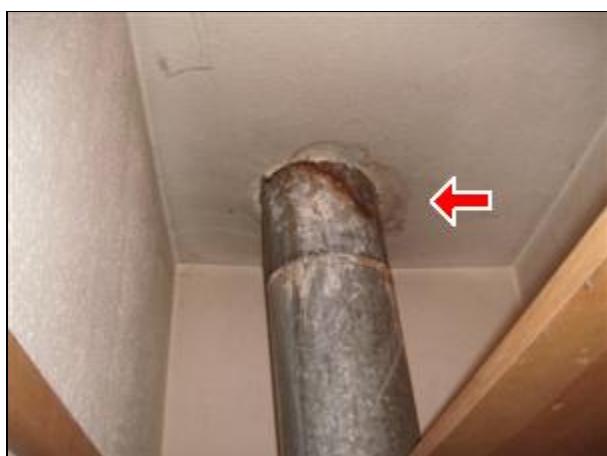
4.1 The ceiling and the floor around the flue pipe for the boiler shows signs of water damage. (in the closet) A moisture meter was used and did not detect moisture at this time. This damage appears to be old. However, this area should be monitored.

Even though the flue pipe is doubled walled if clothing is hung in the closet it could be a potential fire hazard. Therefore it is recommended to build a dividing wall or barrier to keep flammables from coming in contact with the flue pipe.

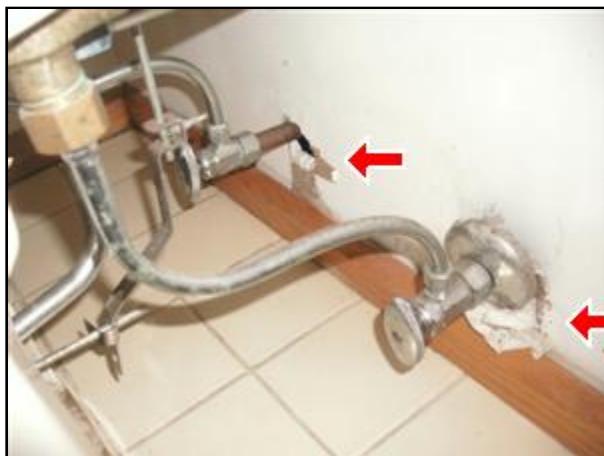
4.2 Picture 2

(2) The drywall on the wall has a hole at the water pipes. This can allow mice to enter the living area. A qualified person should repair or replace as needed.

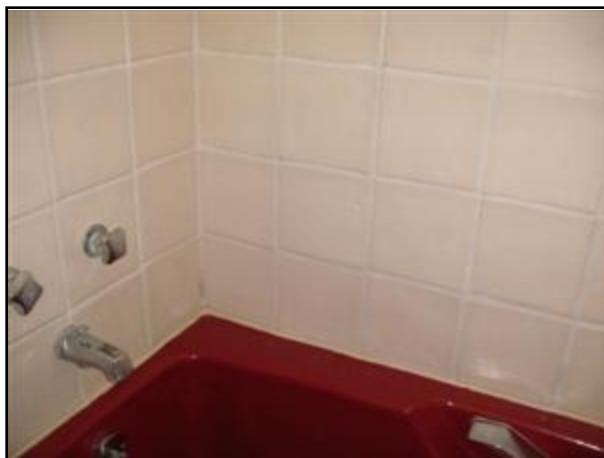
4.2 Picture 3

(3) The Tile surround at bathtub and or shower on the wall need grout sealer applied at the bathrooms and all rooms with tile. Moisture can seep behind the tile and cause damage and mold. This is not important to do immediately but in the near future. Please follow through to make sure the work is completed.

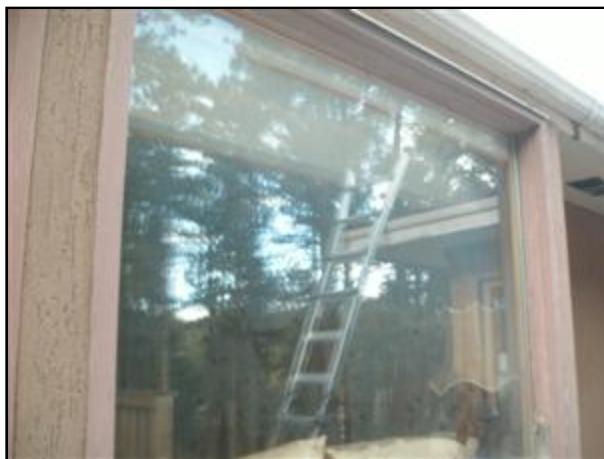
4.5 Picture 1

**4.5** Some windows are cloudy (lost seal) at the all or most rooms throughout the house. In order to correct the cloudy appearance of glass, a replacement of glass pane or the unit will be necessary. A qualified person should repair or replace as needed.

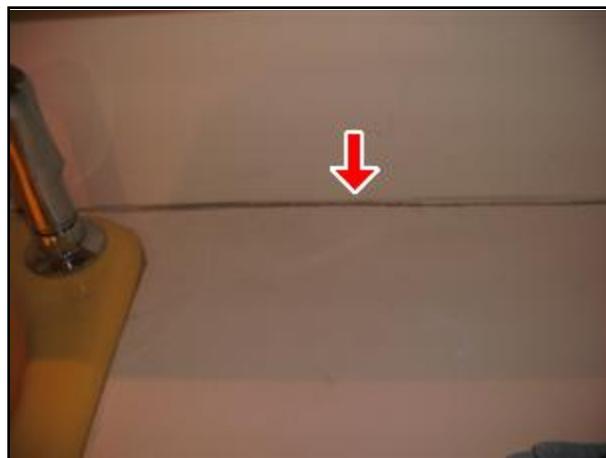
4.7 Picture 1

**4.7** Laminated countertop needs caulking with silicone along backsplash in the kitchen. This can lead to water infiltration and cause damage to the tiles and possibly mold. Recommend repair or replace as necessary.

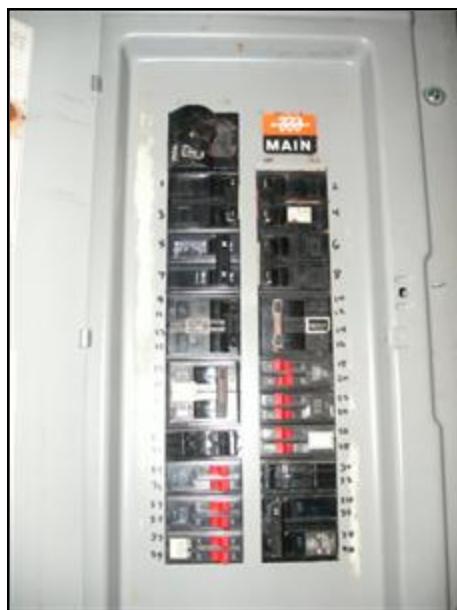
6.2 Picture 1

**6.2 (1)** The main breaker panel is a Murray. They are known to have the breakers fail by burning or melting. It is recommended that a licensed electrician evaluate the condition of the breakers in this panel and any other electrical defects found by the electrician.

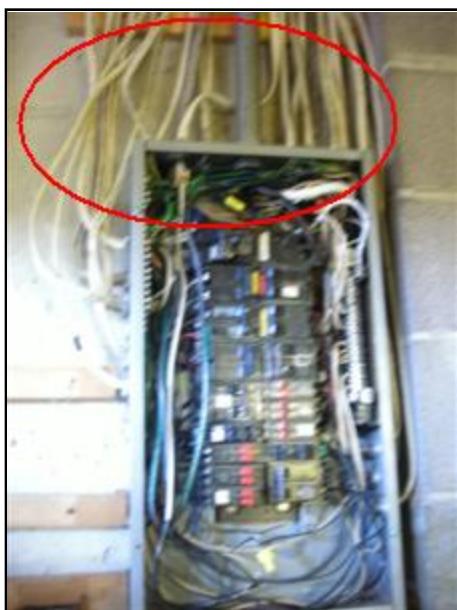
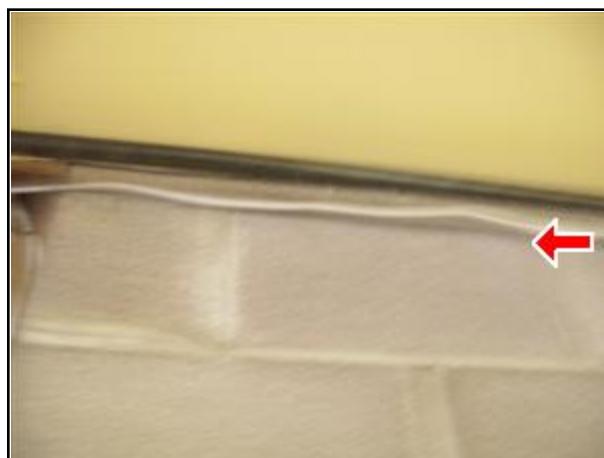
**6.3** There are exposed electrical wires in the garage. Wires should be enclosed in the wall or in conduit.

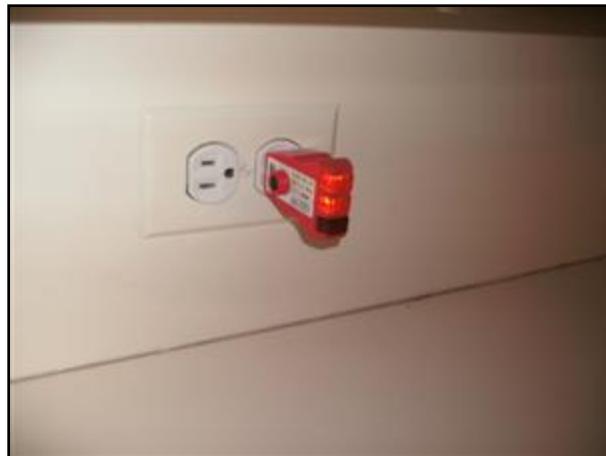
6.5 Picture 1

**6.5 (1)** There are no GFCI (Ground Fault Circuit Interrupter) outlets in the Kitchen. Although not required in the kitchen at the time this house was built, a GFCI protected device is an inexpensive and strongly suggested safety upgrade. If this house was built today, such a device would be required.

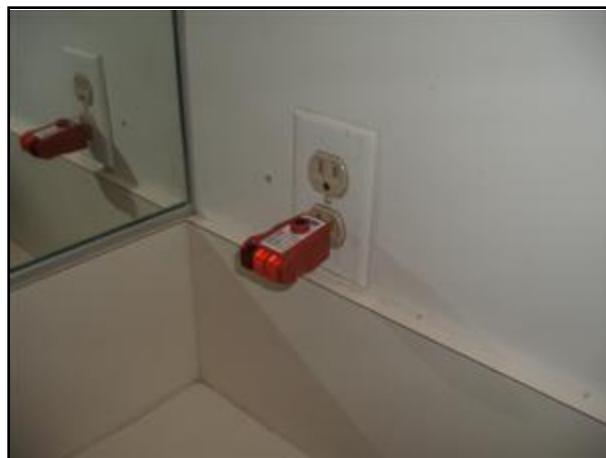
6.5 Picture 2

**(2)** There are not GFCI (Ground Fault Circuit Interrupter) outlets in the bathroom(s). Although these may not have been required in the bathroom at the time this house was built, a GFCI protected device is an inexpensive and strongly suggested safety upgrade. If this house was built today, such a device would be required.

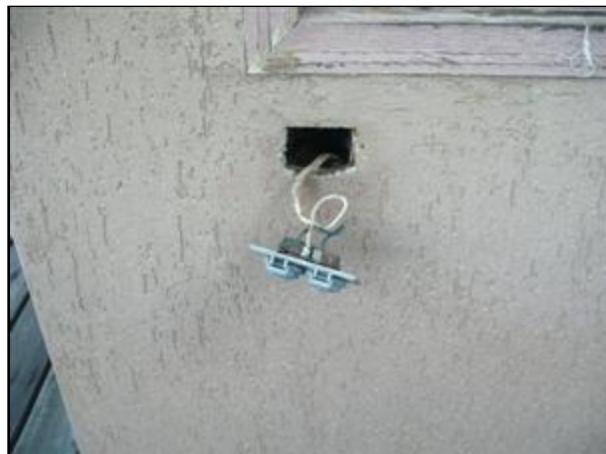
6.5 Picture 3

(3) The exterior outlet at the Deck loose in the wall, and needs to be secured properly. Electrical issues are considered a hazard until repaired. A qualified licensed electrical contractor should perform repairs that involve wiring.

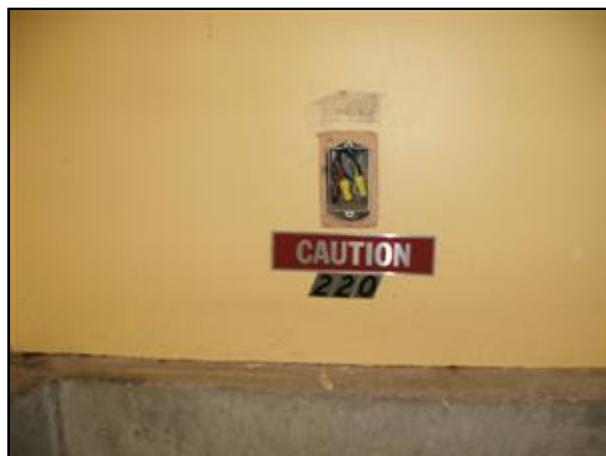
## 6.6 Picture 1

**6.6 (1)** There is an outlet labeled 220 volts. There is a disconnect next to this outlet. However, the disconnect is wired incorrectly which indicates this outlet may not be protected unless there is a breaker for this outlet in the main panel. It is recommended a licensed electrician evaluate.

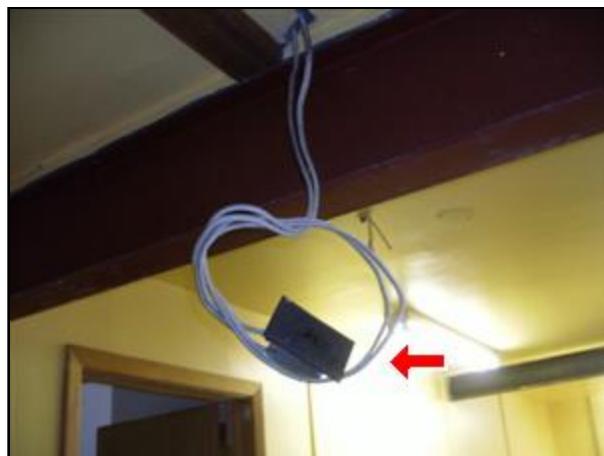
6.6 Picture 2

(2) The ceiling switch is hanging by it's wires in the garage. This is a safety issue that needs to be corrected. A qualified licensed electrical contractor should perform repairs that involve wiring.

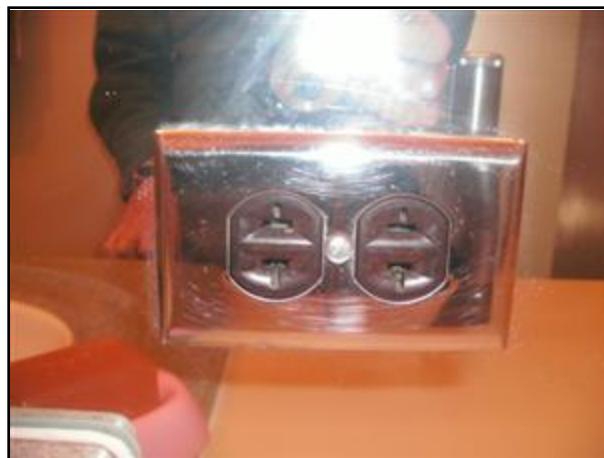
6.6 Picture 4

🏡 (4) Most outlets are not grounded in the apartment. Electrical issues are considered a hazard until repaired. This was not a requirement when the house was built. However, with the electrical demands of today this may not meet your personal needs. Components that require ground outlets like computers and LCD and Plasma TV's are not recommended to be plugged into these outlets. . A qualified licensed electrical contractor should perform repairs that involve wiring.

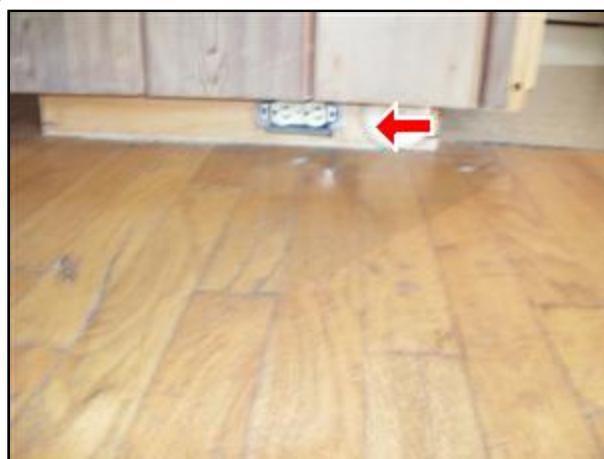
6.6 Picture 5

**6.6** (5) The Outlet(s) is missing cover-plate in the kitchen. This is a safety issue that needs to be corrected. I recommend repair as needed.

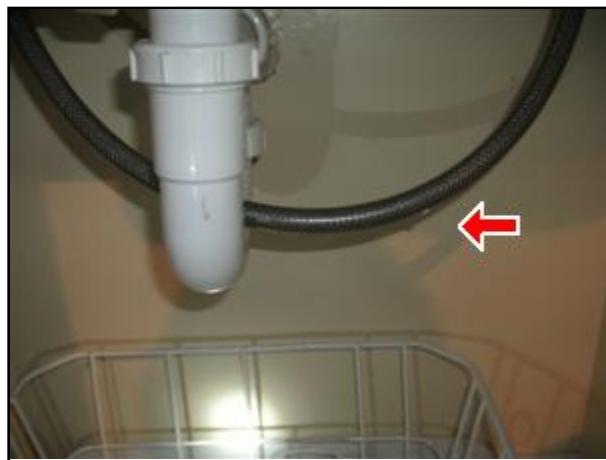
7.0 Picture 1

7.0 (1) The spray nozzle leaks at the kitchen sink. Repairs are needed to prevent further damage to the area below. A qualified person should repair as necessary.

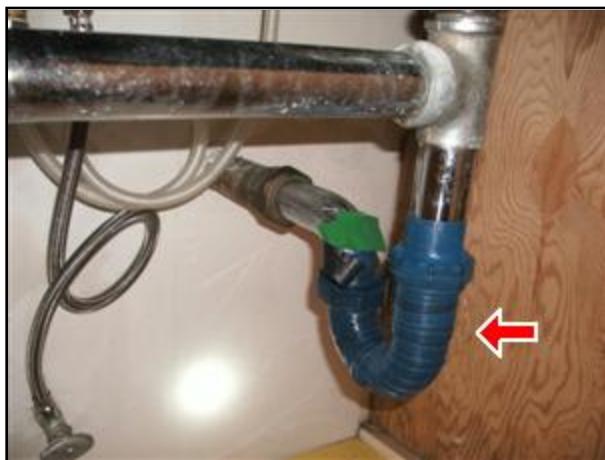
7.1 Picture 1

**7.1** The plumbing waste line (under sink) has been repaired improperly at the apartment bathroom. While this repair is working, it is only considered temporary. A qualified licensed plumber should repair or correct as needed.

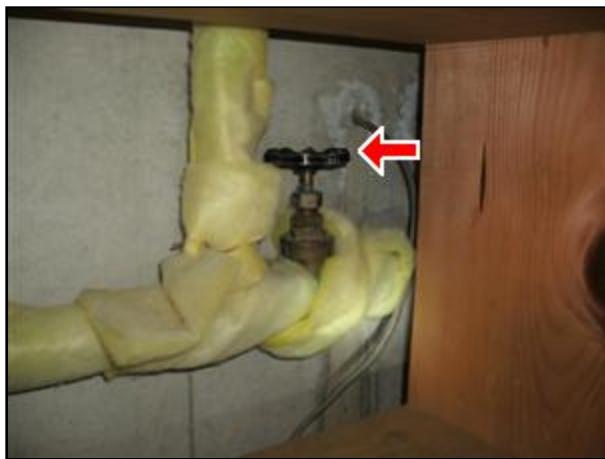
7.3 Picture 1

**7.3** The main water shut-off is the black knob located in the basement. This is for your information.

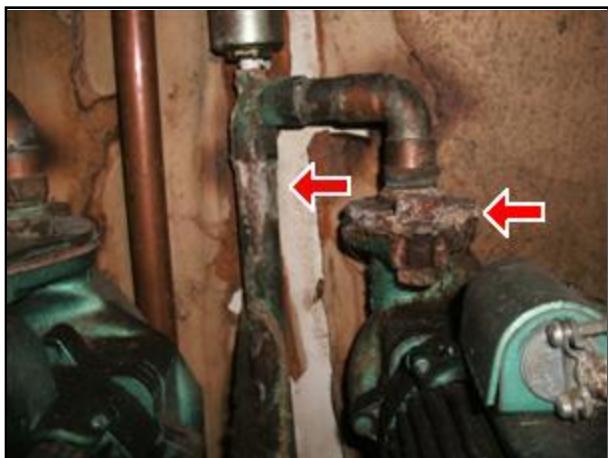
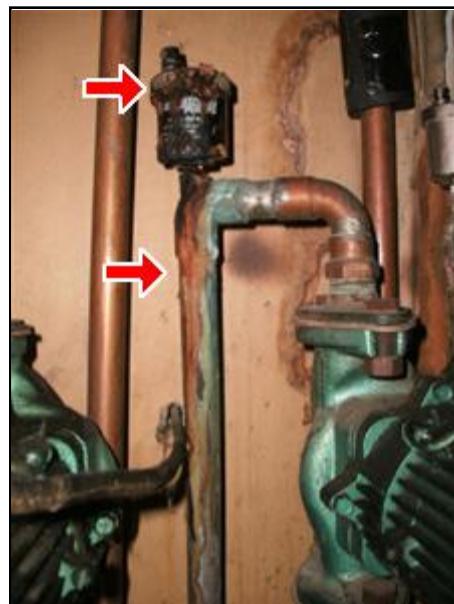
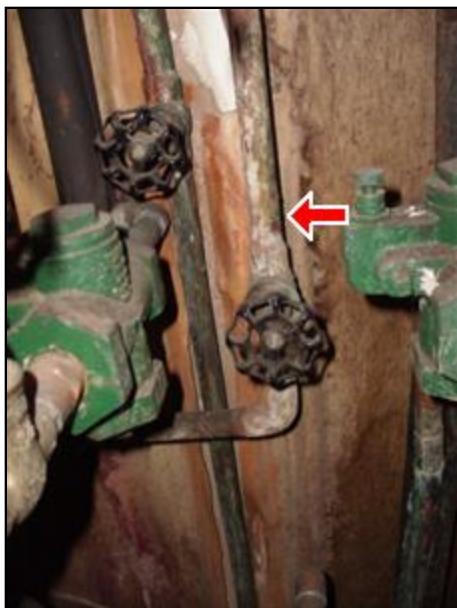
**8.4** (1) The boiler piping is rusting and may have leaked but the rust sealed the leak . There is evidence of previous water damage. If these pipes should leak it could cause serious damage to the boiler system. Also, there is a mold like substance on the drywall behind the boiler. It is recommended a qualified heating person repair, plumber or HVAC professional.

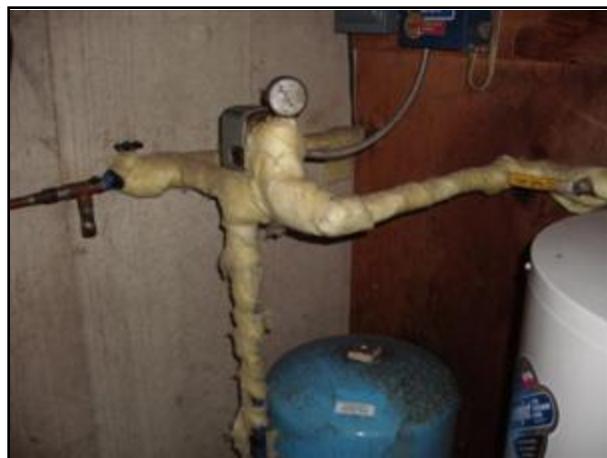
8.4 Picture 5

(2) The water pipes are in the boiler room which have heat tape and insulation wrapped around some of the pipes. This is to prevent the pipes from freezing. The heat tape should be checked periodically to ensure they are working properly.

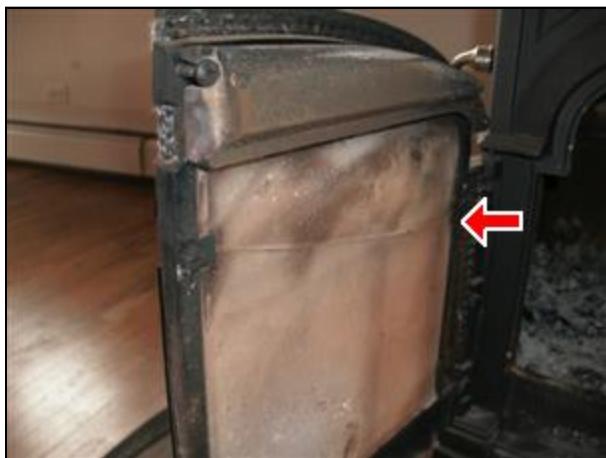
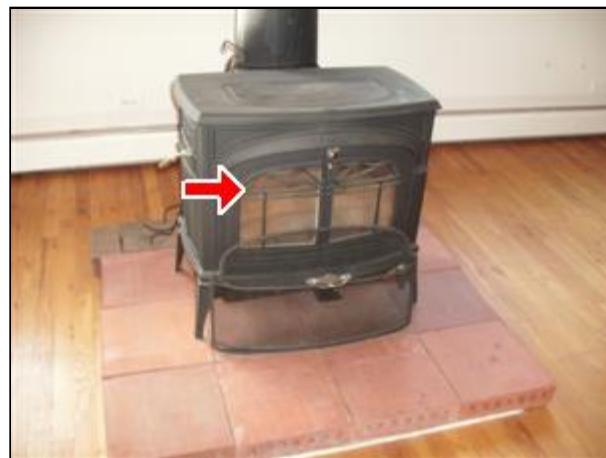
**8.7 (1)** The glass doors for the wood stove in the Living room has broken glass . I recommend repair as needed.

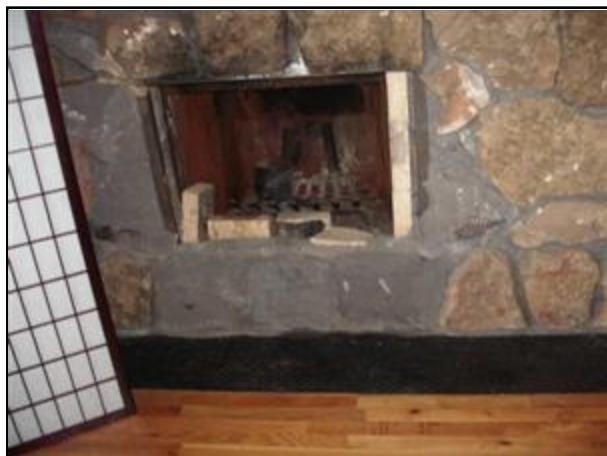
**(2)** The fire box (Burn Area) for the the fireplace at the Living room is rusted. It appears water is infiltration from the chimney because there are no caps on the flues. A qualified chimney sweep such as Tom Quinlan 303-946-6535 should inspect and repair as needed.

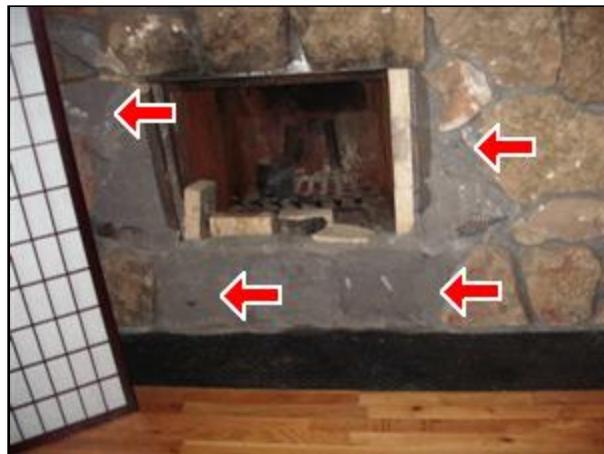
8.7 Picture 5

(3) Some of the stones are missing from the fireplace.

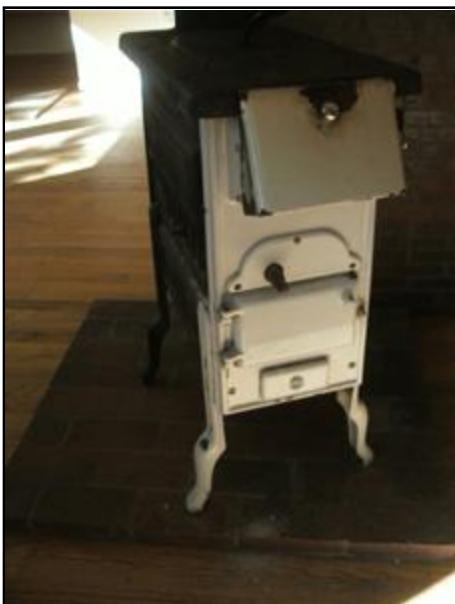
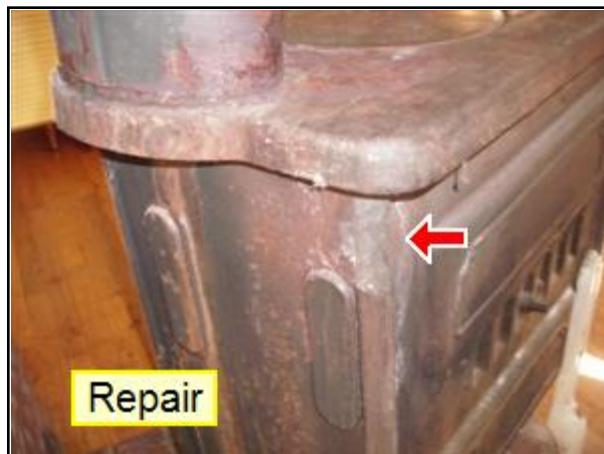
(4) The old wood stove may not be safe to operate. It is recommended to have a professional repair or replace the wood burning stove.

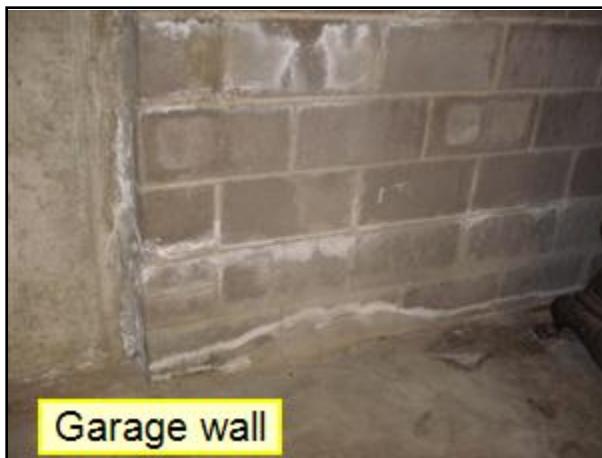
9.0 Picture 1

**9.0** White efflorescence (powder substance) on wall indicates moisture is in contact with the masonry. This does not necessarily indicate that intrusion will occur. I recommend checking the gutters and the downspout drain lines for proper operation. Also, a water proofing paint could be applied to the interior side of the block if necessary. Efflorescence is found on many homes without water intrusion occurring inside the home. But, it should alert you to the possibility that future steps may be needed.

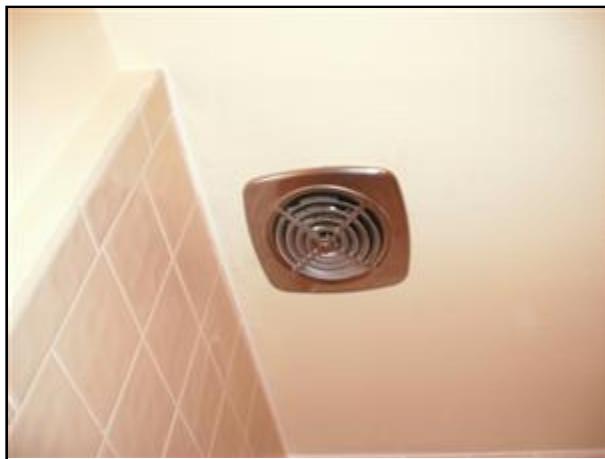
10.4 Picture 1

**10.4** The Exhaust fan did not work at the apartment bathroom . Bathrooms need a working vent fan or window to keep the moisture levels low so mold growth will be inhibited. . A qualified person should repair or replace as needed.

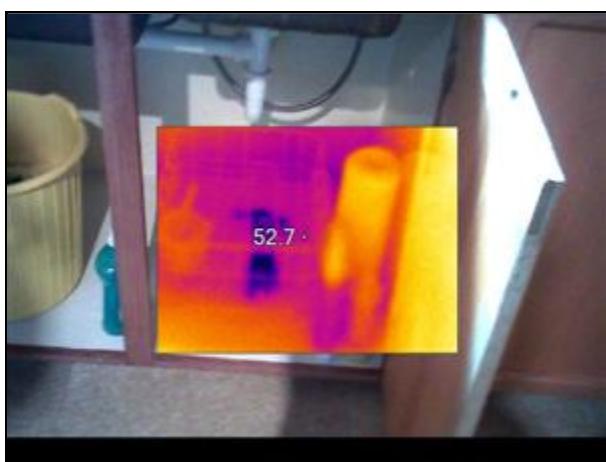
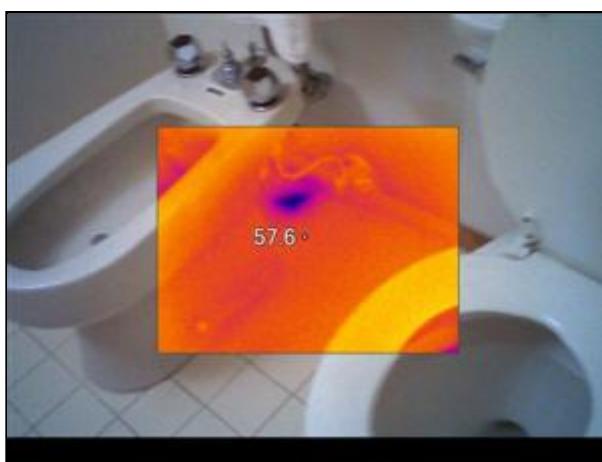
**12.1** A leak was detected under the kitchen sink and at the master bathroom toilet.

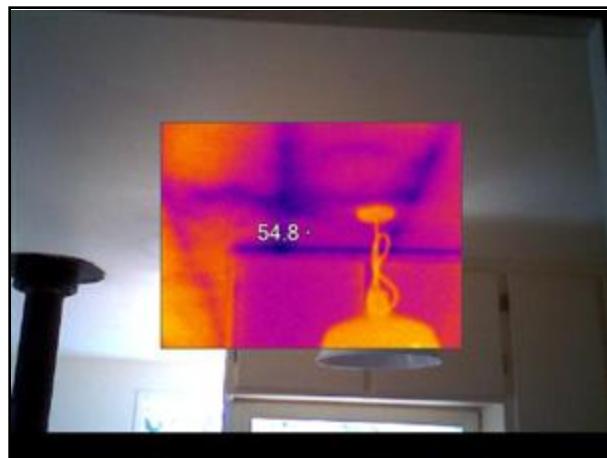
12.2 Picture 1

**12.2** The ceiling about the apartment kitchen has areas of missing insulation.

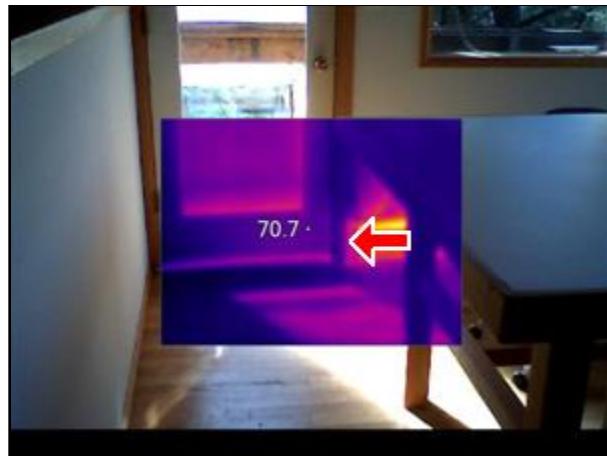
12.3 Picture 1

**12.3 (1)** The door to the upper deck is not weather tight,
