**Vehicle Research and Test Center  
2007 Ford Taurus into 2006 Ford Taurus  
7°, 70 mph, No Frame Rail Overlap  
TRC Inc. Test Number: 101116**

**Prepared By:  
Transportation Research Center Inc.  
10820 State Route 347  
East Liberty, OH 43319**

**Final Report  
November 2010 – January 2011**

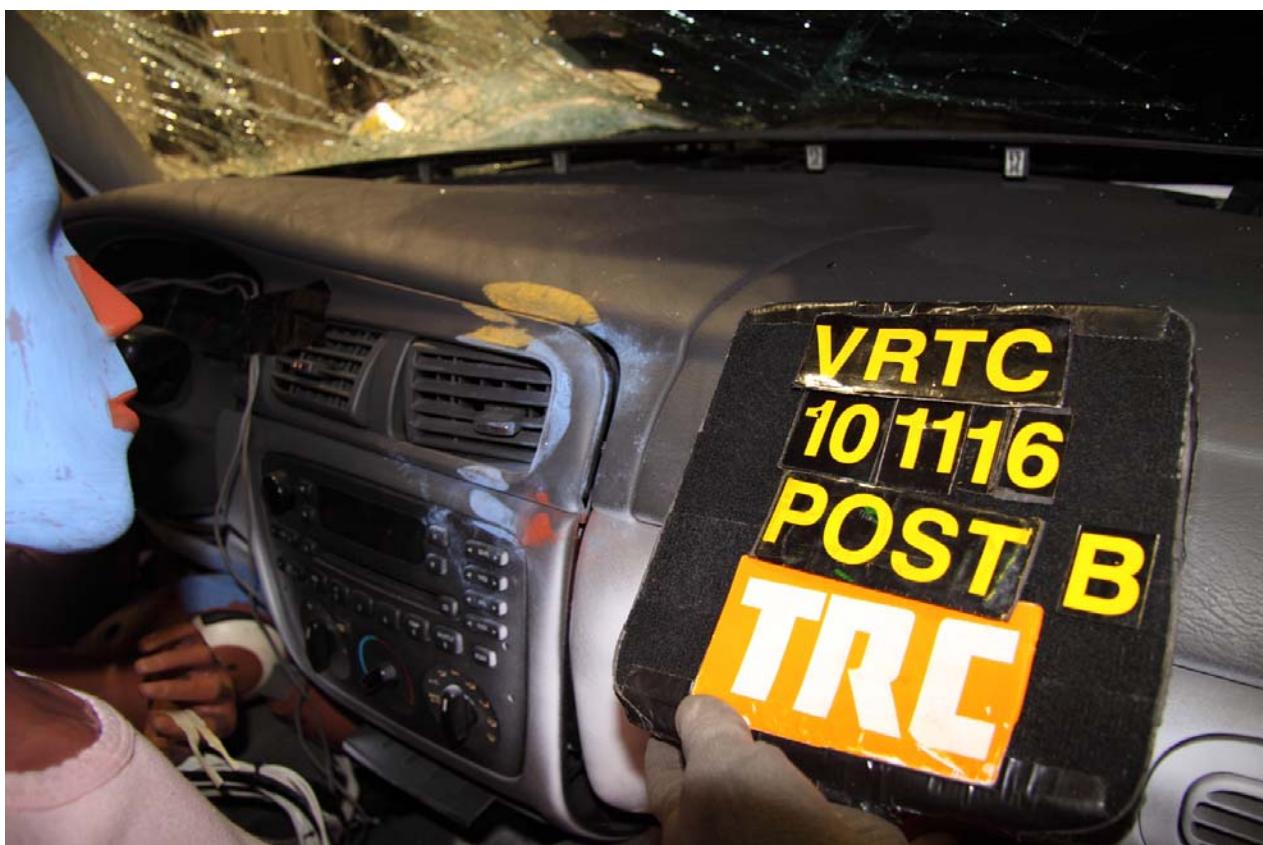
Figure A-206 Post-Test Bullet Vehicle Right Front Passenger Dummy Head Contact-View

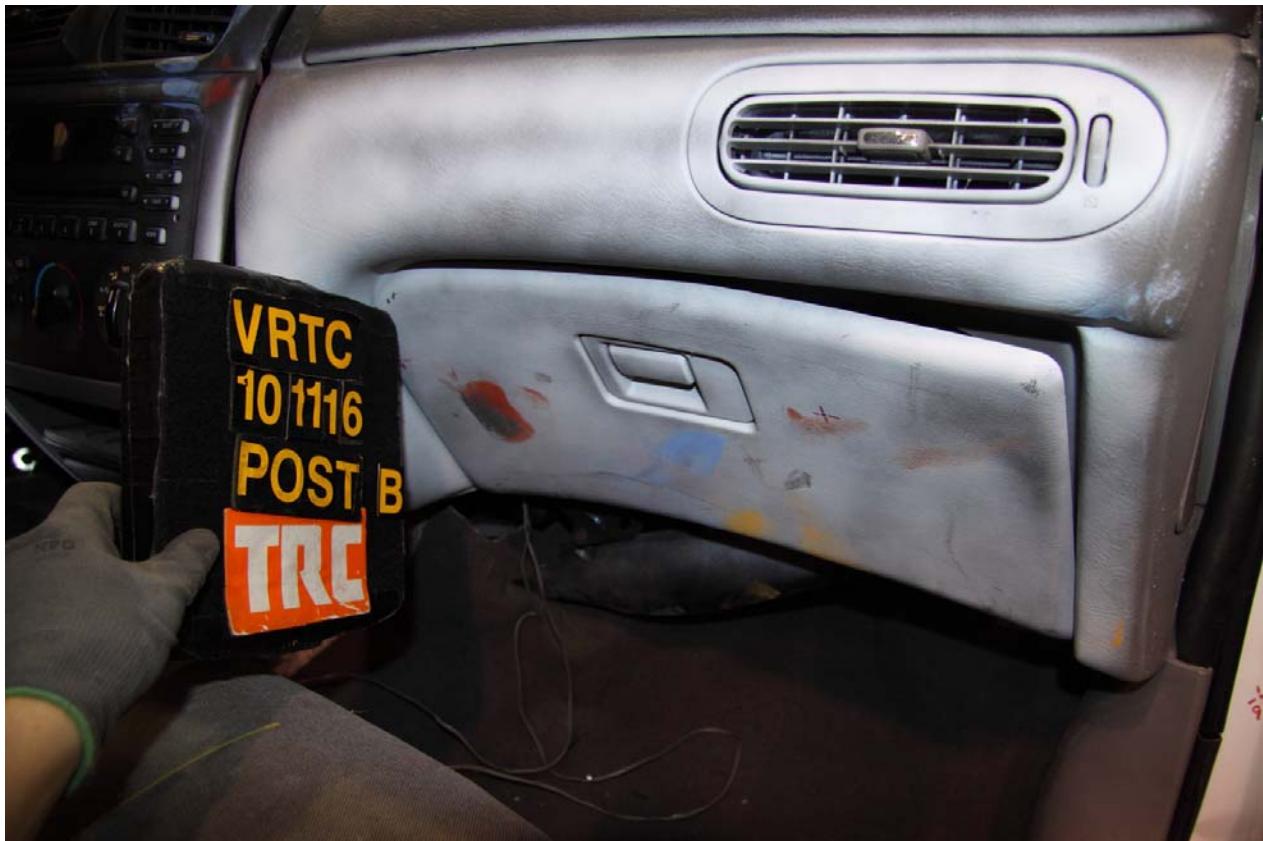
Figure A-207 Post-Test Bullet Vehicle Right Front Passenger Dummy Knee Contact-View 1

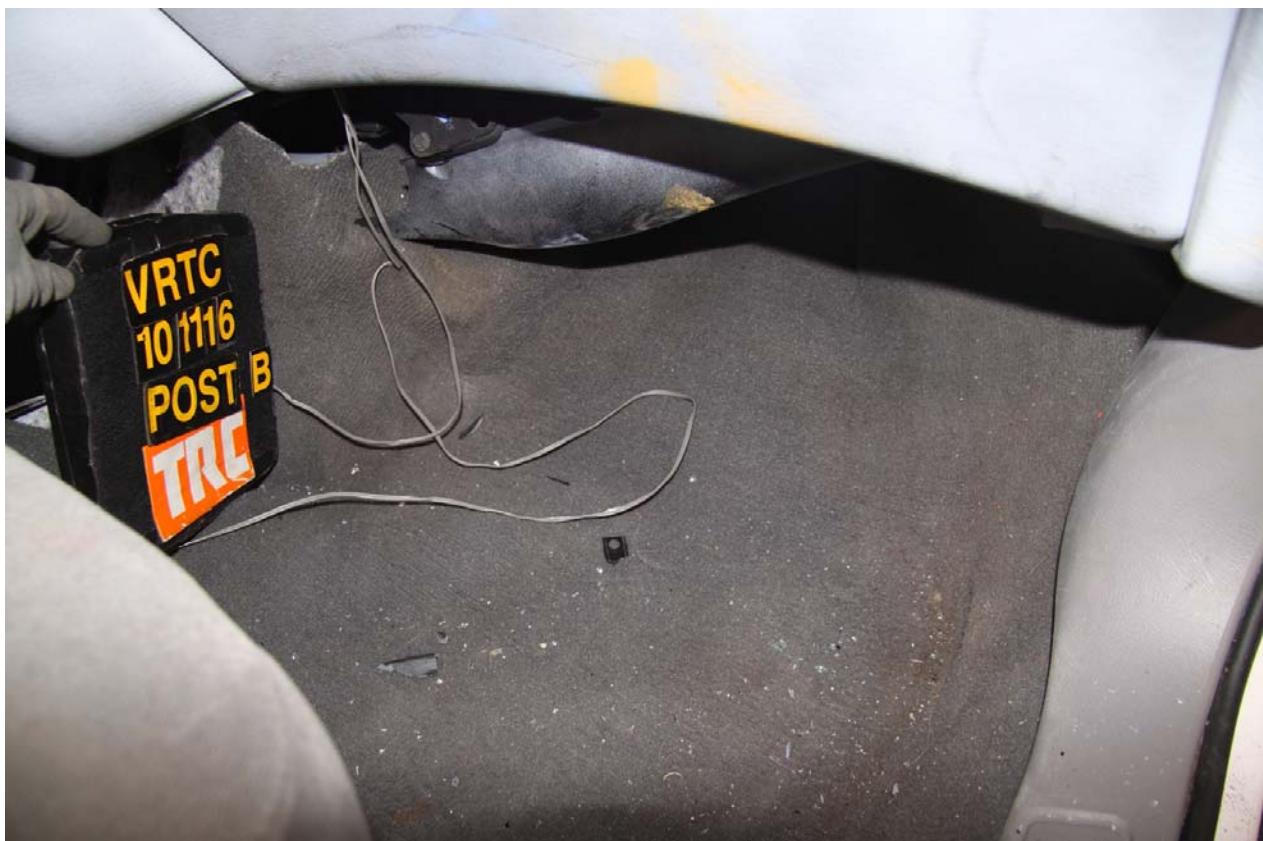
Figure A-208 Post-Test Bullet Vehicle Right Front Passenger Dummy Knee Contact-View 2

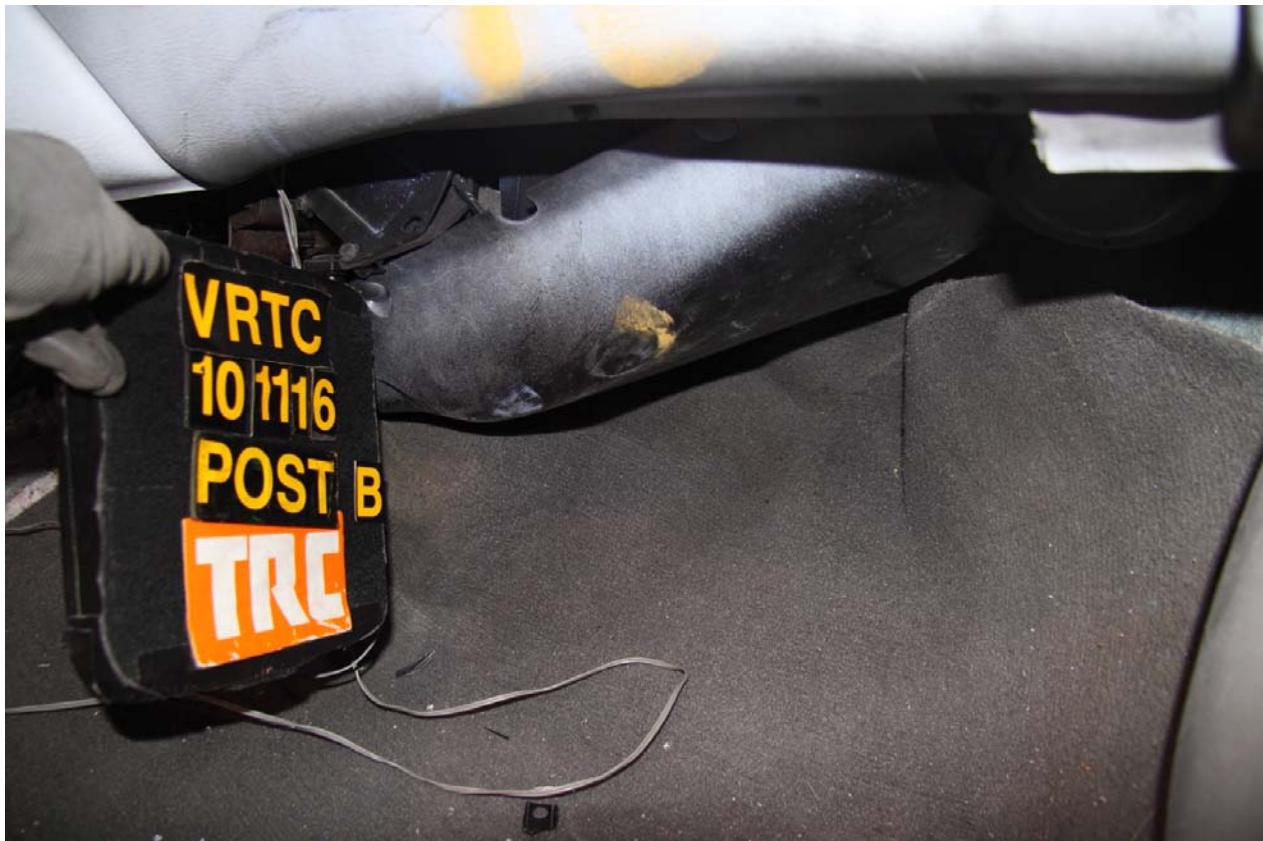
Figure A-209 Post-Test Bullet Vehicle Right Front Passenger Dummy Foot Contact View

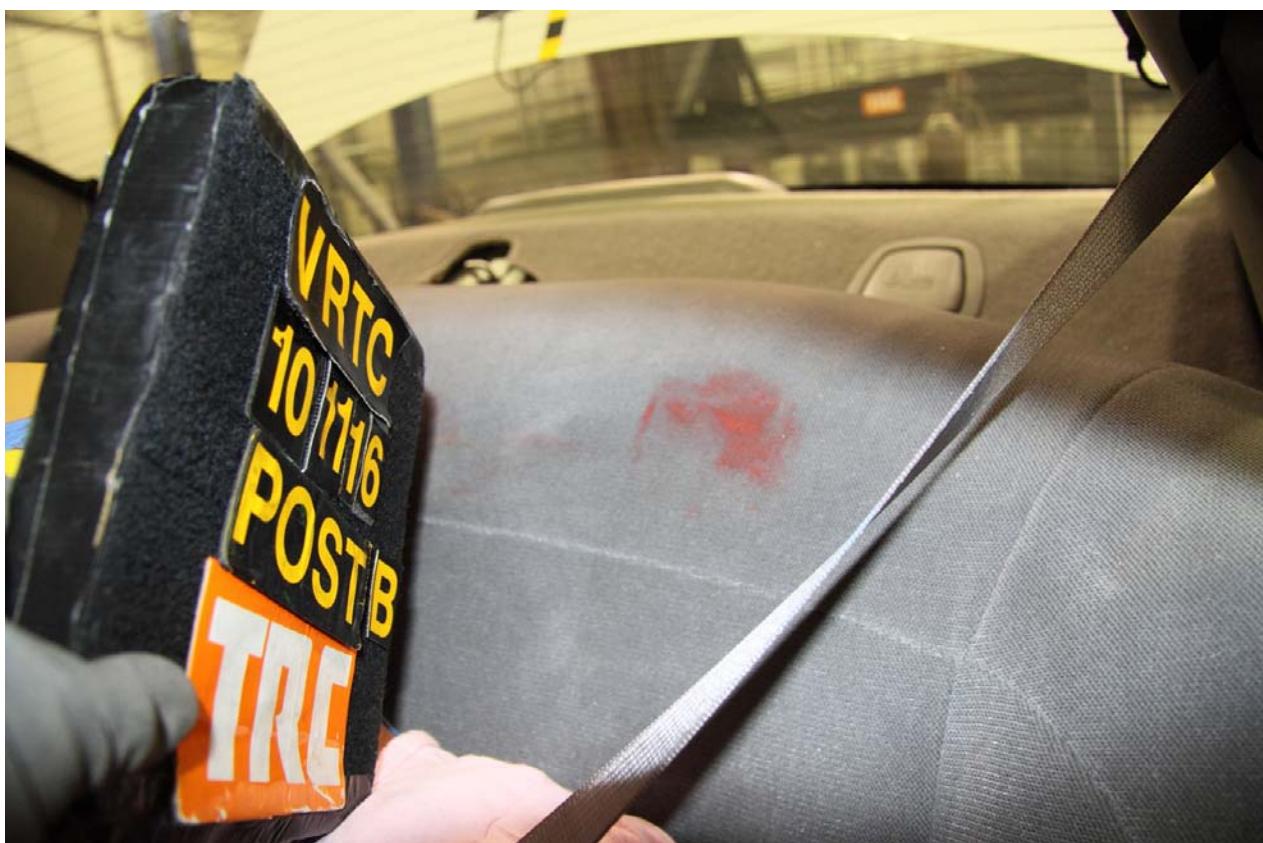
Figure A-211 Post-Test Bullet Vehicle Left Rear Passenger Dummy Head Contact – View 1

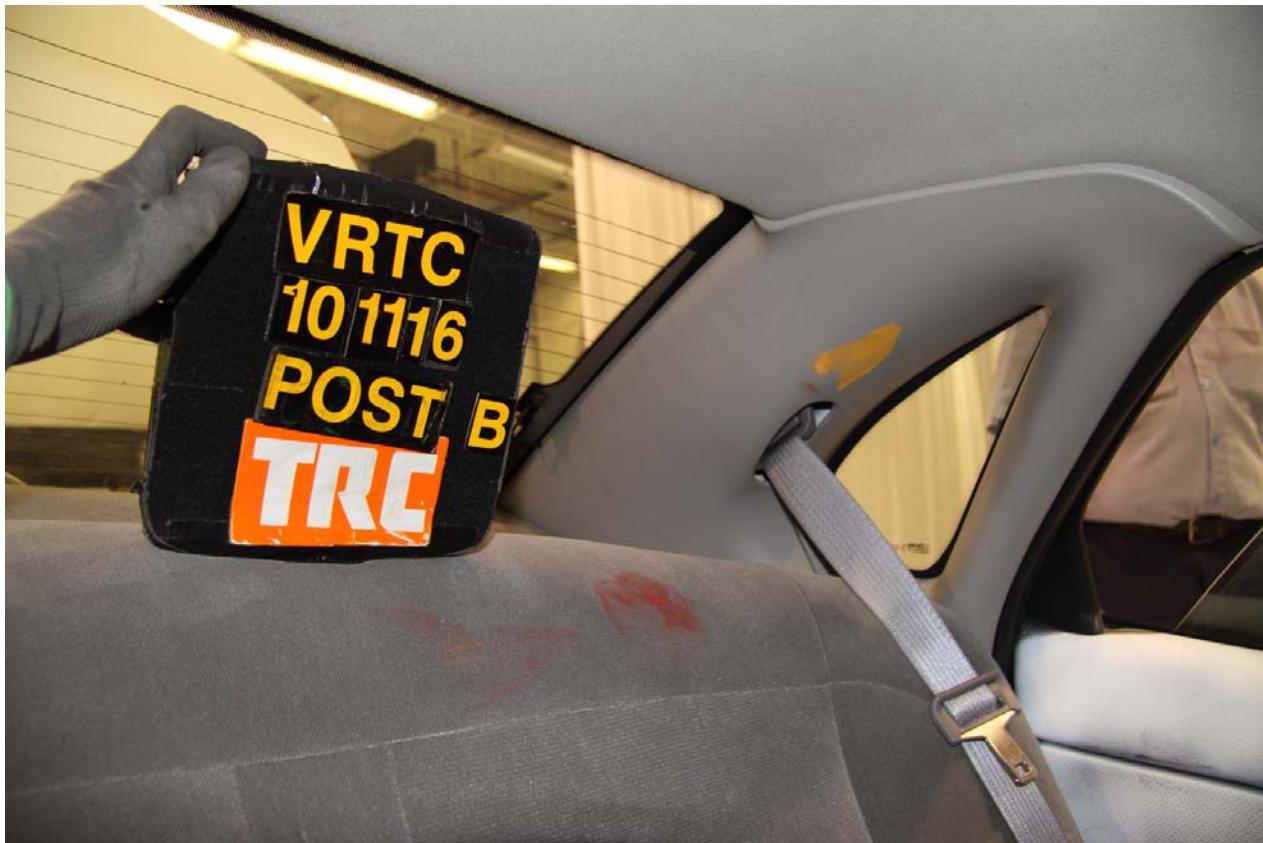
Figure A-212 Post-Test Bullet Vehicle Left Rear Passenger Dummy Head Contact – View 2

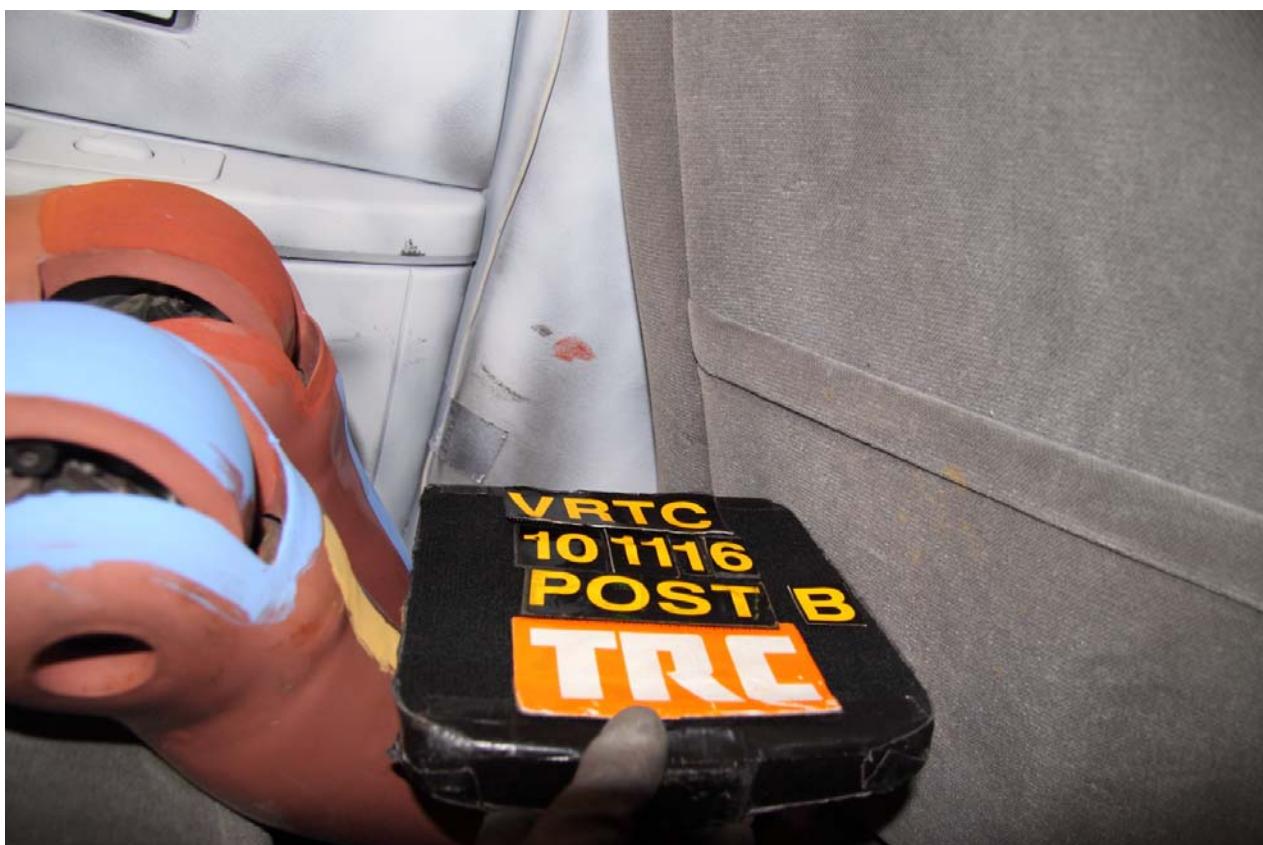
Figure A-213 Post-Test Bullet Vehicle Left Rear Passenger Dummy Knee Contact View

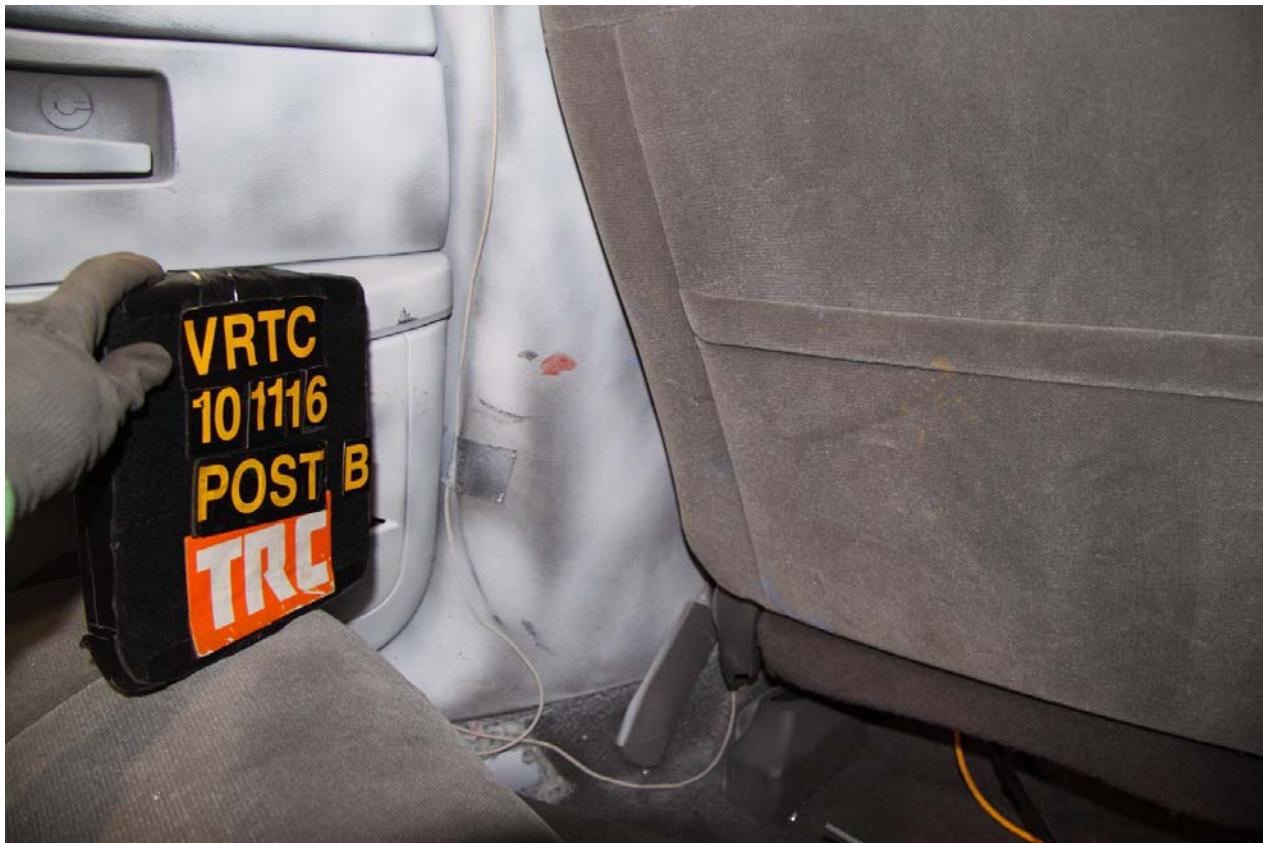
**Figure A-214 Post-Test Bullet Vehicle Left Rear Passenger Dummy Foot Contact View**

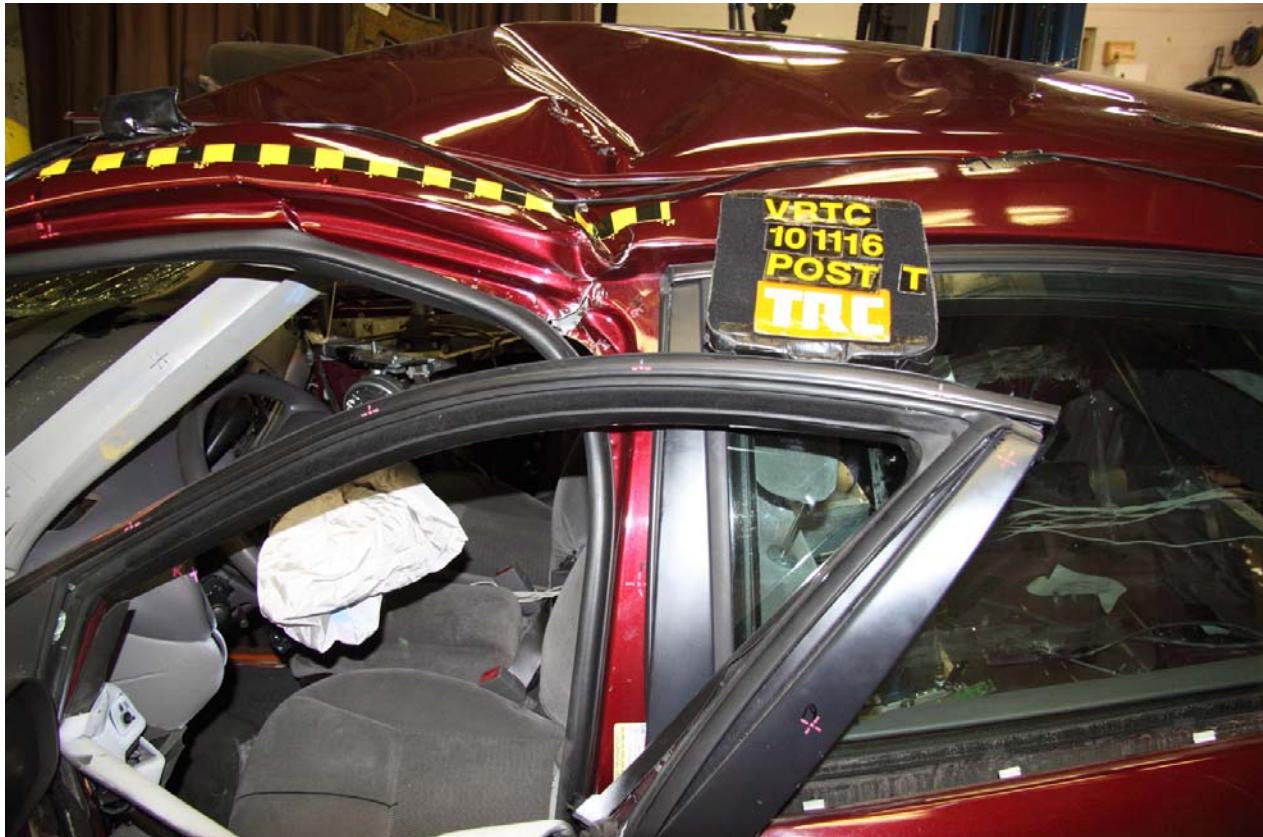
Figure A-221 Post-Test Target Vehicle Damage – View 1
