On Point Locating, Inc.

Sample Job Report

On Point personnel worked to locate buried utilities surrounding the indicated lot on Lincoln Ave. Utilities were located and marked out to evaluate suitability of the proposed borehole locations on site. Utilities on N 1st St. were established to be in the street, not in conflict, clearing the N 1st St. sidewalk proposed borehole locations. Proposed locations along the northwest edge of the lot are also a safe distance from any buried utilities. Proposed borehole locations along the N 2nd St. sidewalk will need to be reconsidered in accordance with the following findings, also pictured on the *Job Site Sketch* (II). Active gas, water, and sewer lines were established to be located in N 2nd St. Active electric and communications lines were established to be located in N 2nd St., as well as beneath the adjacent sidewalk. The electric run in the sidewalk is likely to be multiple conduits buried in a common trench. Also located under the N 2nd St. sidewalk is an unknown anomaly. **The unknown anomaly was marked in blue on site, but this does not necessarily represent a water line.** The anomaly was detected consistently along the indicated l

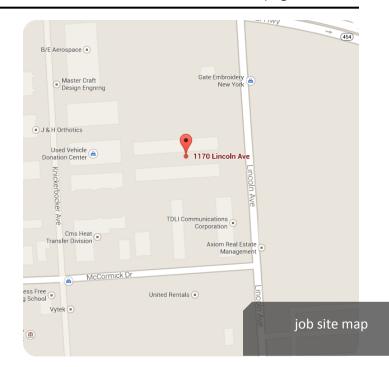
street view
