Radiation Light Field QA

Department: South Bay Radiation Oncology

Machine Name:SB-LA-1Data Acquired: 1/19/2022Vendor:VarianData Analyzed: 1/20/2022

Model: Truebeam Serial #: Status: Pass

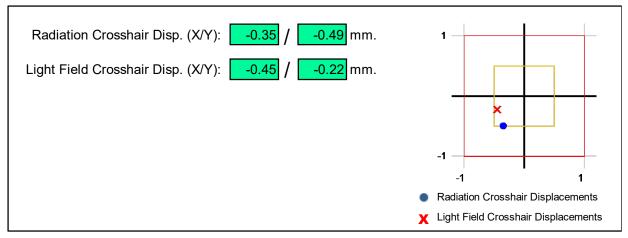
Crosshair Displacements

Radiation Light Field Displacements

Light Field Rotation: 0.20 deg.
