Imager Quality Analysis

Department: South Bay Radiation Oncology

Machine Name:SB-LA-1Data Acquired:1/20/2022Vendor:VarianData Analyzed:1/21/2022

Model: Truebeam Serial #: --

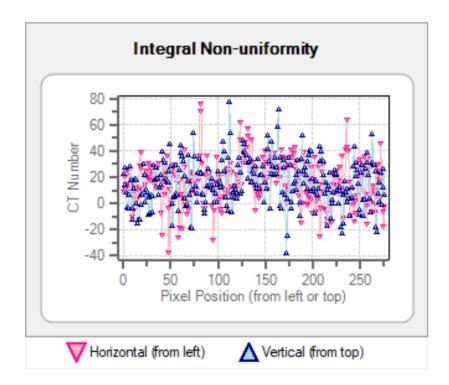
Uniformity and Noise

ROI	CT # Uniformity	Image Noise
1	27.298	32.359
2	15.032	28.064
3	14.020	29.786
4	16.117	28.039
5	14.407	27.215

Integral non-uniformity		
Vertical Horizonta		
2.949	2.897

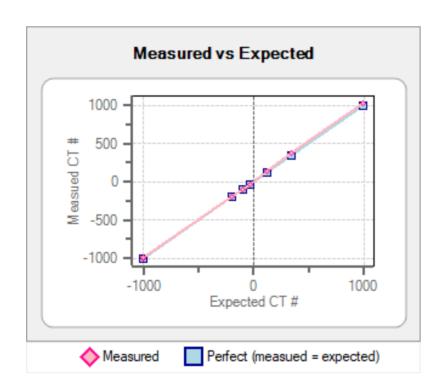
HU Constancy

ID	Material	Measured (HU)	Expected (HU)
1	Air	-996.526	-1000.000
2	PMP	-191.092	-200.000
3	LDPE	-99.500	-100.000
4	Polystyrene	-36.082	-35.000
5	Air	-998.041	-1000.000
6	Acrylic	129.786	120.000
7	Delrin	377.281	340.000
8	Teflon	1019.811	990.000

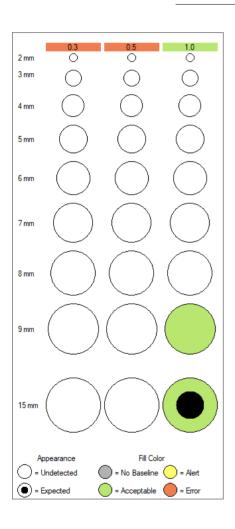
Low Contrast Detectability

Contrast Level	Lowest Detected (mm)		C x D (of Low Detected)
0.3		0.0	
0.5		0.0	
1.0	9.0	22.2	56.7
