REPUBLIC OF THE PHILIPPINES DEPARTMENT OF ENVIRONMENT AND NATURAL RESOURCES ENVIRONMENTAL MANAGEMENT BUREAU

INVESTIGATION REPORT ON POLLUTION COMPLAINT

: RVM Enterprises

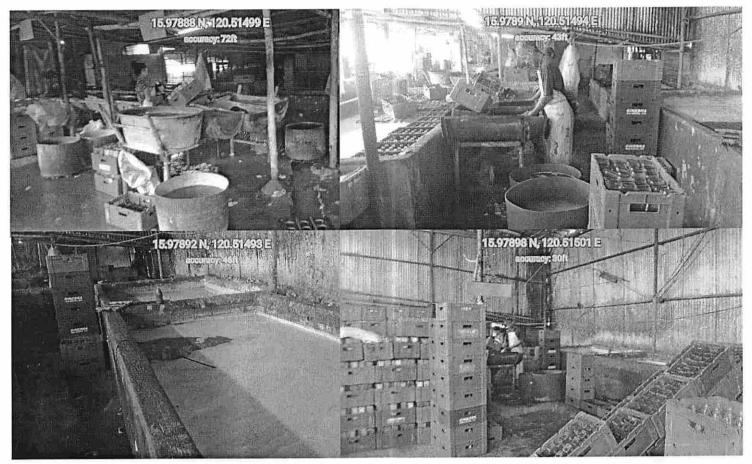
1.1 The establishment is operating during investigation and is engaged in washing and cleaning of consumed liquor bottles of Ginebra and La Tondena.

1.3 The process of the operation includes soaking of the empty bottles in the water and removing of bottle stickers with the use dish washing agents.

PHOTOS SHOWING THE BOTTLE WASHING AND CLEANING OPERATION OF RVM ENTERPRISES.

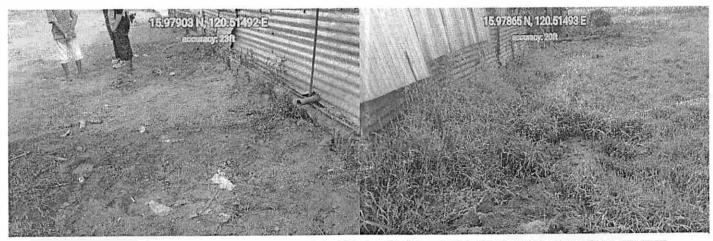
1.5 Although, the process facility provides septic tanks, domestic wastewater such as kitchen and bath wastewater, from the workers quarter were discharge directly to the adjacent property of the complainant thru the protruding pvc pipes.

2.1 It was found that wastewater from the workers quarter is directly discharge the adjacent property of the complainant. Although, the adjacent property has no development yet, a small wastewater lagoon was already created due of the discharges by the workers.

PHOTOS SHOWING THE PROTRUDING PIPE AND LAGOON IN THE ADJACENT PROPERY OF THE COMPLAINANT DUE OF WASTEWATER DISCHARGES FROM THE WORKER'S QUARTER.

1. During investigation, the owner was advised to direct their workers to remove all the protruding pipes and divert their wastewater discharges from the septic tanks provided. The owner, immediately instructed his workers to act on it.

1. The respondent to divert the domestic wastewaters (kitchen and bath wastewater) from the workers quarter to the septic tanks provided.
