# Failure of Stainless Steel Welds Due to Microstructural Damage Prevented by In Situ Metallography

**Key-words:** In situ metallography; Microstructure; Heat affected zone; Austenitic stainless steel; Welding.

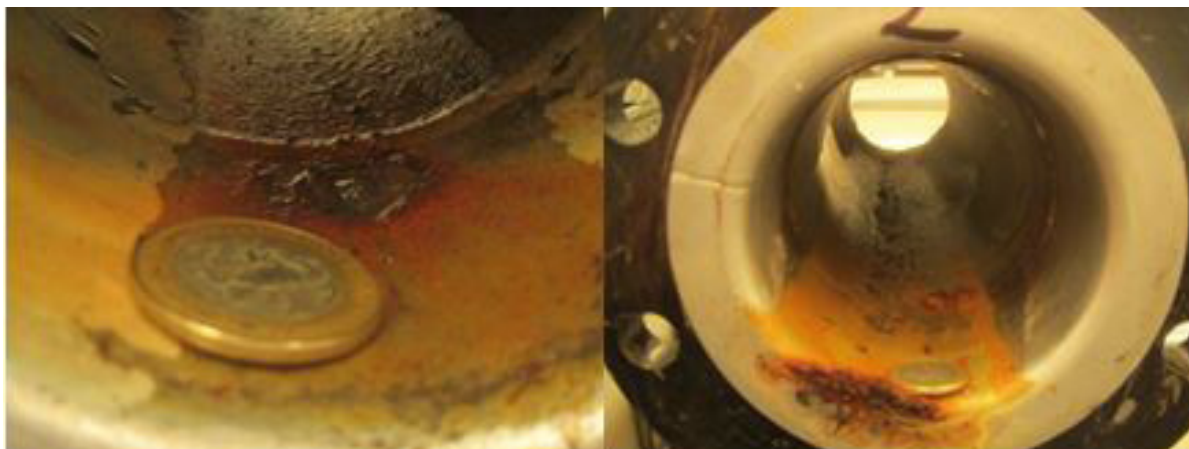
In order to make clear the necessity of monitoring the state of the microstructure in stainless steel weldments, especially in the HAZ; the following case is shown because it illustrates the need for in situ metallography stainless steel welded joints. With this case it is demonstrated that this type of failure can happen after the welding process. In this case, chiller tubes made of AISI 304 austenitic stainless steel were welded and after it they were tested with the pressure test using common tap water. After a few days, those tubes showed leakages in areas adjacent to the weld. In the inner surface of the tubes was evidence of reddish corrosion products as seen in the Figure 1.

**Figure 1.** Damaged tubes of chiller under analysis. It is seen evidence of reddish corrosion products.
