## Microstructural Analysis of the Steels from Buildings 7, & 1 or 2 from the World Trade Center

R. R. Biederman,\* Erin M. Sullivan,\* R. D. Sisson, Jr.,\* and George F. Vander Voort\*\*

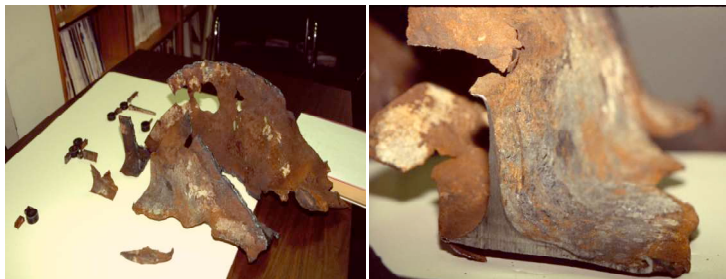
Several samples from Buildings 7, and 1 or 2 of the World Trade Center were collected during the FEMA forensic investigation shortly after September 11, 2001. Macroscopically these samples revealed severe “erosion” of the steel beam thickness from 1/2 inch to total metal loss in some regions, as well as localized plastic deformation. We were asked to determine the cause of this “erosion” as well the temperature that the steel experienced. Figure 1 shows typical examples of the severe erosion that occurred in the beam.

FIG. 1. Severely Eroded 1/2 inch wide flange beam from WTC 7.
