Project: GMS

Unit : 4

# Installation and Commissioning Quality Control Record

## Unit G4 Preliminary Report

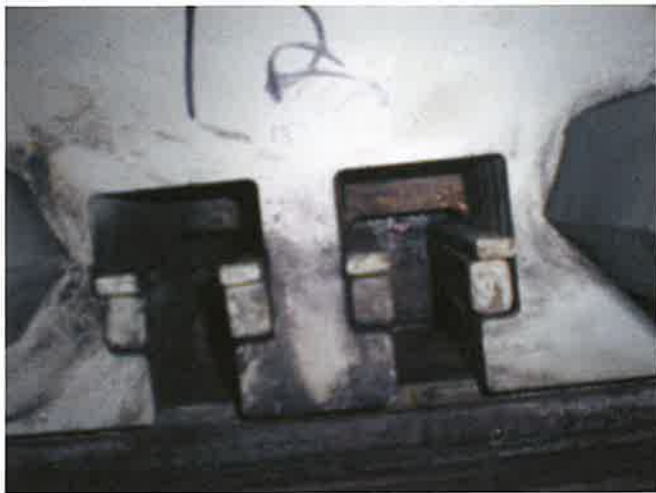
No grease could be observed from the bottom of the rotor pole keys

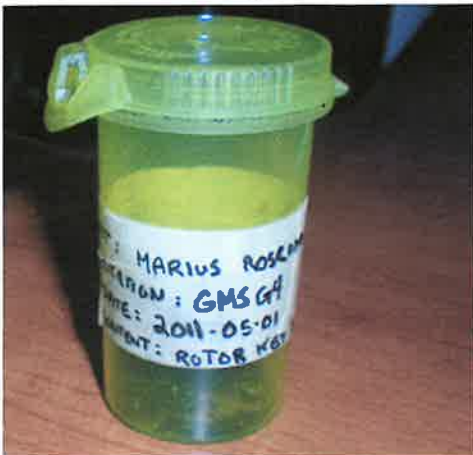
As a result, dust power was collected using a knife and scraping the surface of the keys

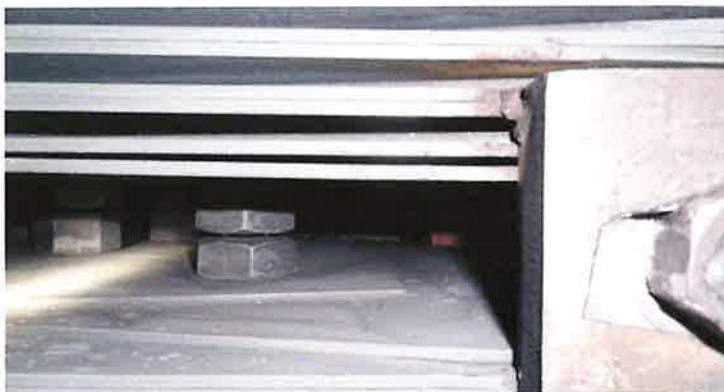
On metal particle was found between two rim plates in pocket #20, at the bottom of the top section. It must have been there since the assembly because it is about 150mm deep into the rim and the bottom plate bent because of it.

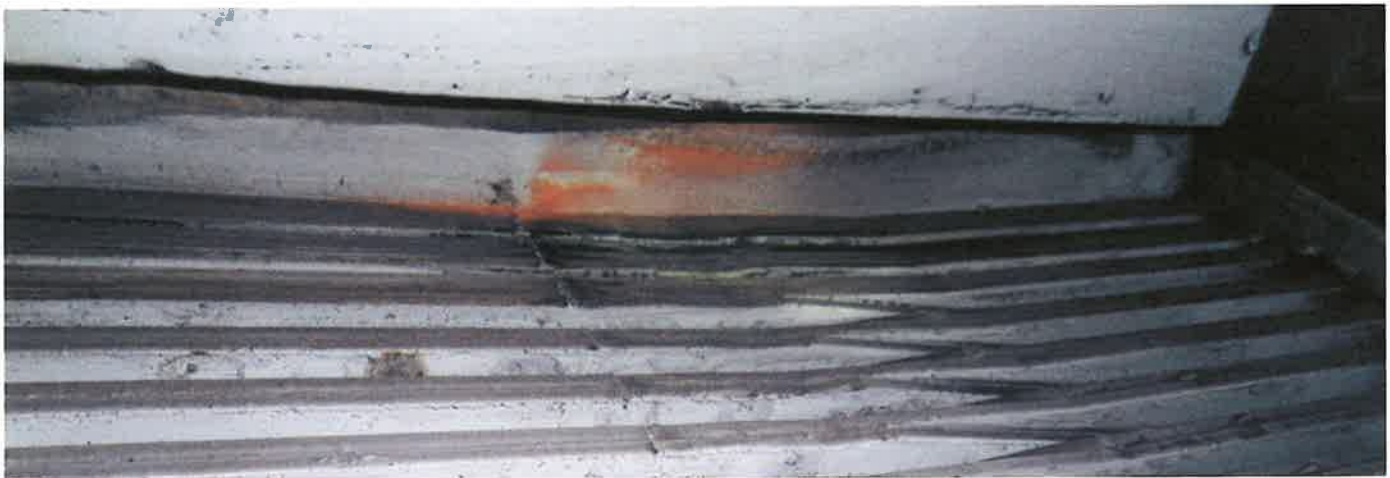
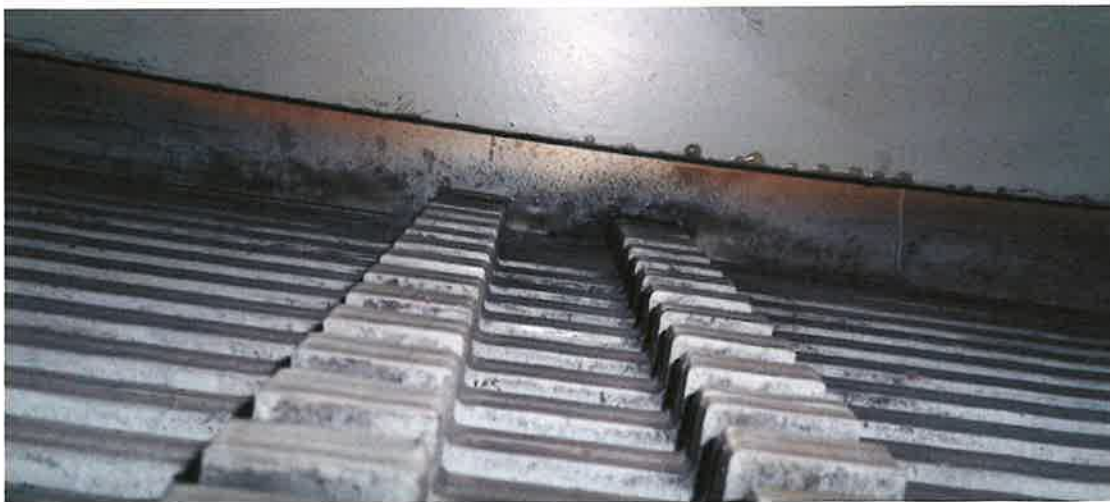
Some fretting ares were found in the rotor.

In all the pockets, the fretting can be found next to the rim, on the very top, where it meets with the rotor spider top plate.

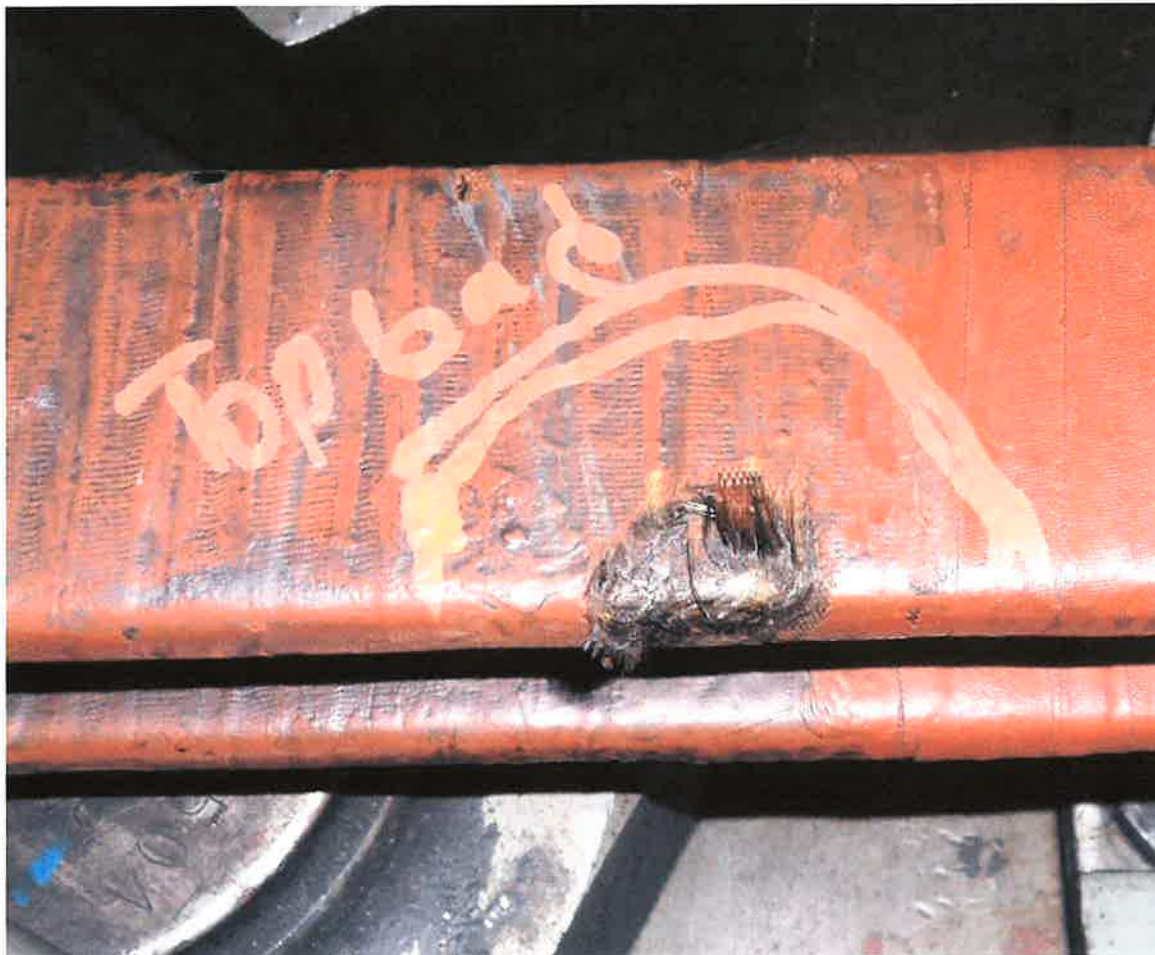
A burned area was found on one of the rotor leads that goes from the pole to the collector.

It is located on the horizontal section, on the rotor floor, inside the rotor central hub.

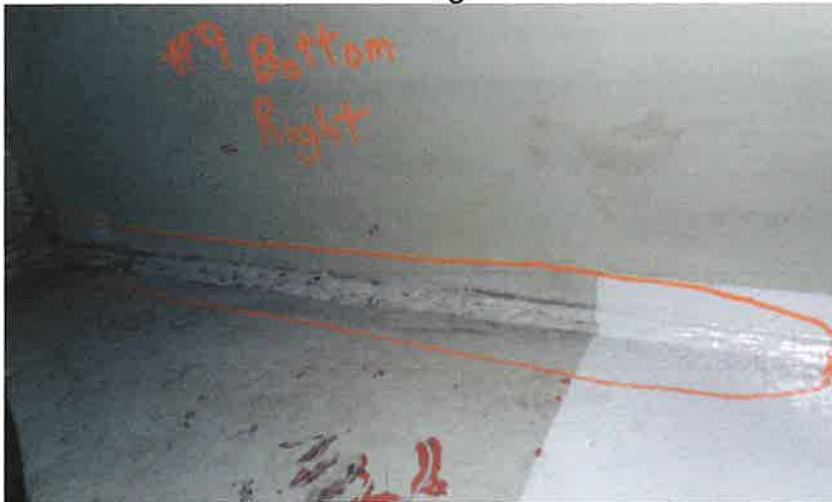
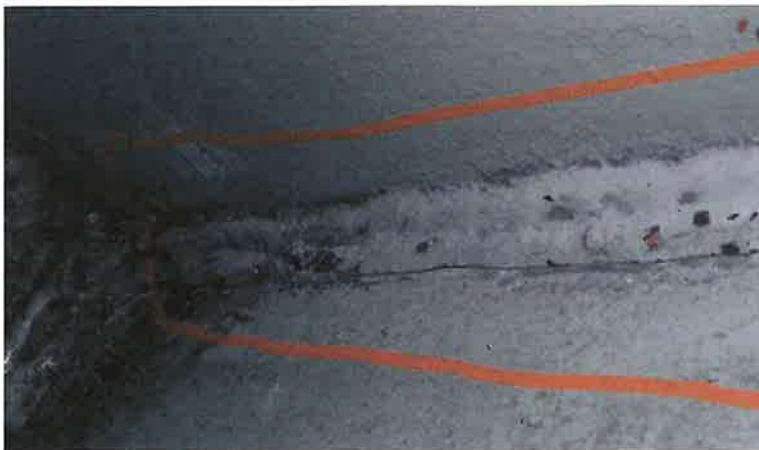
1 - In rotor pocket #9, at the bottom right corner, between the plate and the spider arm.

This crack is about 300mm long.

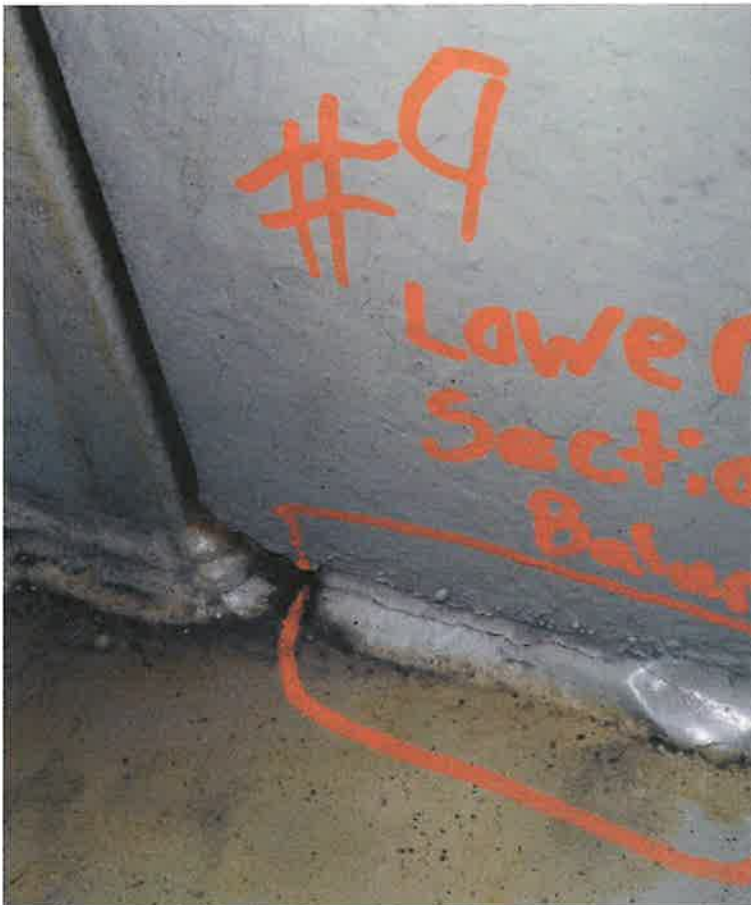
2 - In rotor pocket #9, at the bottom right corner, between the rotor floor and a balance weight  
This crack is about 100mm long.

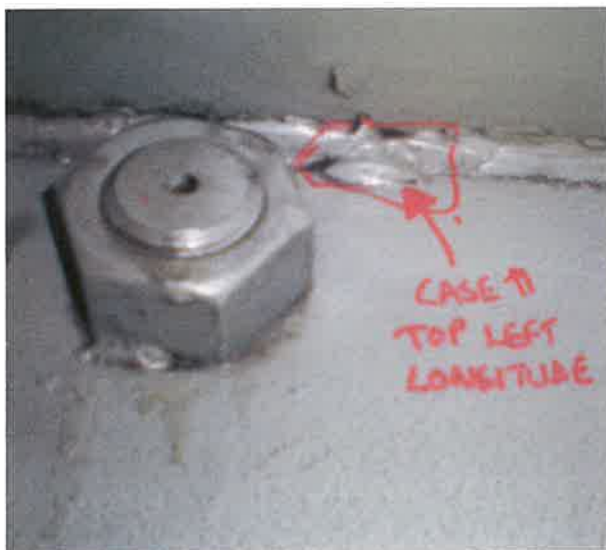
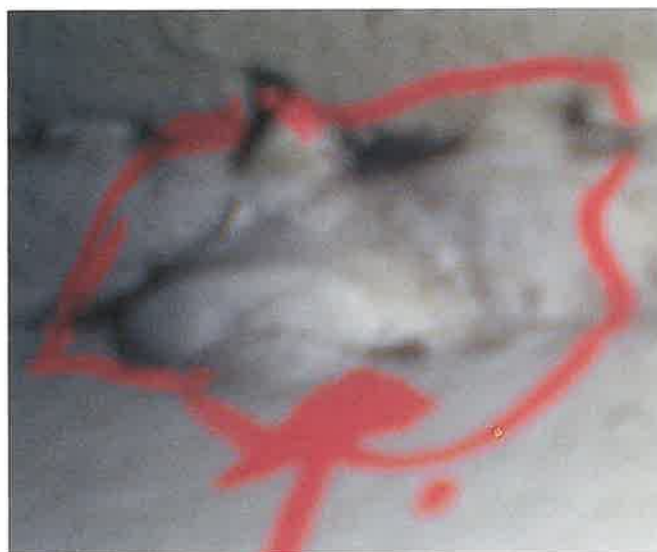
3 - In rotor pocket #11, at the top, left hand side, approximately to the middle, there appears to be a crack of approximately 1/2" long.

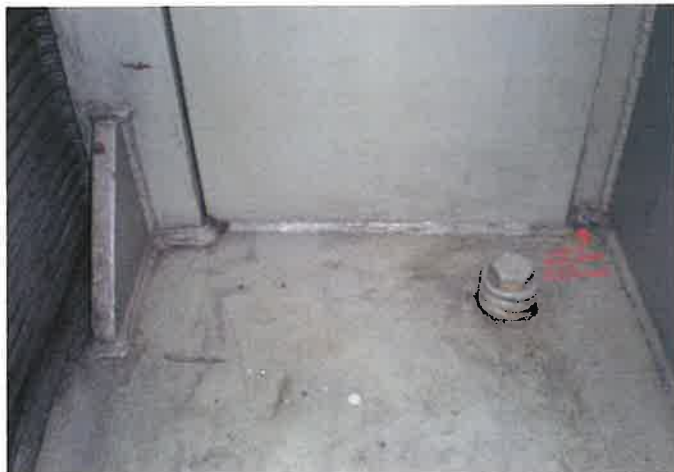
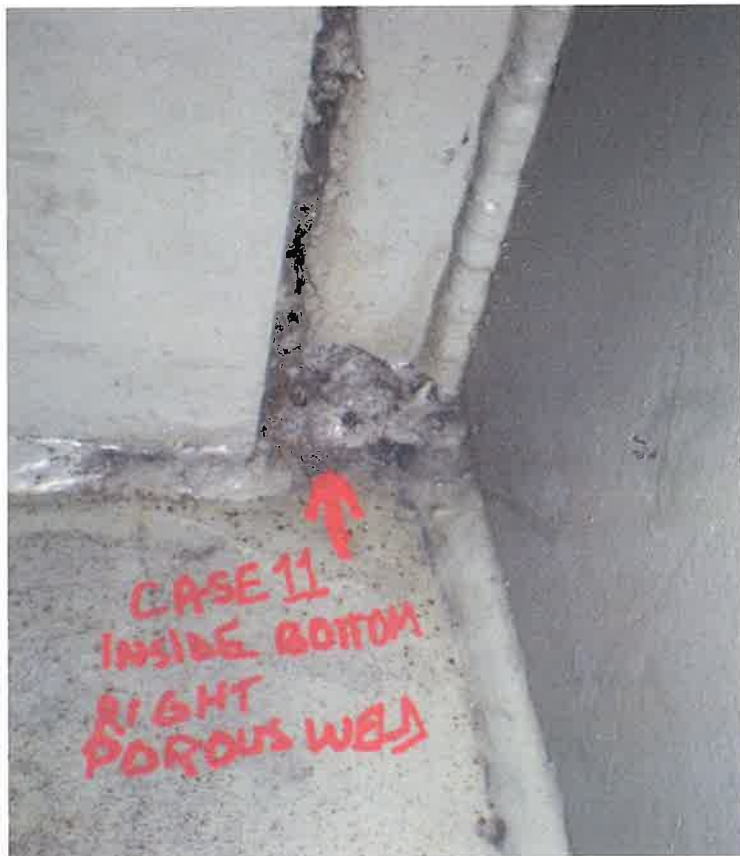
4 - In rotor pocket #11, at the bottom right corner on right hand side, there is presence considerable porosities into the weld.

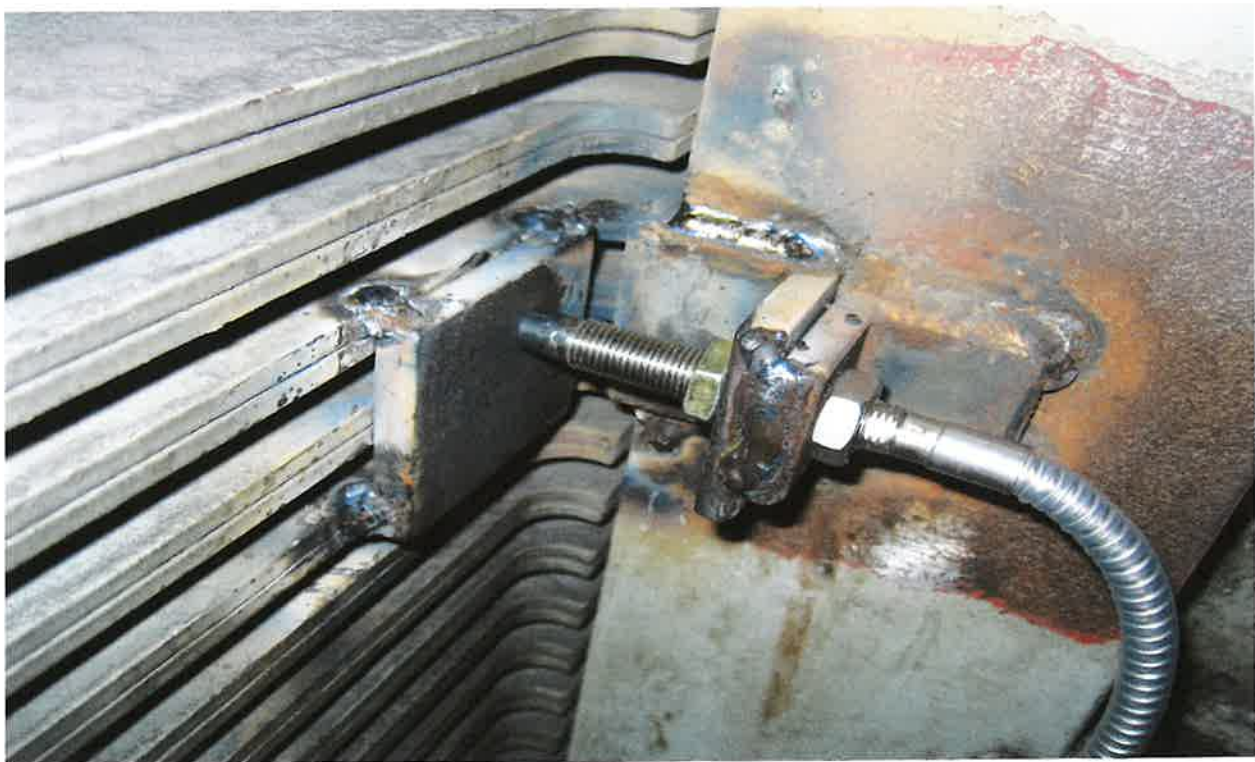
**Fig. 1.0**

**Sensor Mounting** – Brackets were already in place from a previous test by BCH in 2006, they were strengthened by welding an additional piece of angle on the inner side. A steel target was also welded to the rim for a target see Fig. 1.0. The Bently Nevada 3300 sensors are calibrated from the factory using 4140 stainless steel targets but I have found that a carbon steel target will meet the calibration requirements for this application.

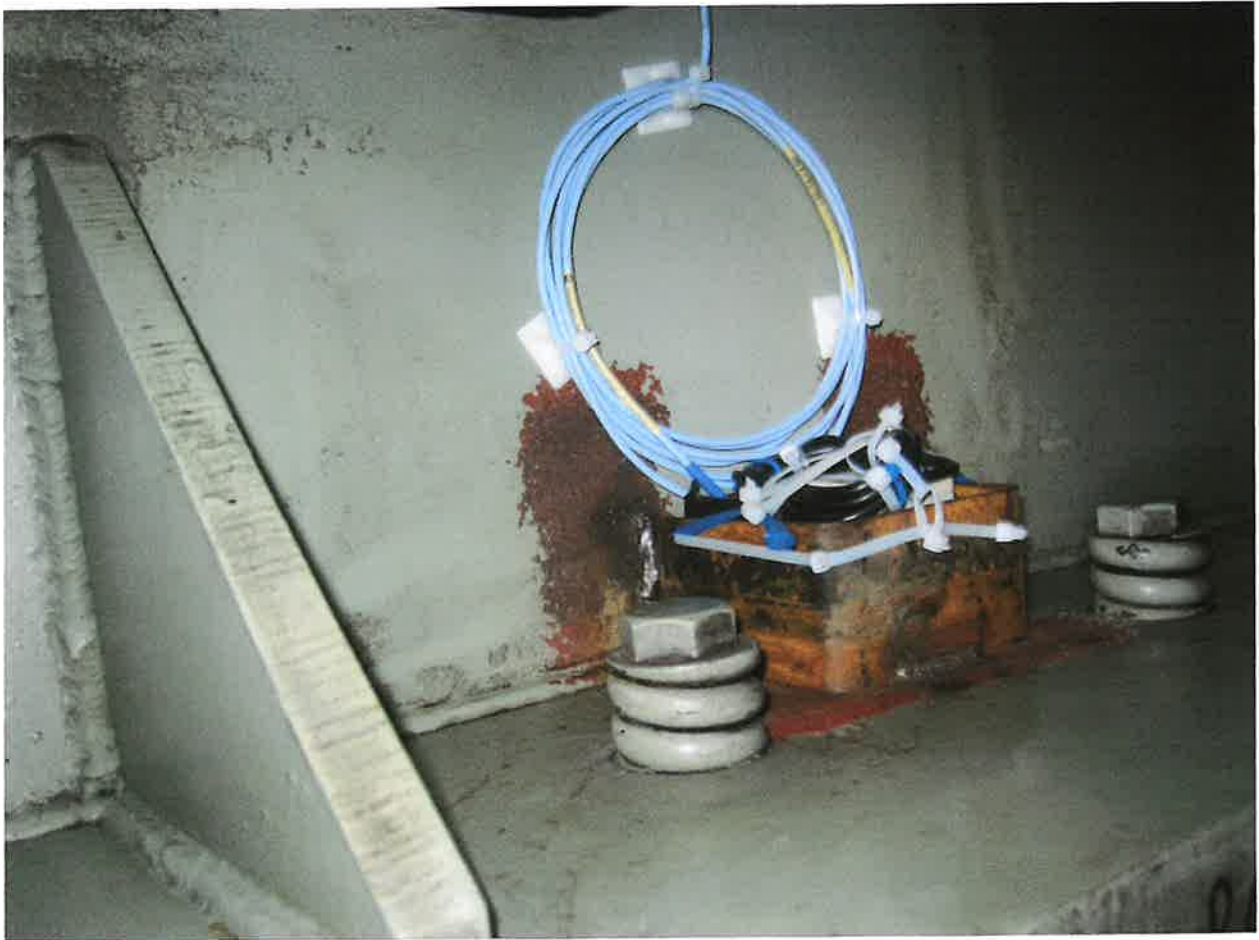
Fig. 2.0

The driver for the 3300 proximity sensor was mounted in metal bracket above the brake track see Fig. 2.0. Each measurement point required one proximity sensor and driver along with a custom made power supply and one data logger. The battery pack and data logger were also mounted inside this bracket. All metal brackets were left in place for future use.
