# INSPECTION AND TEST PLAN

Document #: I-GMS - 6301 Rotor flange machining  
 Revision: 00  
 Unit #:  
 Codes: WC: Welding (Customer)  
 WC: Witness point (Customer)  
 MA: Hold point (Andritz Technical Support)  
 MA: Witness point (Andritz Technical Support)

Installation  
**INSPECTION AND TEST PLAN**  
Rotor flange machining  
Project: GMS Poles Unit 1-4

ITP step #: 6301-1  
Project: GMS - rotor flange machining

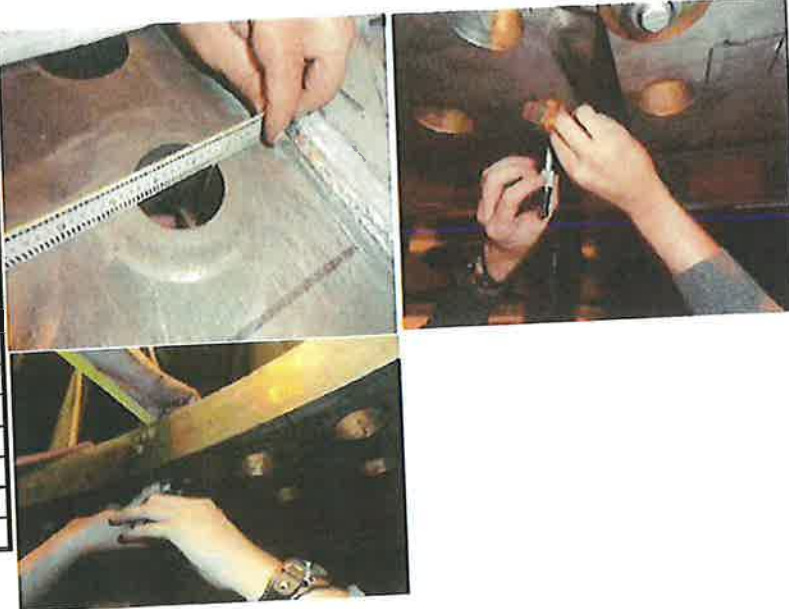
Equipment: Thickness of rotor coupling flange before machining

Avg 3.466 3.480  
Max 3.470 3.489  
Min 3.461 3.475

Note: \* Measurement are taken in coupling holes using a straight edge and dept mic.
