NOTE TO FILE: NDE ON ROTOR AT DISASSEMBLY, TOGETHER WITH ANDRITZ ENGINEERING EVALUATION, DETERMINED THE NEED TO STRUCTURALLY MODIFY THE ROTOR (SEE BELOW).

## Installation INSPECTION AND TEST PLAN

**Document #:** I-GMS - 6300      **Revision :** 03  
**Project:** GMS Poles Unit 1-4      **Unit #:** 4

**RE: Inspection of G-4 Cross Braces and Spider Assembly Welds - WAC Bennett Dam**

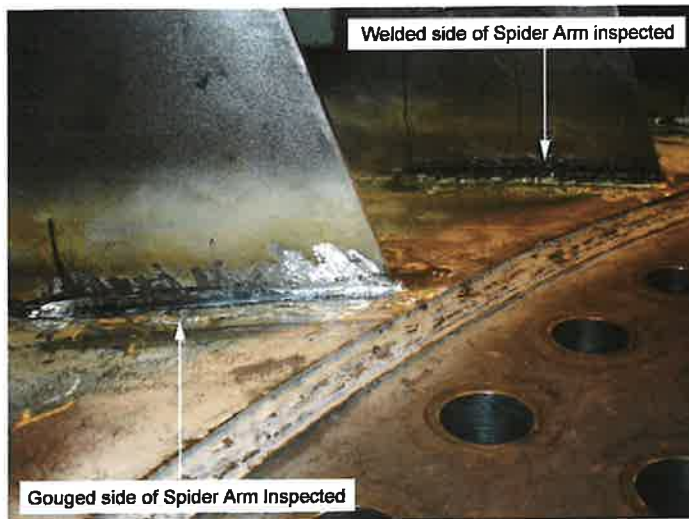
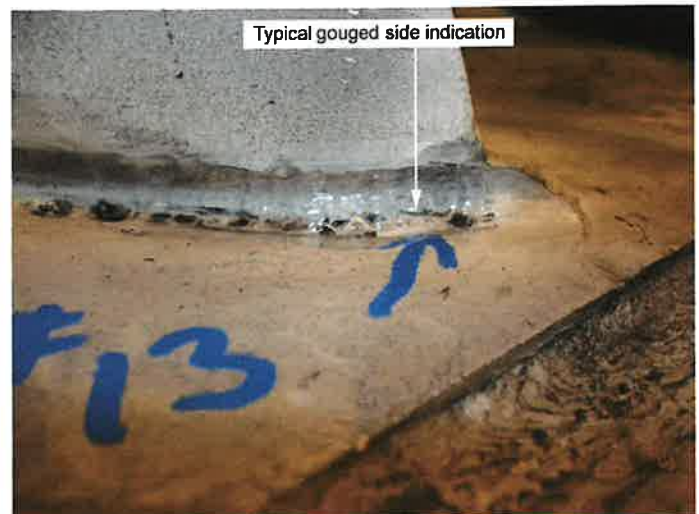
Eight crack like indications were identified during the course of the inspection. These areas were demonstrated to onsite Andritz staff for rework and consisted of indications in four areas on various Spider Arms in the gouged side and four other areas on the welded side of four other Spider Arms. All indications were removed by grinding and retested to ensure complete removal. No other indications were noted at this time.

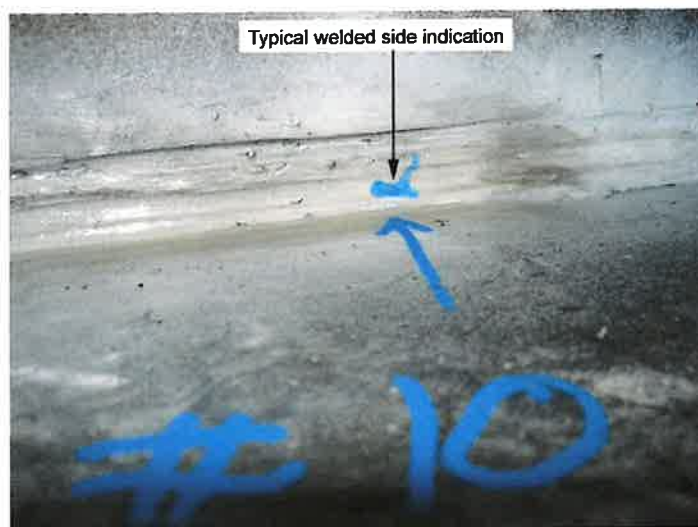
Eight crack like indications were identified during the course of the inspection. These areas were demonstrated to onsite Andritz staff for rework and consisted of indications in four areas on various Spider Arms in the gouged side and four other areas on the welded side of four other Spider Arms. All indications were removed by grinding and retested to ensure complete removal. No other indications were noted at this time.

Comments : 4 areas on the backgouge side and 4 areas on the welded sides  
revealed indications. All indications were removed by grinding and  
retested to ensure complete removal. No other indications were noted

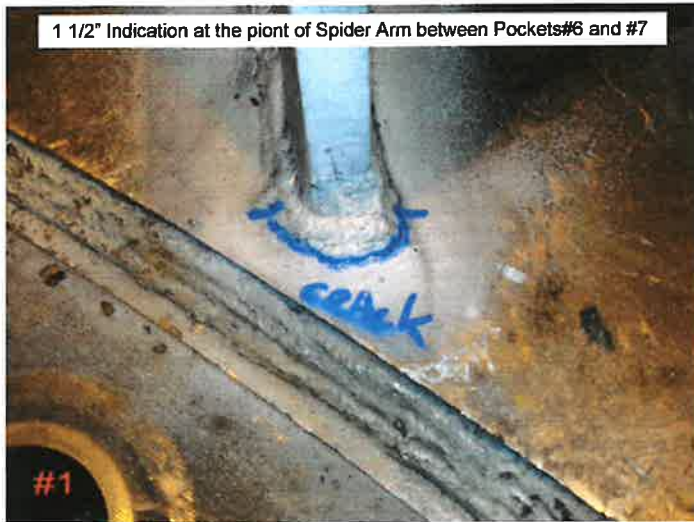
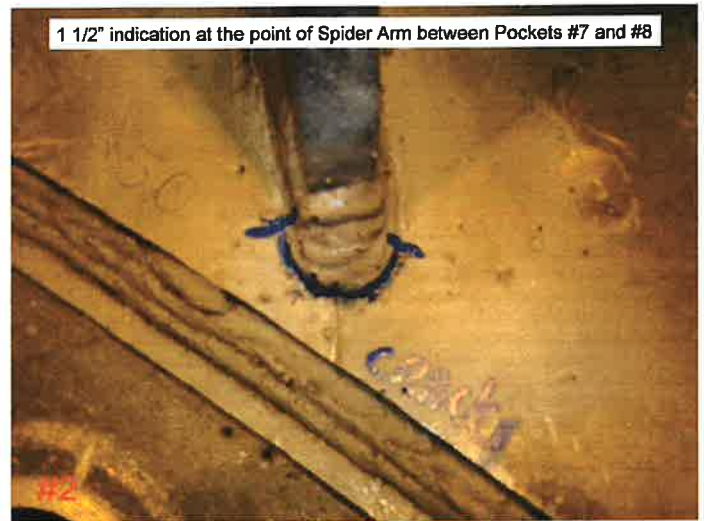
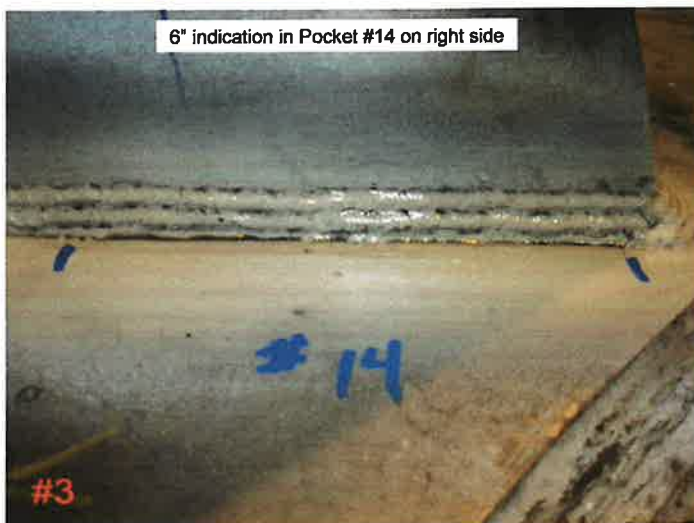
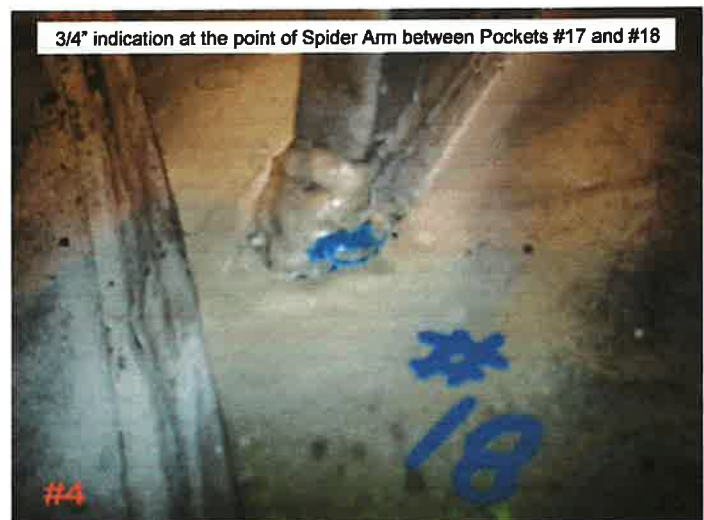
Four crack like indications were identified during the course of the inspection. These areas were demonstrated to onsite Andritz staff for rework and consisted of two indications which were removed by grinding only and the other two indications required grinding and re-welding. All indications were retested to ensure complete removal. No other indications were noted at this time.
