# Installation and Commissioning Quality Control Record

## Welding visual inspection

Q-0400-011

Project: GMS

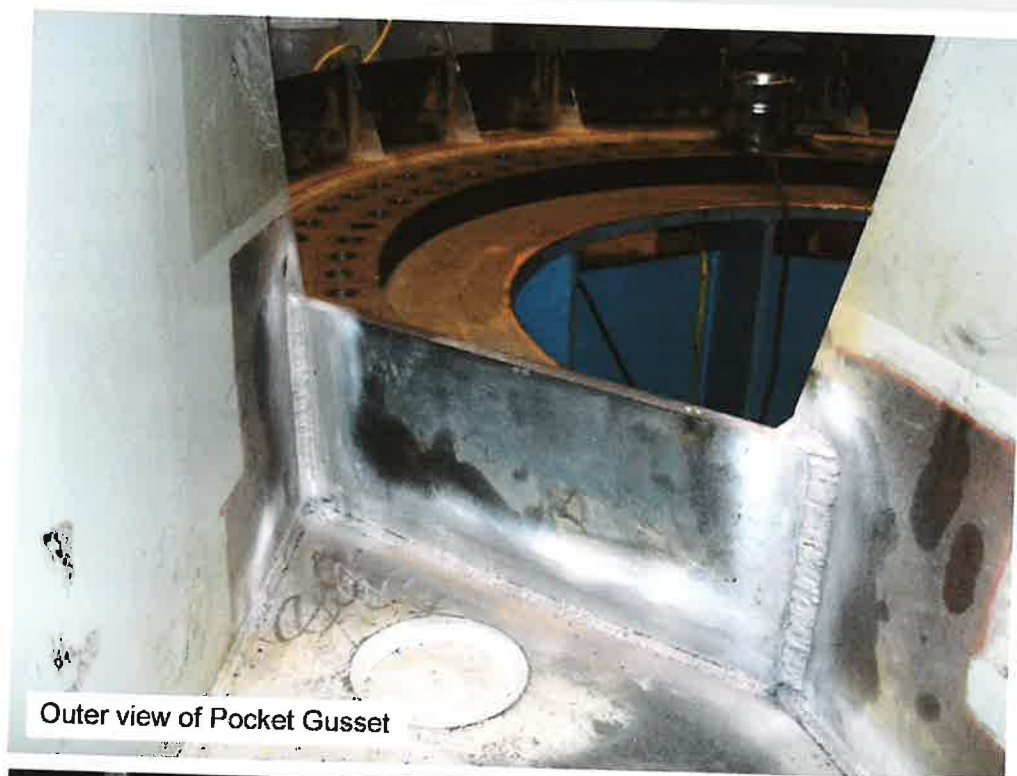
Outer view of Pocket Gusset

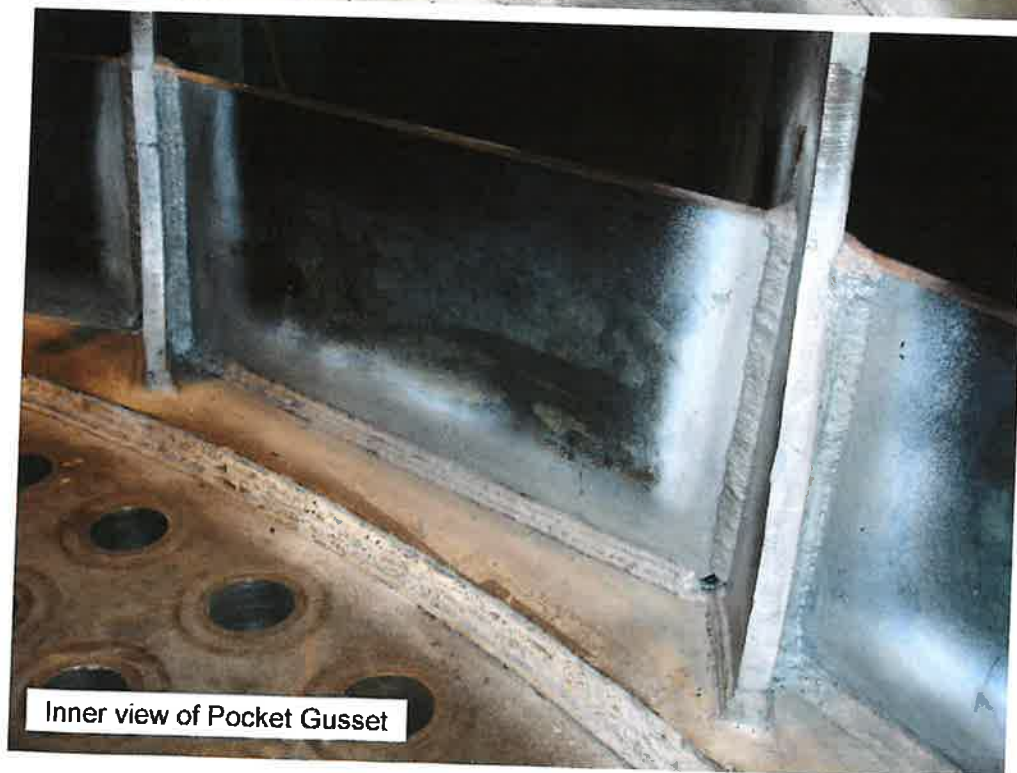
Inner view of Pocket Gusset
