Spyder Tonneau Latch Release Motor Replacement

Dan Craft

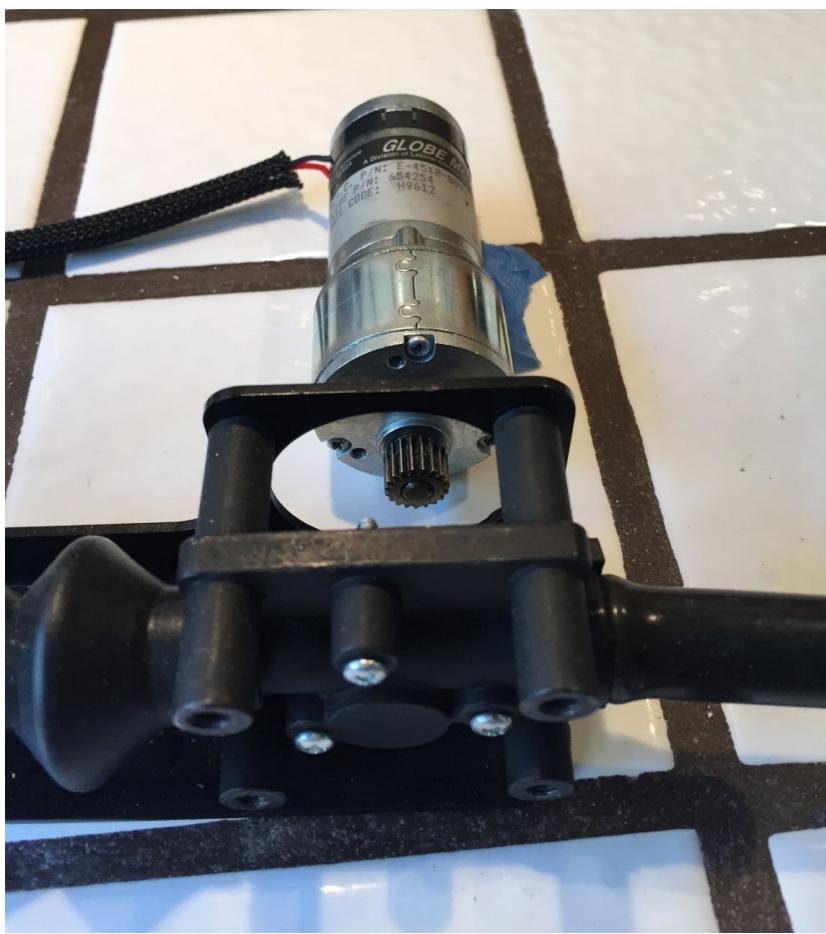
STEP: Remove The Motor from the Bracket

Note: Globe's part number is 65A254, not the listed 654254. (That must have been an A.S.C. transcription error.)

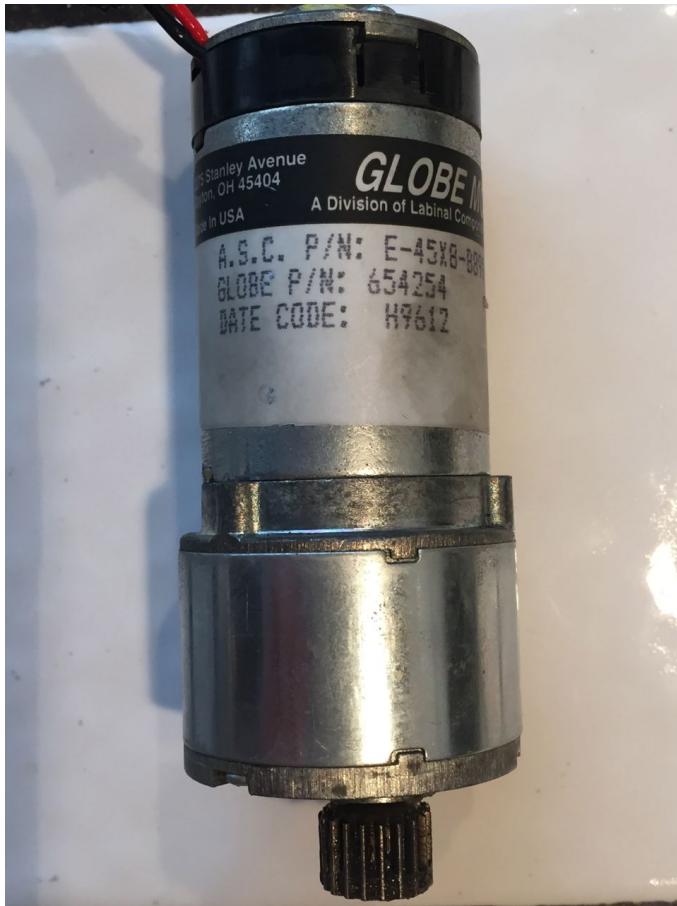
Original Problem: It turned out my problem started when the tonneau latch bracket became loose. It has space for adjustment in its mounting holes, so the mounting bolts must be tight to keep the bracket still. The mounting bolts had loosened enough for the bracket to have play in the adjustment holes, so the latch release cable was just moving the bracket, not the latch. Finally, when trying to close the convertible top, the tonneau wouldn't release and I heard a "thunk, thunk, thunk"—that didn't sound good. It had stripped three teeth of one of the gears in the tonneau release motor gearbox (top gear in photo below).

I opened the gearbox to verify it was the suspected stripped gear teeth that was the problem.

STEP: Have the Motor Repaired

She email'd me a repair cost of \$98, including shipping, when they'd examined the motor. I had to pre-pay with a check.
