Initial Incident/Accident Report

Fill the Information Below							
Company: Rezayat Company Limited					Date: 01-04-2021		
Location: Auditorium (Part 1)					Time: 04:00 PM		
Project/ Site Name: Catering Auditorium & Recreation Facilities : 097-C76R							
Person(s) Involved:	✓	Employee		Contractor		Others

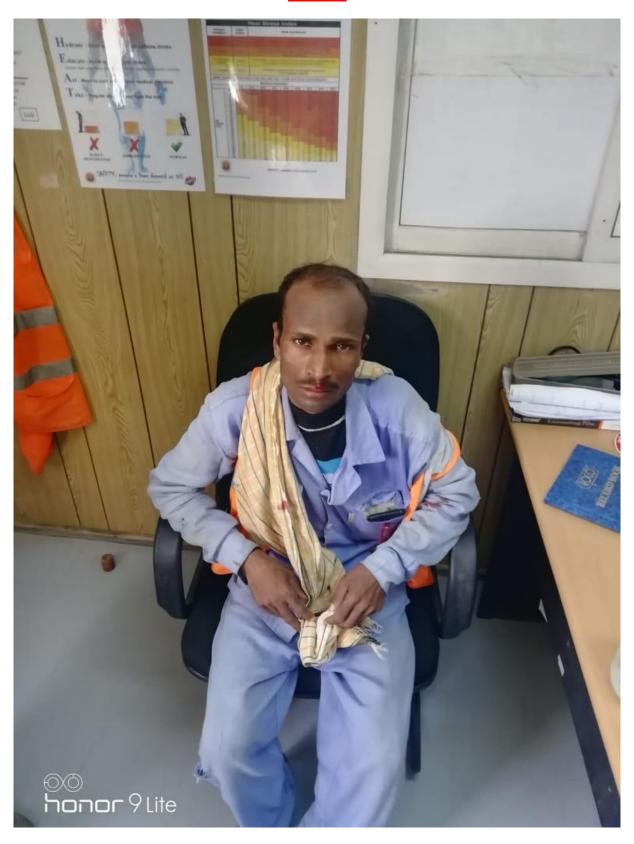
<u>Injury</u>

Ojir Miya (IP) was deputed by his foreman for the De-shutterring of formworks in part 1. While he was removing the plywood from the column with the help of crowbar, he pulled the crowbar with some significant force, the crowbar slipped from the plywood and the backside of the crowbar hit his face (between nose and lips). He got a deep cut as the backside of crowbar was sharp. He was working at a height of approx. 10m and he could have lost his balance because of this hit. Fortunately he was hooking his harness at the time of incident.

First aid was given to him in the first aid room and he was sent to hospital for further treatment.
