Incident and Injury Investigation Report

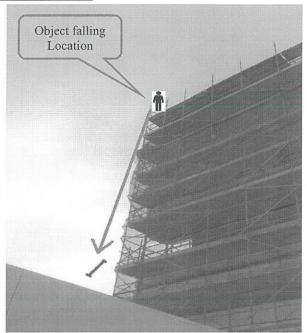
Incident Picture

incident?		N/A								
What was the machine/equi incident?	pment	doing at th	e of the	N/A	N/A					
What was the material/s / si incident	ubstand	ce/s doing		Scaffolding Ledger (Tube) was placed on bottom cup of cup lock						
Immediate Cause/s of the In	cident/	/injury:								
		Neglige	nce	of the Wor	ker (Erec	tor)				
Root Cause/s of the Incident	/injury	<i>7</i> :								
People: Poor Team W	ork by t	the worker	s, Wo	orker did not	get assista	nce				
Process / Ledger was le Procedure: erecting anoth				ock node (To	op Cup was	not locked o	on both end	ls of ledge	r) and	
Equipment:										
Workplace: Working on a	very hi	gh scaffold	ing p	latform in a	hot weathe	r conditions				
Corrective Action to prevent	reoccu	ırrence:								
Elimination:										
Substitution:										
Engineering Control: Safety	net to b	e installed	at an	appropriate	height to p	orevent falli	ng of object	:		
Administrative Control: Ref and erection of scaffolding, that workers are following a conditions during the hot w with the time interval, and	Adequathe erection to the erec	ate superv ction & dis conditions	ision mant s whe	have to be a tling procedu en assigning	vailable to ire. Also en for the job,	monitored to sure the wordstate the wordstat	he activity rker's phy	and to en sically & n	sure nental
